Experimental Investigation of Chevron Special Concentrically Braced Frames with
a Yielding Beam Plastic Mechanism

Master of Science in Civil Engineering

University of Washington
2018

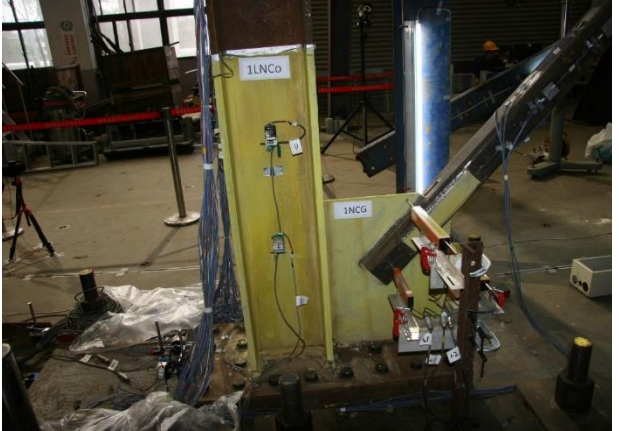
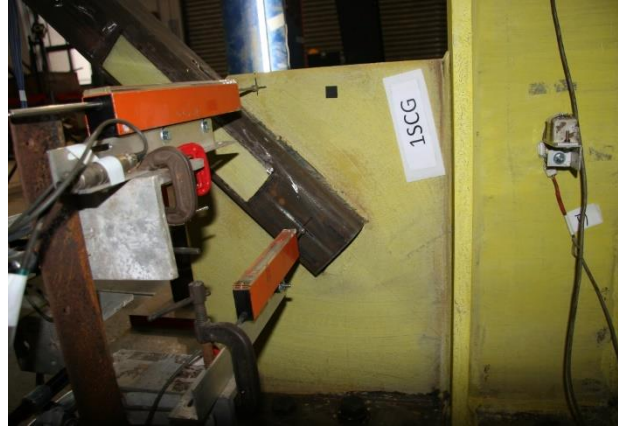
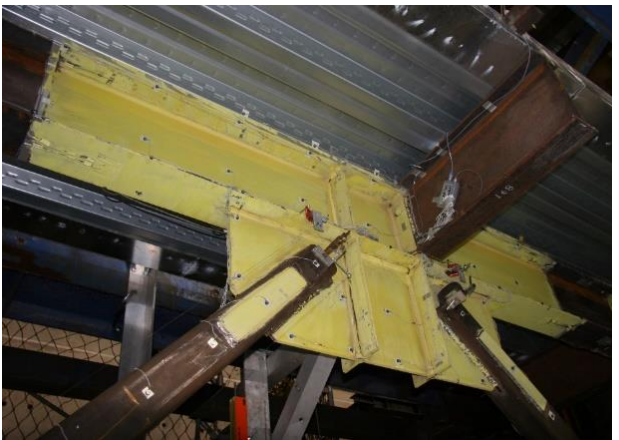
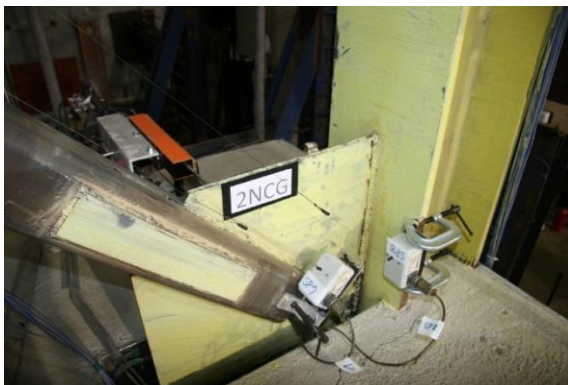
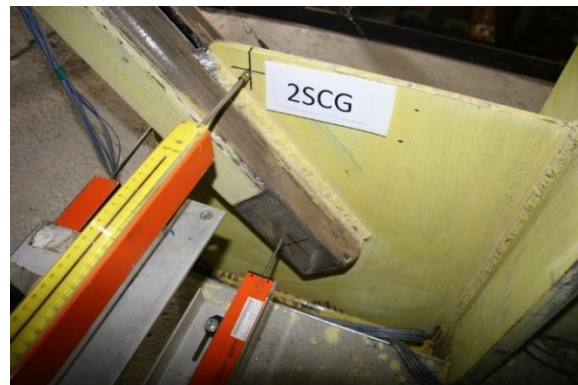
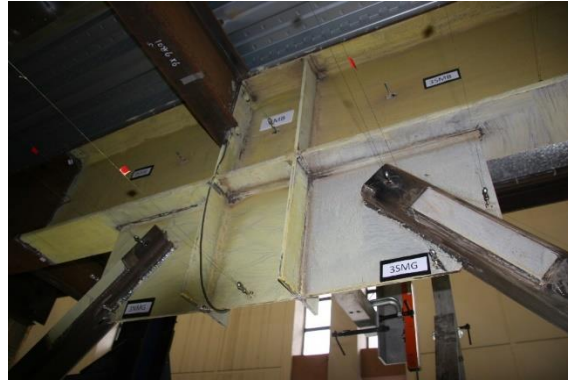
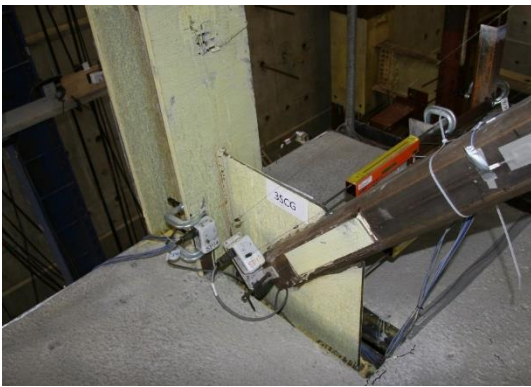
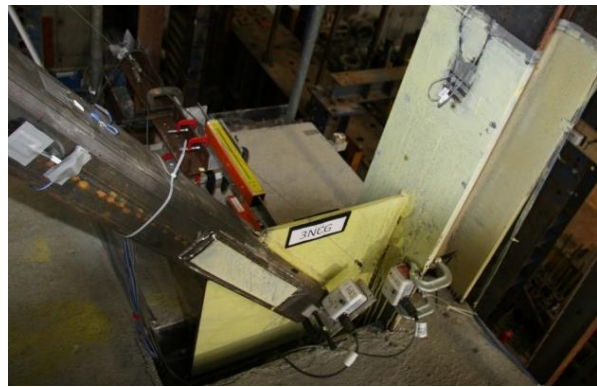
Figure 6.26 Initial Conditions

The following sections describe the progression of yielding and buckling of the SCBF components. Detailed review of the cyclic response is divided in three sections based on the extent of damage. In the initial state, global-frame response is largely elastic. The next part describes moderate damage of the frame after the braces have buckled. The frame then enters severe damage state when components have begun to sustain severe yielding and buckling and an ultimate fracture leads to instability. Discussion and test pictures focus on the first and second stories since inelastic action only occurred in these stories, as designed. For reference, images showing the initial condition of the frame are presented in Figure 6.26.

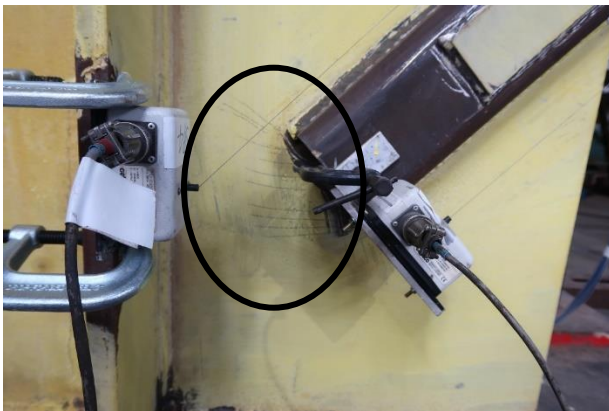
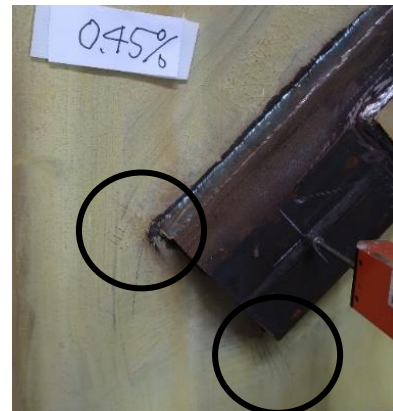
(a) 1SCG

(b) 1NCG

Figure 6.27 Story damage at low roof drifts
(Circled regions indicated observation of yield lines)

Roof	Drift (%)			Observed Damage
	1F	2F	3F	
0.15	0.12	0.16	0.17	<ul style="list-style-type: none"> Yield lines near the toe of brace-to-gusset weld on east and west faces of the gusset plate at 1NCG, 1SCG, 2NCG, 2SCG as shown in Figure 6.27 (a), and (b). This is likely from welding heat effects on the plate

0.30	0.26	0.32	0.33	<ul style="list-style-type: none"> Yielding at the corner of the gusset plate at 1SCG and 1NCG, 2SCG and 2NCG Initial beam yielding at 1SMB, 1NMB, 2SMB, and 2NMB on the flange at the edge of the mid gusset plate weld as shown in Figure 6.27 (d).

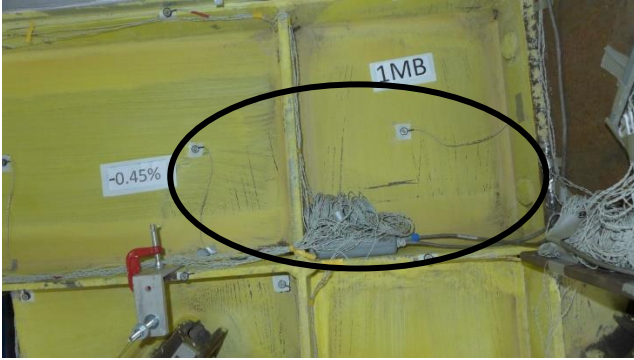
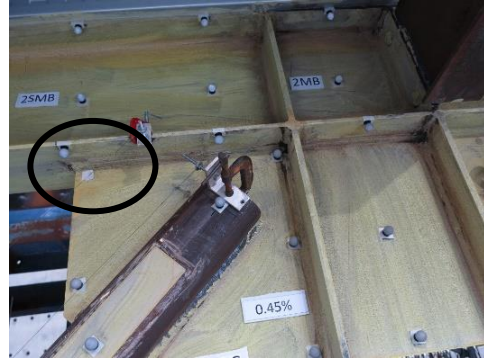
(c) 1MB

(d) 2MB

0.43	0.49	0.45	0.45	<ul style="list-style-type: none"> 1st story braces buckle, first south (first cycle) then north (second cycle). There was a large and sudden deformation upon initial buckling evident in Figure 6.27 (e) and (f). Yielding of beam web at 1MB and 1FSB and of flanges at 1SMB 1NMB, shown in Figure 6.27 (c). Initial yielding of beam flanges at 2SMB 2NMB and beam web at 2MB and 2FSB and 2FNB yielding on outer and inner flange above the gusset plates at 1LSCo and 1LNCo

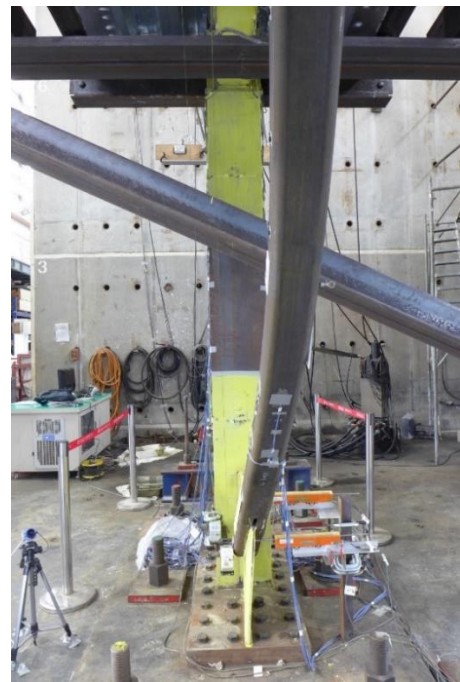
(f) 1SBr buckled at -0.45% roof drift

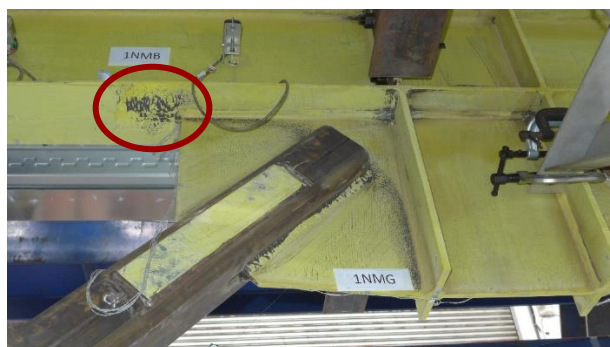
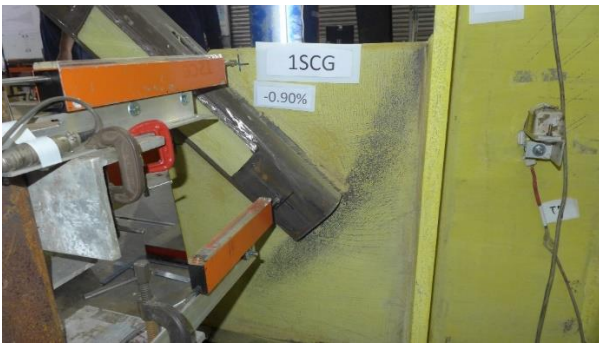
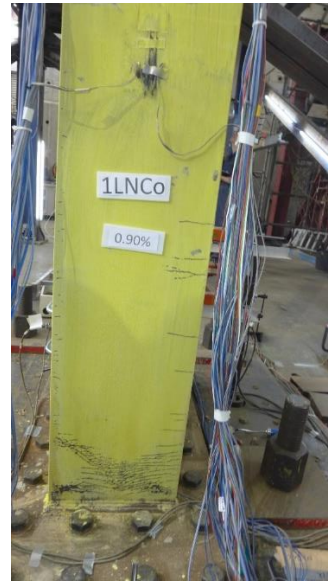
(a) 1NMB

(c) 1SCG

(d) 1LNCo

Figure 6.28 1st story damage at 0.9% roof drift

0.90	1.14	1.15	0.45	<ul style="list-style-type: none"> • Yielding at the bottom flange of 2FSB and 2FNB and top flange at 2MB and 2FNB and 2FSB. The damage at the first story was consistent with the second story at these locations as shown in Figure 6.28 and Figure 6.29 (c) (d) and (e) • Initial yielding at 1UNCo • Local buckling in 2SMB flange • Moderate yielding at gusset plates and beams, shown in Figure 6.29 (a) (b) (e)

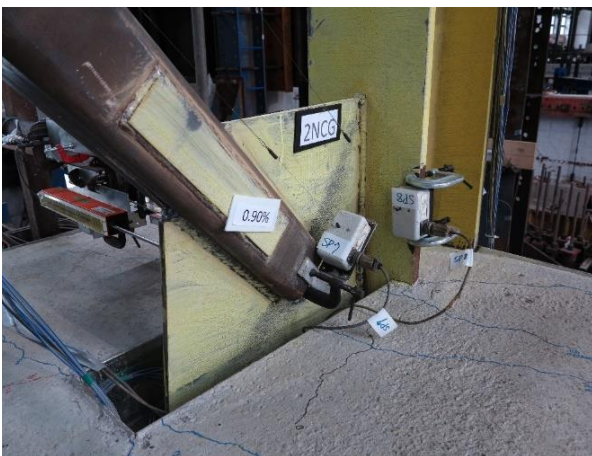
(a) 2NCG

Figure 6.29 2nd Story damage at 0.9% drift

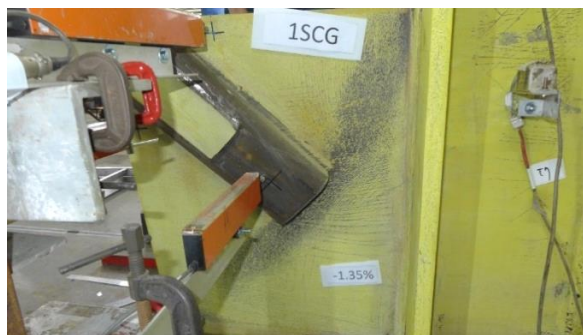
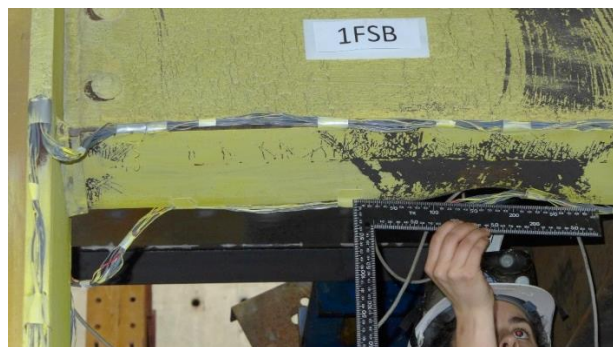
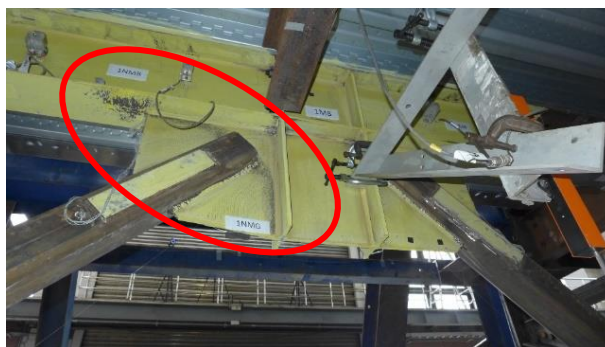
Figure 6.30 1st story damage at 1.35% roof drift

1.35	1.80	1.71	0.50	<ul style="list-style-type: none"> • Visible separation of deck and top beam flange at 1B(SL) • Initial buckling of flange at 2NMB • Moderate local buckling of top and bottom flanges on 1FNB and 1FSB. Buckling at beam ends begins just past the edge of the second story corner gusset plate shown in Figure 6.30 (c) • Continued yielding of 1LNCo and 1LSCo at the web, shown in Figure 6.30 (a) • 2LSCo initial yielding near corner gusset • 2USCo and 2UNCo flange yielding at beam-column connection, shown in Figure 6.30 (b) • Moderate yielding at beams and gussets on first and second stories as seen in Figure 6.30 (b) and (d) and Figure 6.31 (a)(c)(d)

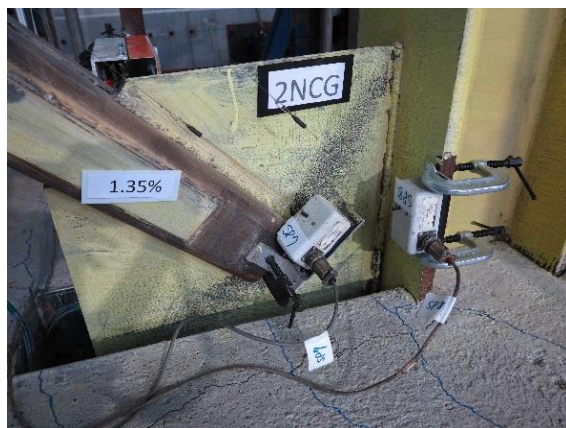
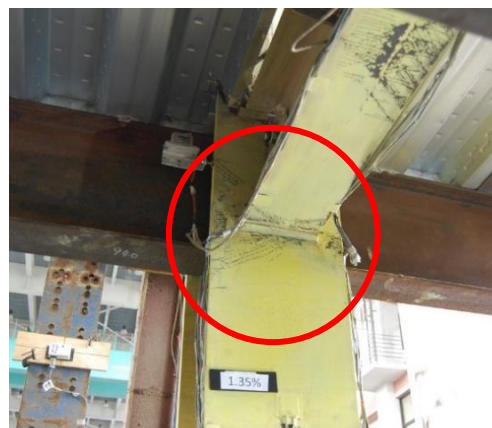
Figure 6.31 2nd story damage at 1.35% roof drift

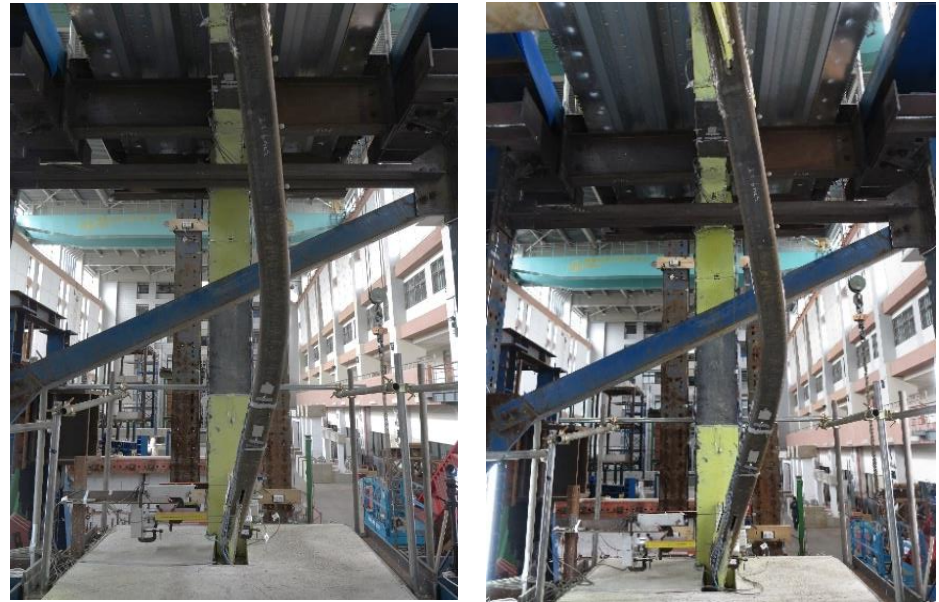
Figure 6.33 2NBr buckled braces at moderate roof drifts

(a) 0.9% roof drift

(b) 1.35 % roof drift

Roof	Drift (%)			Observed Damage
	1F	2F	3F	
0.60	0.86	0.70	0.46	<ul style="list-style-type: none"> • 2LNCo yielding on outer and inner flange above the gusset plates • 2LSCo yielding of bottom flange at 1FSB and 1FNB • 2NBr and 2SBr buckle, first at the south then the north. The deformation is evident in Figure 6.34 (a)

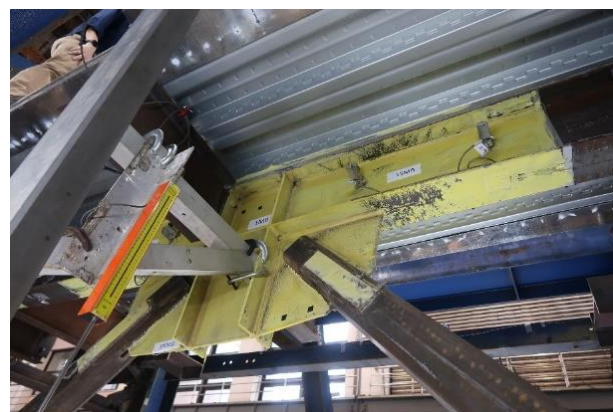
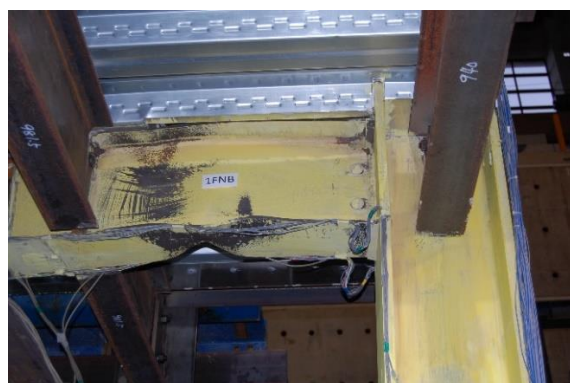
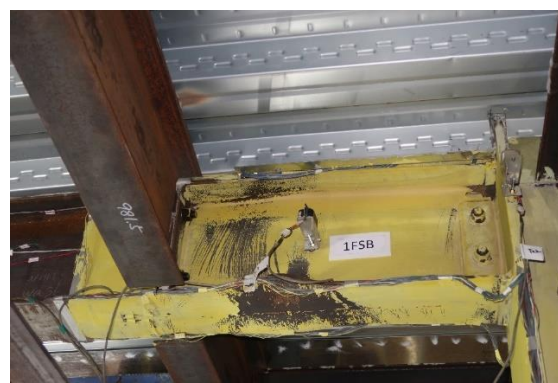
Figure 6.35 1st Story damage at 1.8% roof drift

Roof	Drift (%)			Observed Damage
	1F	2F	3F	
1.80	2.50	2.40	0.54	<ul style="list-style-type: none"> • Initial local buckling at 1LNCo flanges and severe yielding shown in Figure 6.35 (a) • Severe local buckling at flanges of 1FNB and 1FSB (24mm) shown in Figure 6.35 (b) • 2MB separation with slab • 1FSB and 1FNB web local buckling and severe flange local buckling and severe yielding evident in Figure 6.35 (c) and (d) • 1FMB max beam to slab separation at the end of the middle transverse beam was 90mm • Initial yielding at 2UNCo web at the moment connection seen in Figure 6.36 (b)

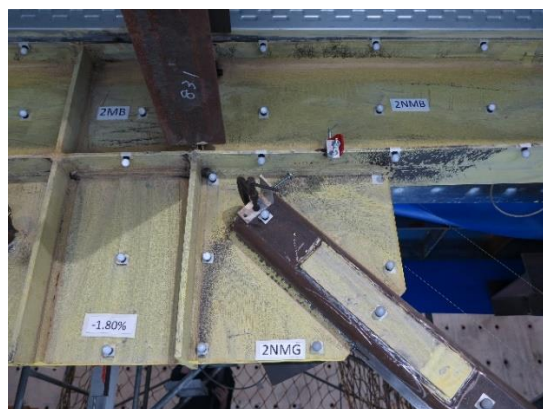
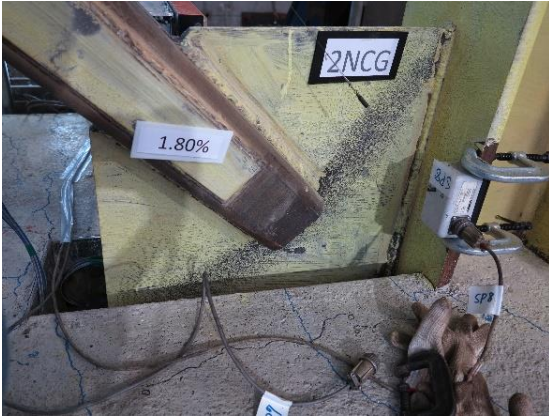
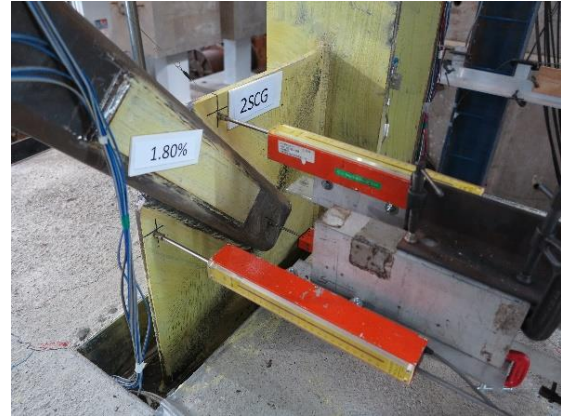
Figure 6.36 2nd story damage at 1.8% roof drift

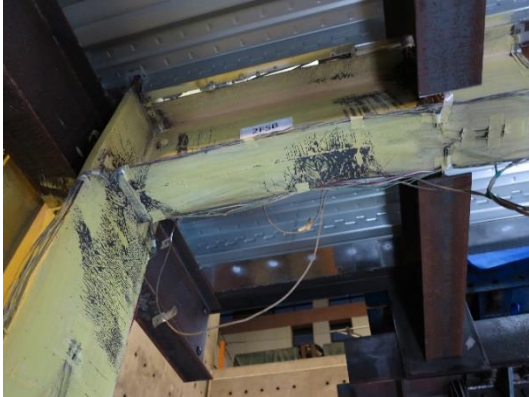
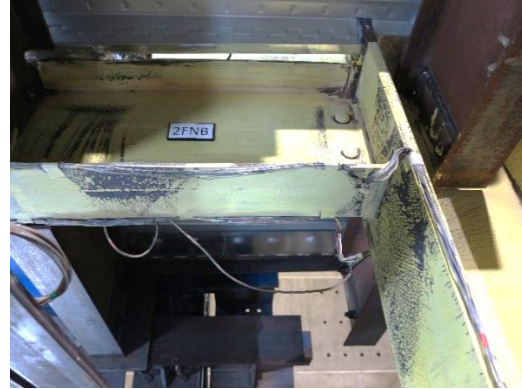
Figure 6.37 2nd Story damage at 2.25% roof drift before column fracture

2.25	3.15	3.02	0.61	<ul style="list-style-type: none"> • Minimal cupping @ 1NBr and 1SBr • 13mm separation between 1MB and slab • Buckling of bottom flange at 2SMB is 38mm • Severe yielding at beam middle and ends, and at the first story columns • There was little yielding 2LNCo and 2LSCo • Severe yielding at 2USCo and 2UNCo inner flanges shown in Figure 6.37 (a) and (b) • Moderate yielding at 2USCo and 2UNCo web at the moment connection seen in Figure 6.37 (c) • When moving toward the second peak of +2.25% roof drift the 2USCo flange fractured behind the bottom beam flange backing bar at the moment connection shown in Figure 6.41. The crack propagated halfway through the web of the column as seen in image (d)
-4.0	-5.9	-5.4	-0.84	<ul style="list-style-type: none"> • Little cupping at 2SBr shown in Figure 6.38

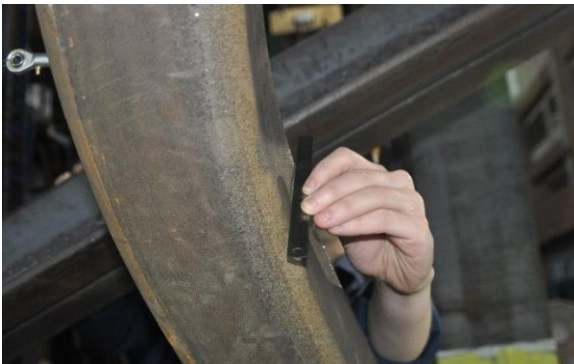
(a) 1NBr at +2.25% roof drift with minimal cupping

Figure 6.38 Brace local buckling

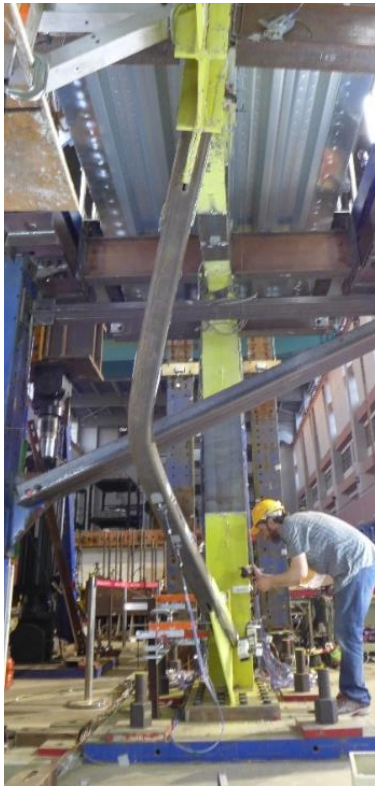
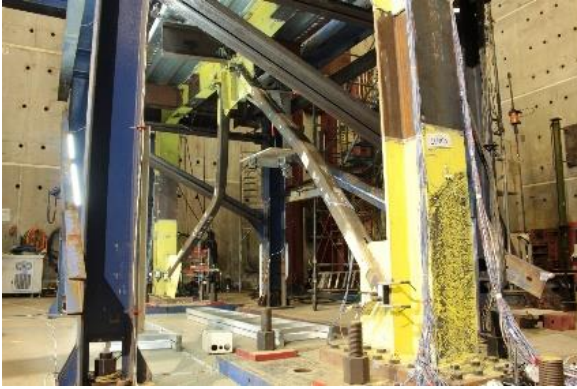
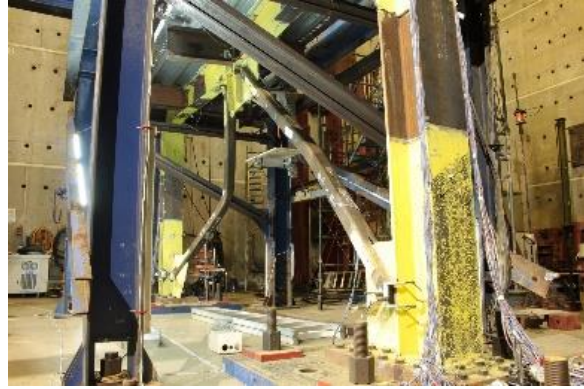
Figure 6.39 1st story buckled braces at high roof drifts

Severe damaged is defined to occur above 1.8% roof drift, which approximately corresponds to 2.5% first and second story drift. Images of the deformed brace shape at each cycle are shown in Figure 6.39 and Figure 6.40.

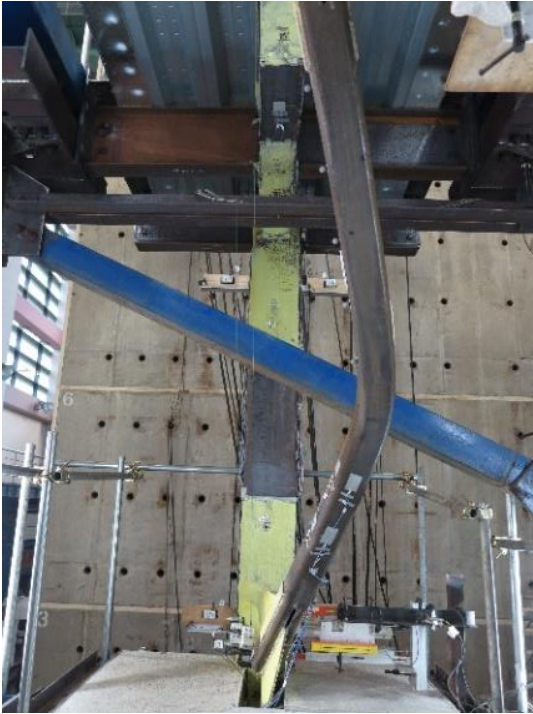
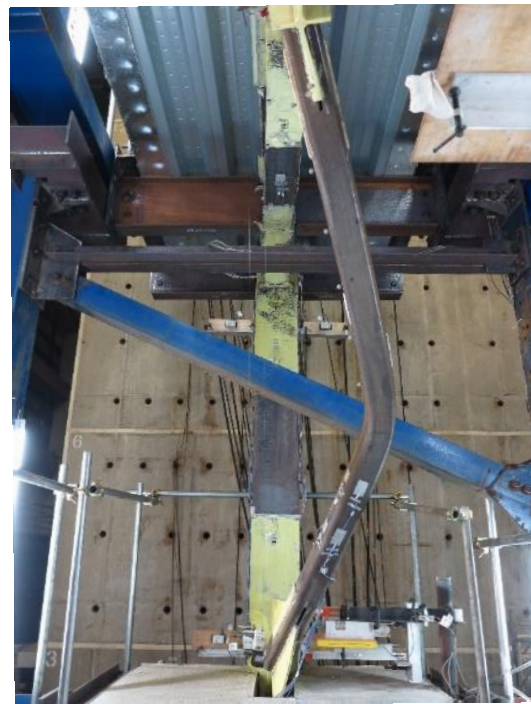
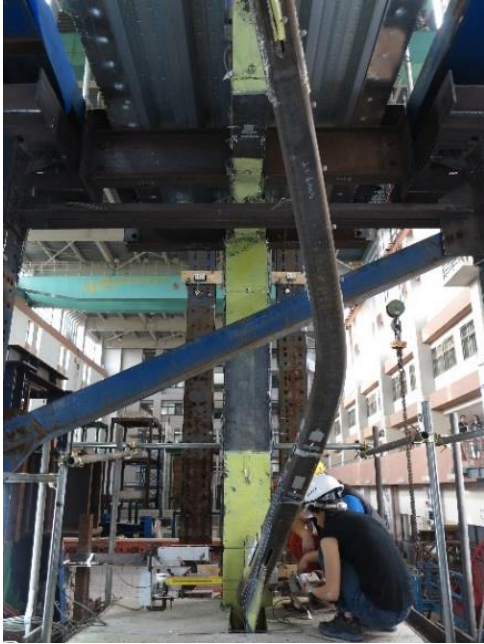
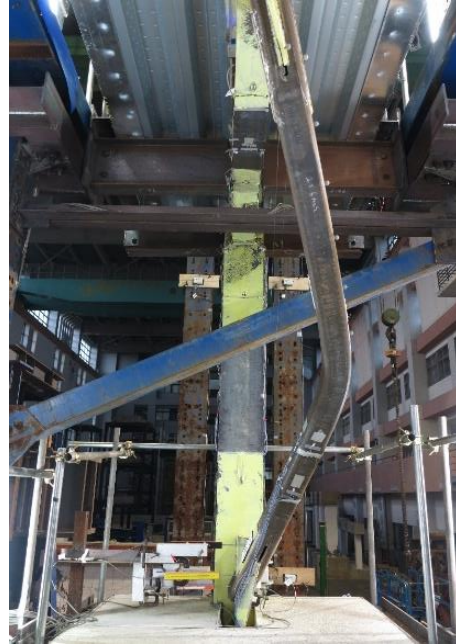
Figure 6.40 2nd Story buckled braces at high roof drifts

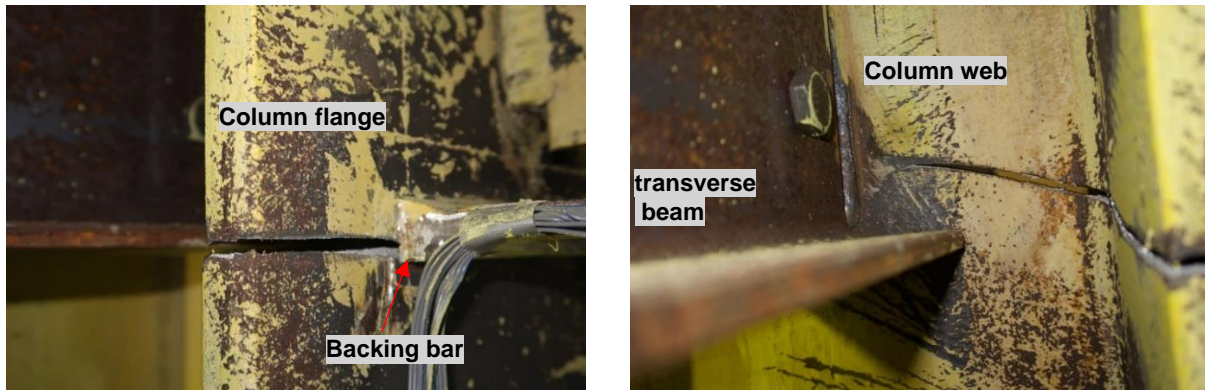
(c) fracture at backing bar

Figure 6.41 Fracture at 2USCo

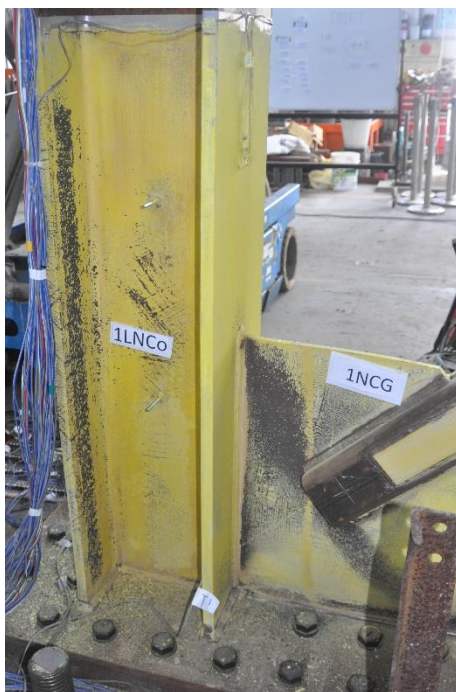
(a) 1LNCo

Figure 6.42 Final condition of 1st story

- Severe yielding of lower column and beam flanges and web, and severe local buckling of flanges and webs at plastic hinge location as seen in Figure 6.42 (a) (b) (e) and (f)
- Both braces bucked in the same direction towards the west
- Only initial yielding incurred at col 1USCo and the column web at the moment connection
- Yielding on the beam was concentrated around the edges of the gusset plates
- Shear stud separation from the concrete occurred between the two outer transverse beams as seen in Figure 6.42 (c) and (d) where 10 studs pulled out. When the studs elongated, the slab cracked longitudinally.
- The slab and beam rotated significantly, in the final condition the east side was lower than the west as shown in Figure 6.42 (g)
- The plastic hinge formed on the at 1NMB, which is distinguishable in Figure 6.42 (c) and (d)

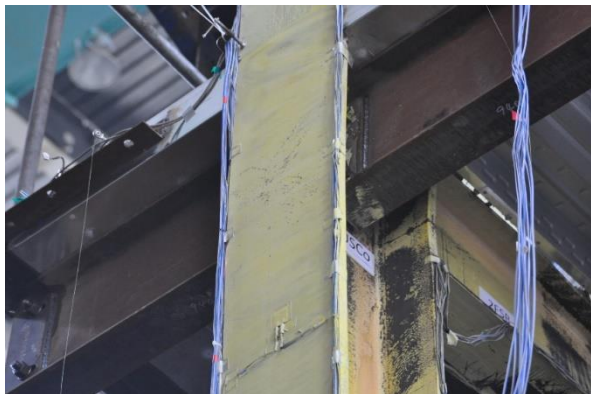
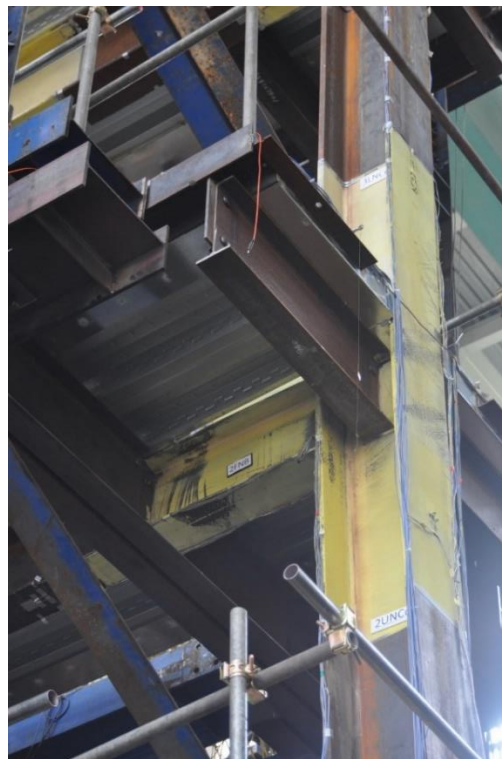
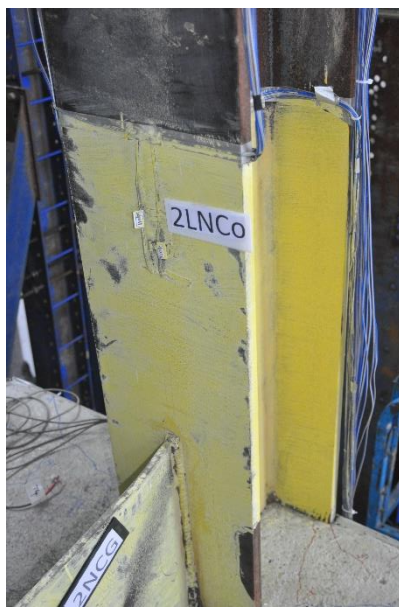
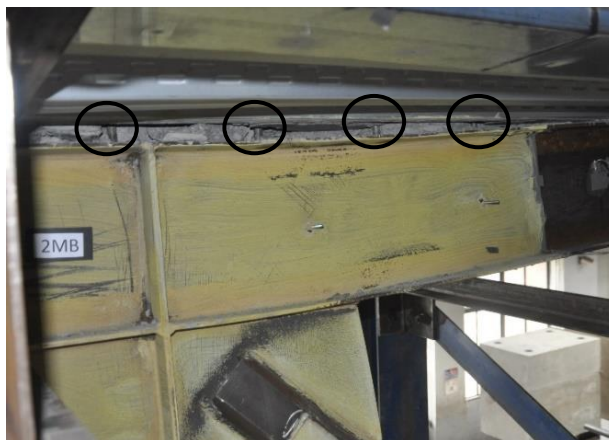
Figure 6.43 Final condition of 2nd story

- More yielding was observed on 1LSCo than 1LNCo
- More yielding was observed at 2UNCo than at 2USCo outer flange
- More yielding was observed on 2USCo than 2UNCo column web at the beam-to-column moment connection and inner flange
- There was little to no yielding of 2LNCo and 2LSCo
- More yielding was observed at 3LNCo than 3LSCo outer flange
- Beam flange buckling and yielding at the beam-end plastic hinges was more severe at the first story than the second story

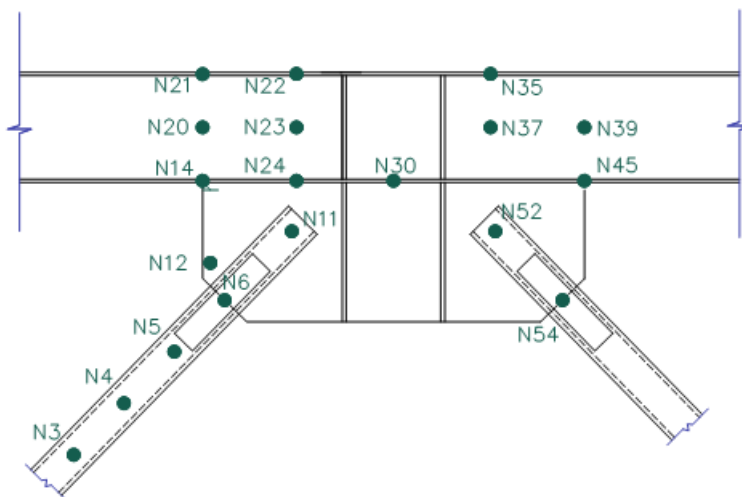
Figure 6.49 Sensor locations on the beam used for out of plane movement calculation
