WRIA 20 Inventory and Characterization Report (ICR)

Prepared by
Miranda Wecker and Rebekah Gentry
UW Olympic Natural Resources Center
Revised June 6, 2011

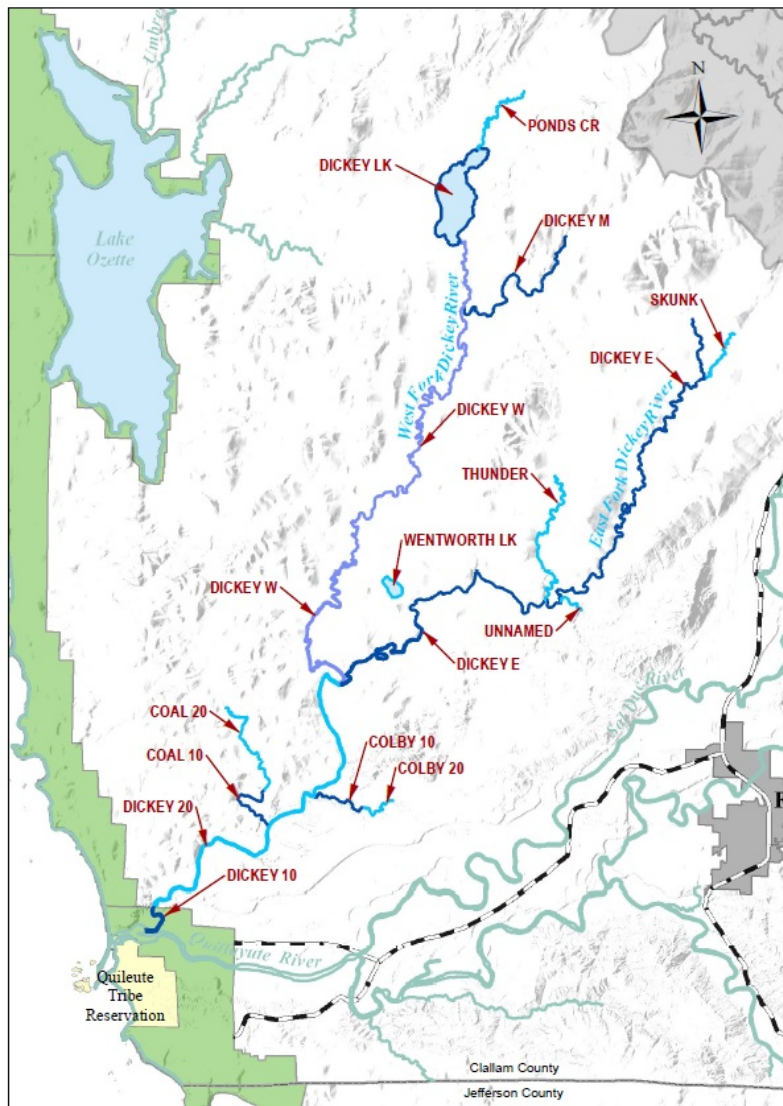
The Dickey System

The Dickey River is a major tributary that drains into the Quillayute River about 1.5 miles from the Pacific Ocean. The Dickey Watershed extends from ridge tops reaching 1,200 to 1,400 feet in elevation to the mouth near sea level. Most of the subbasin is low elevation, lying below 440 feet. The Dickey basin contains the mainstem segments DICKEY 10-20 (8.7 miles long); three major tributaries: DICKEY E (16.5 miles), DICKEY W (14.9 miles) and DICKEY M (4 miles); several creeks: COAL 10 (~1.4 miles), COAL 20 (~2.5 miles), COLBY (~1.2 miles), PONDS CR (2 miles), SKUNK (1.3 miles) and THUNDER (3.5 miles); and the two lakes: WENTWORTH LAKE and DICKEY LAKE (520 acres). An estimated 830 acres of wetland areas occur within the subbasin, most of which are concentrated in the DICKEY W. An unnamed tributary that meets the definition of shoreline of statewide significance flows into DICKEY E.
