DETERIORATION OF GREEN CONFLICT PAINT FOR BICYCLE FACILITIES

FINAL PROJECT REPORT

Emad Kassem, Michael Lowry, Ebenezer Fanijo, and Maged Mohamed
University of Idaho

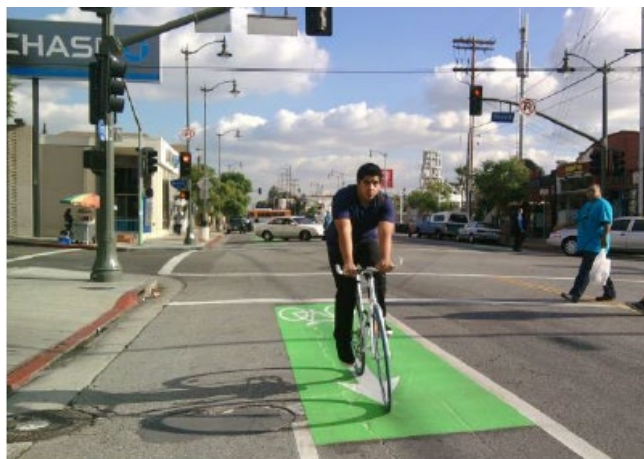
Figure 2.1. Green conflict paint used to enhance bike lane visibility (NACTO, 2012).

Bike lanes are part of a roadway adjacent to the car's travel lane that should be occupied only by bicyclists. Bike lanes are commonly installed on the right side of the roadway and are defined by longitudinal pavement markings to show their area boundaries and to direct bicyclists in the right direction. Bike lanes may be entirely colored with bright colors to increase safety. Recently, colored bike facilities have been used to establish order in the roadway and enhance road safety by providing a specific area for bicyclists that will minimize conflict with cars as much as possible. Figure 2.1 shows a green lane installed.

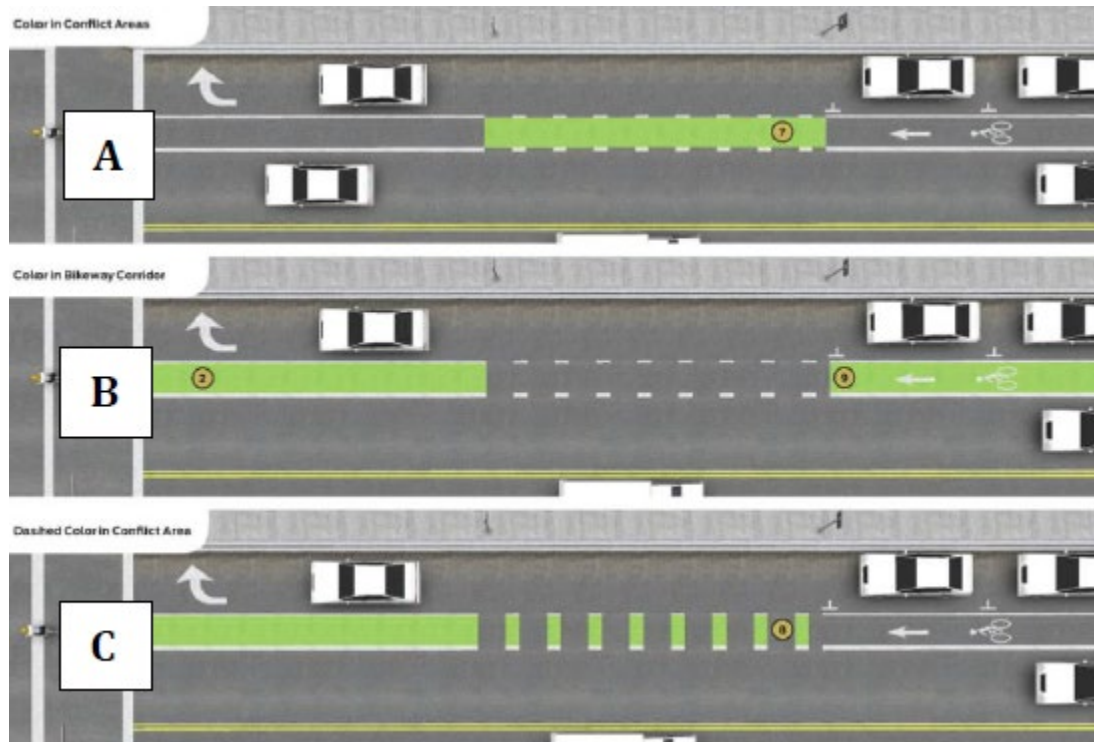
Figure 2.2. Three design alternatives for conflict zones at right turn pockets (NACTO, 2012).

where right turn pockets are present. Figure 2.2 shows the three suggested designs. Design A (top) specifies solid green paint for the conflict zone. Design B is the opposite application (i.e., green paint in the bike lane but not in the conflict zone). Design C uses dashed green paint for the conflict zone and solid green before the stop bar.

Research is needed to examine various aspects of green conflict paint, including its durability and optimal performance. Some cities have chosen to use Design C on the assumption that dashes are more visible to motorists and because it is less expensive. Research is needed to verify whether dashes have the added benefit of providing better friction for motorists and bicyclists. If this is true, then perhaps solid paint should not be used near the stop bar or at any location where bicyclists are expected to stop suddenly. Friction should be tested under varying degrees of deterioration, weather conditions, and paint materials. The MUTCD's interim approval includes recommendations for daytime and nighttime chromaticity. However, because green paint is new to traffic engineering, it is not clear how the colored paint under the specification will withstand deterioration. Perhaps other color specifications will maintain color better. The MUTCD interim approval does not specify retroreflectivity requirements. Because

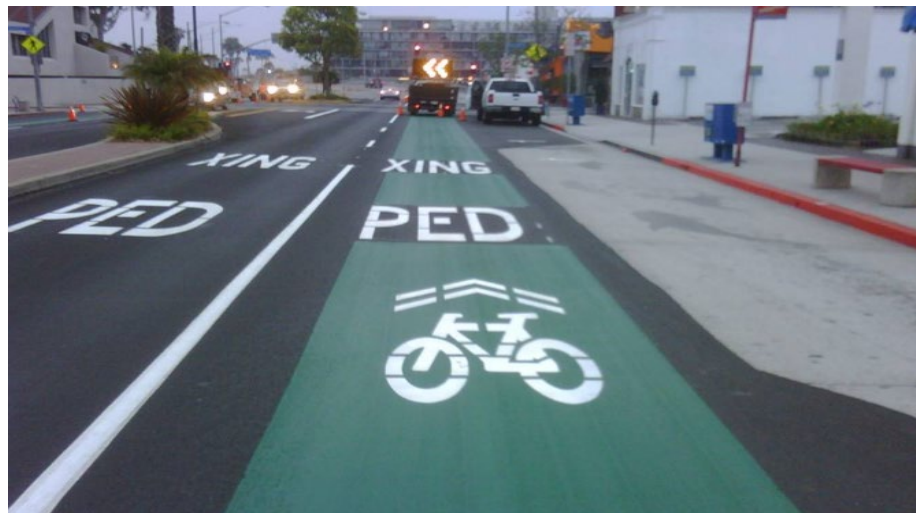
Figure 2.3. A typical green bike lane (NACTO, 2012).

Waterborne markings (which can also be called traffic paint or Latex) often have less than one year of expected service life. Therefore, they are considered nondurable pavement markings. Even though waterborne markings have a shorter service life than other marking materials, they are still extensively used on road facilities because of their lower cost and more eco-friendly characteristics in comparison to other products. Waterborne markings are recommended for use on low-volume roads or for use as an interim pavement marking material because they are easily worn by tires and winter maintenance machinery such as snowplows and often require annual maintenance. Figure 2.3 shows an application of a green bike lane made with a waterborne material.

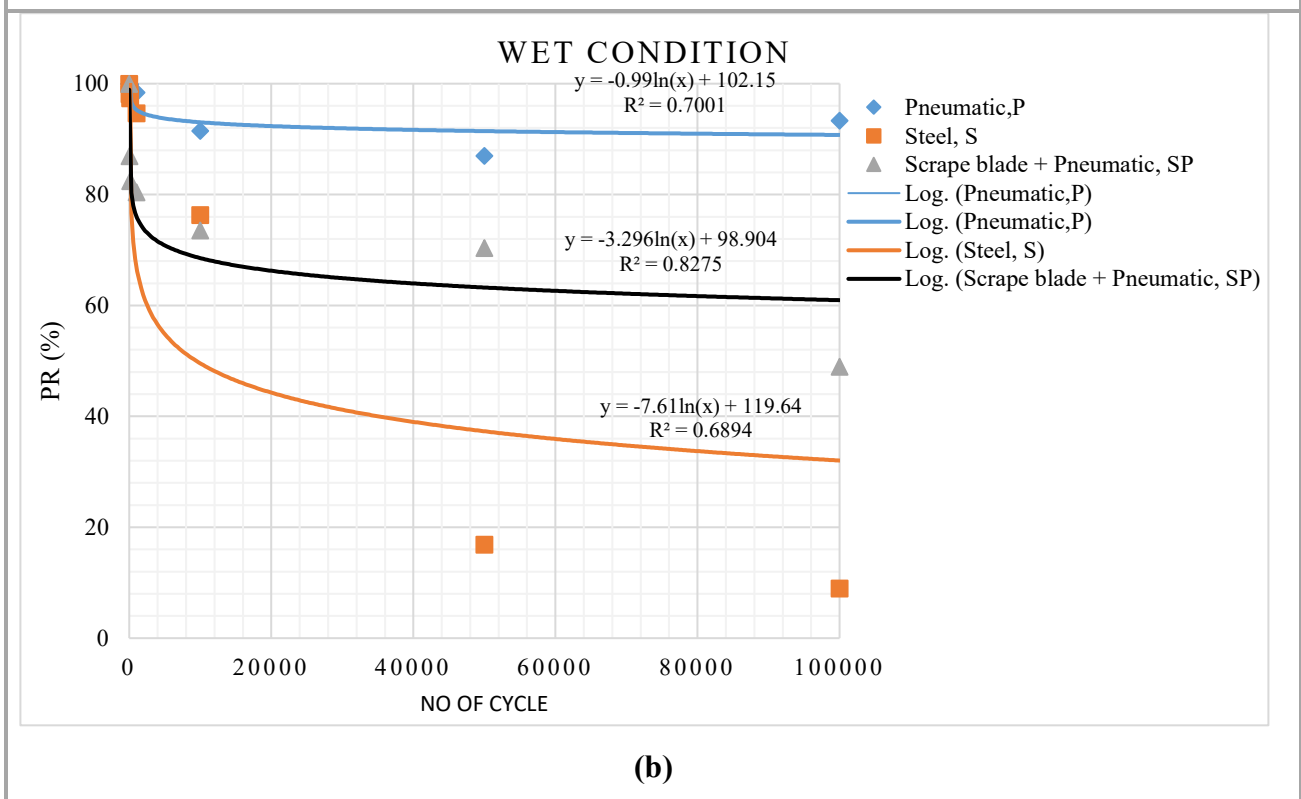
Figure 4.1. A plot of the percentage of retroreflectivity at different loading conditions for thermoplastic materials in (a) dry and (b) wet conditions

Figure 4.1 shows the percentage of retroreflectivity (PR) versus number of cycles under each loading wheelset for the thermoplastic pavement marking in wet and dry conditions. As expected, the retroreflectivity for the test samples decreased with the number of cycles. The drop in retroreflectivity was significant from the start to 10,000 cycles, whereas the drop was relatively small between 10,000 to 100,000 cycles, after which the test was terminated. These results were similar to the performance of pavement markings in the field. According to Kopf (2004) and Mohamed et al. (2019), the retroreflectivity of pavement markings drastically decreased immediately after installation, followed by a stable drop until the end of their service life (Kopf, 2004; Mohamed et al., 2019).

The percentage of loss in retroreflectivity (LIR) for the thermoplastic materials tested under the steel wheelset was higher (about 78 percent reduction after 100,000 cycles) than under the pneumatic wheelset (25 percent reduction) or scraper blade set (50 percent reduction). This was due to the harsh polishing conditions caused by the steel wheelset. The steel wheelset severely changed the surface of the test samples even after 10,000 cycles (30 percent reduction

after 10,000 cycles). The scraper blade set also caused significant reduction in retroreflectivity (about 50 percent) because of the abrasion caused by the blade. Furthermore, the percentage of loss in retroreflectivity in wet conditions was higher than in dry conditions. For example, the thermoplastic materials experienced a drop of 91 percent in PR under the steel wheelset in wet conditions in comparison to a 78 percent drop in dry conditions. This was also consistent with the findings from Mohamed et al. (2019).

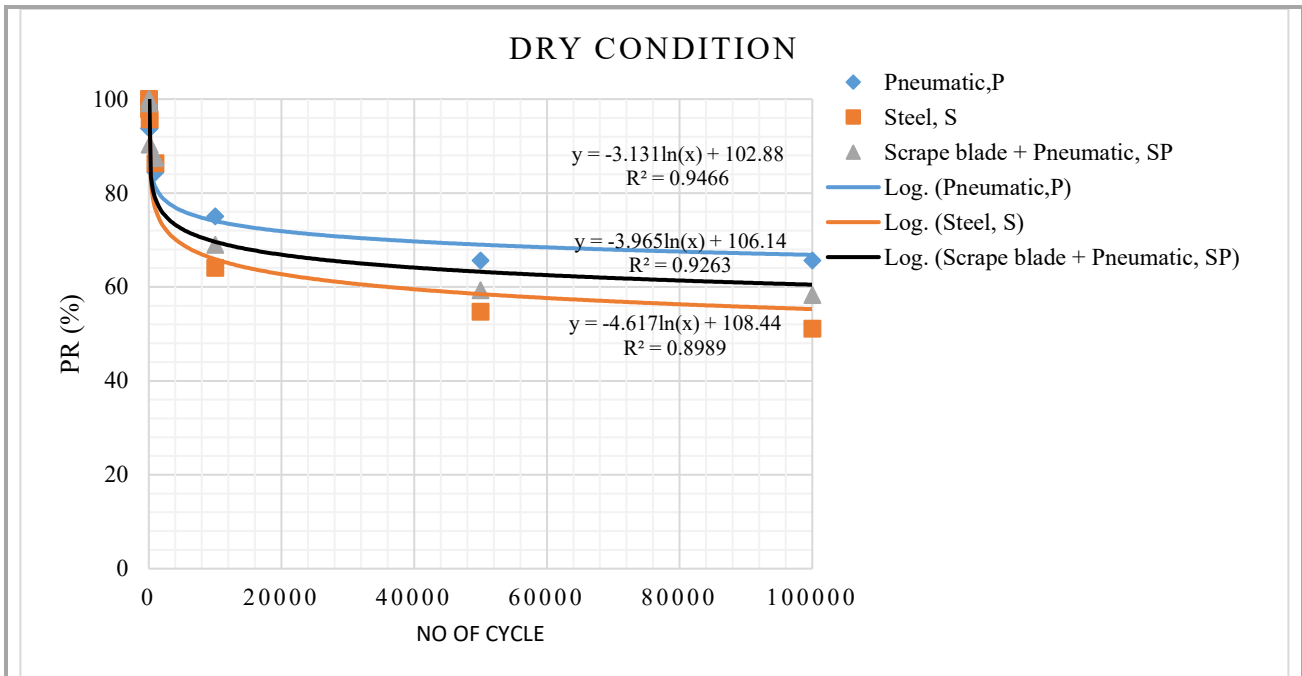
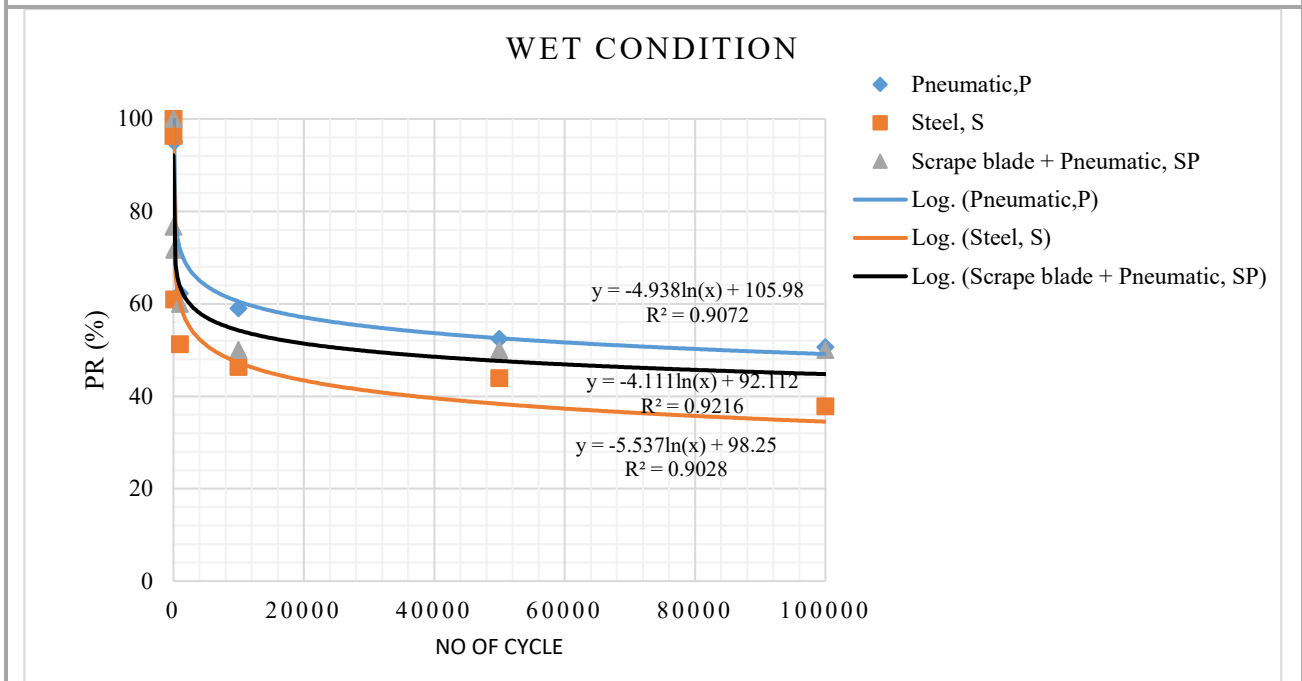
Figure 4.2. A plot of the percentage of retroreflectivity at different loading conditions for MMA materials in (a) dry and (b) wet conditions

Figure 4.2 shows the PR for the MME materials under different loading conditions in wet and dry conditions. The loss in retroreflectivity for the MME materials followed a trend similar to that of the thermoplastic materials. However, the LIR was generally less than that of the thermoplastic paint, in which, after 100,000 cycles, the LIR was 49 percent for the steel wheelset, 42 percent for the scraper blade set, and 34 percent for the pneumatic wheelset in dry conditions.

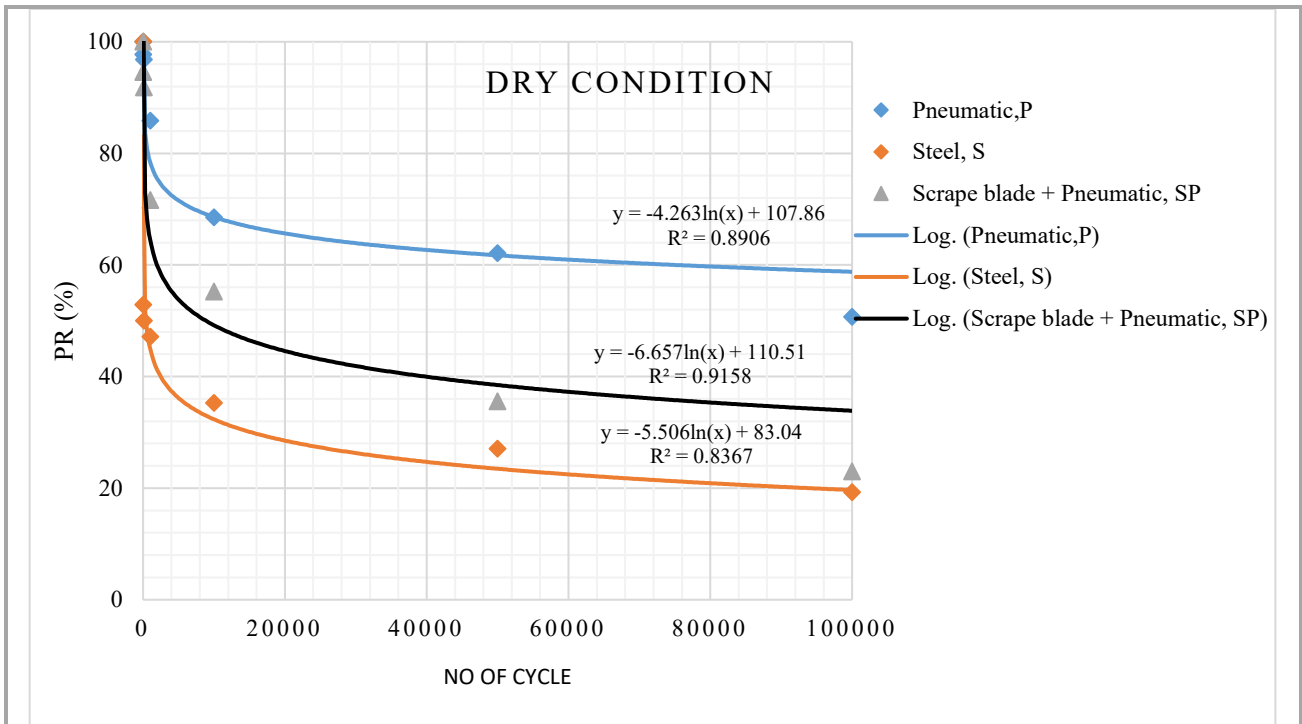
Figure 4.3. A plot of the percentage of retroreflectivity at different loading conditions for waterborne (with glass beads) material in (a) dry conditions and (b) wet conditions

Figure 4.3 shows the PR under different loading conditions in wet and dry conditions for the green waterborne paint mixed with glass beads, figure 4.4 shows the results for the green waterborne paint without glass beads. Like thermoplastic and MME materials, retroreflectivity decreased with the loading cycles. In comparing the retroreflectivity performance of the waterborne paint with glass beads to the one without glass beads, overall, the former had a smaller percentage of loss than the latter in both dry and wet conditions. This is could be because the waterborne paint without glass beads had lower retroreflectivity than the waterborne paint with glass beads. Also, note that the green waterborne paint was thinner in comparison to the thermoplastic and MME materials at the surface. A noticeable reduction in thickness was observed for the waterborne paint even after only 1,000 cycles.

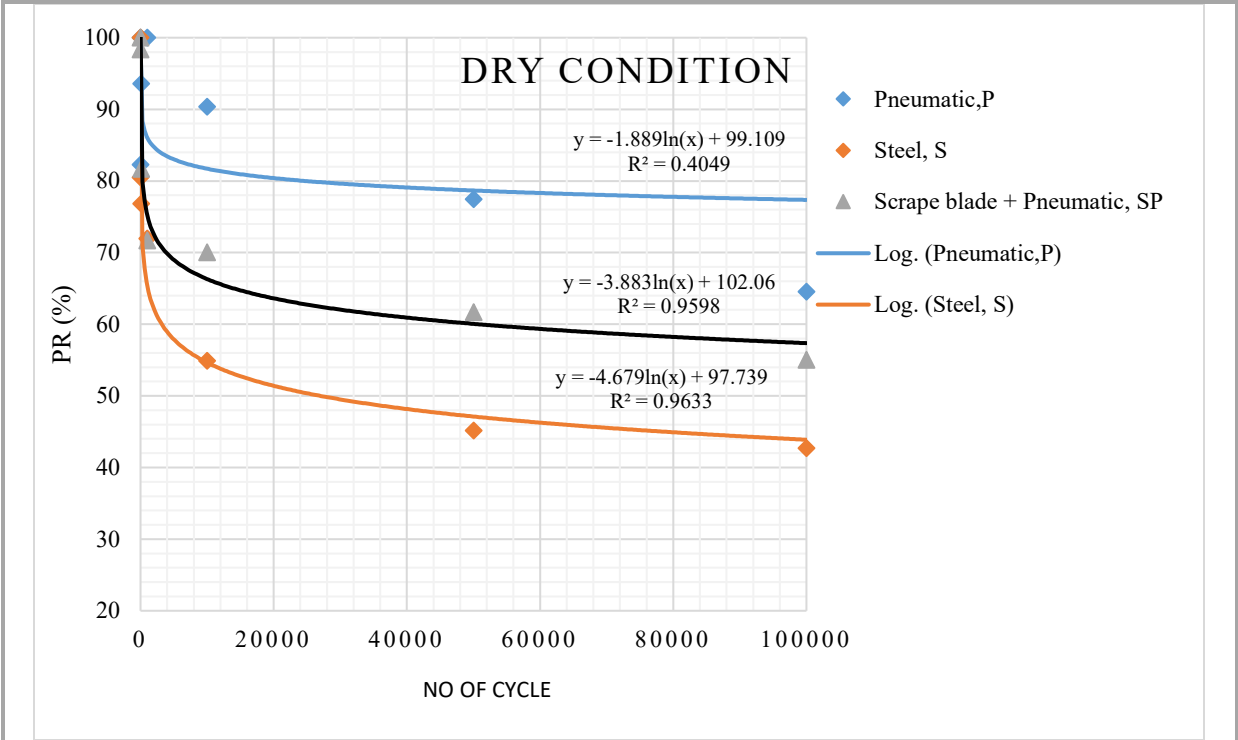
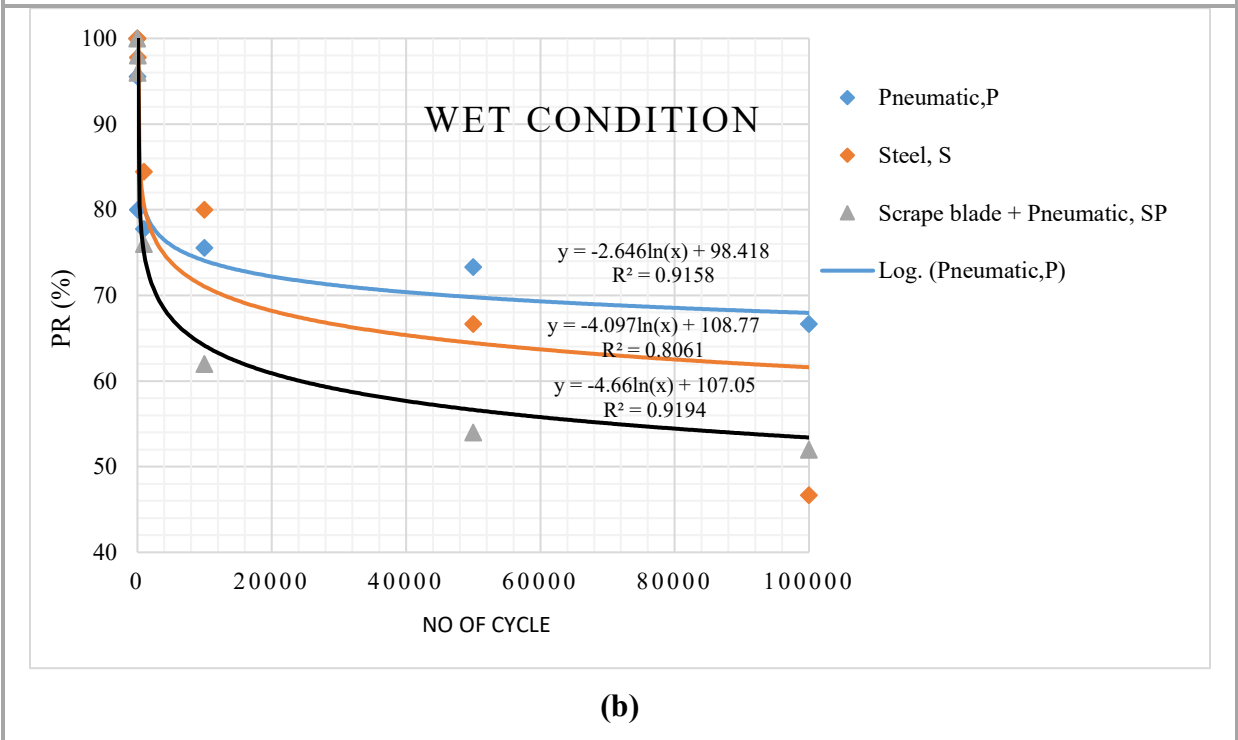
Figure 4.4. A plot of the percentage of retroreflectivity at different loading conditions for waterborne (without glass beads) material in (a) dry conditions and (b) wet conditions.

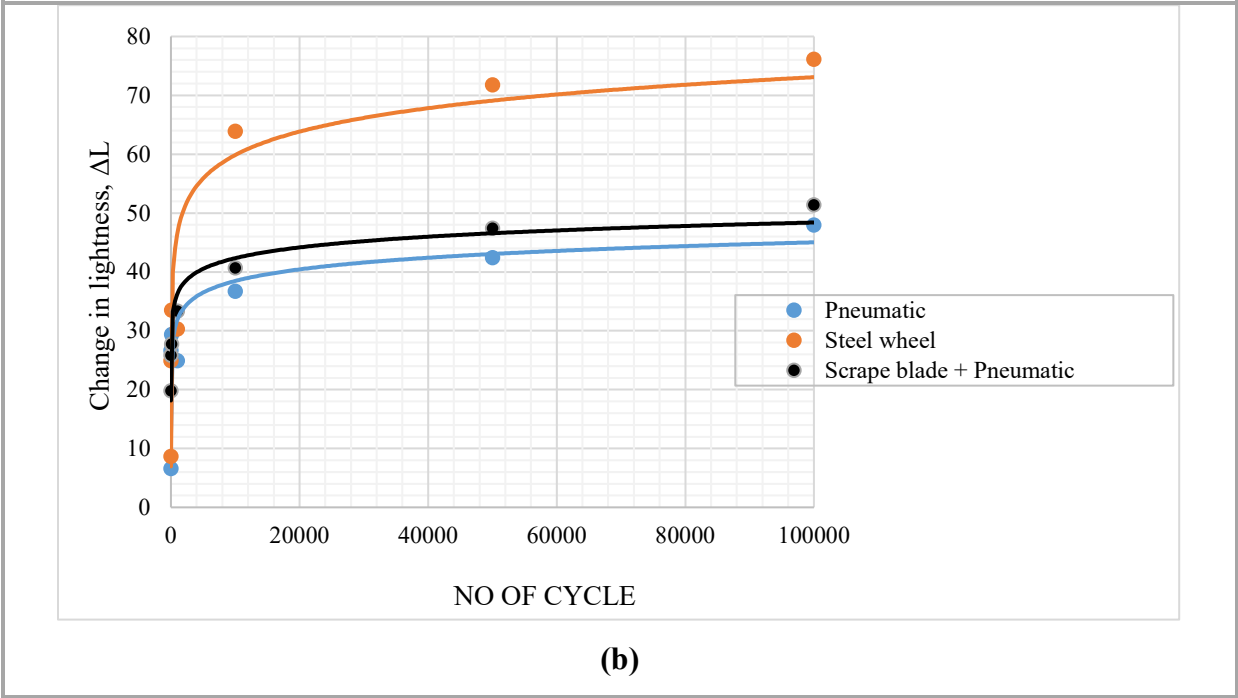
Figure 4.5. Changes of the thermoplastic material due to different loading conditions in (a) color; (b) lightness

The color difference was used in this research as a performance measure to quantify the effect of different conditions on the original color of the test samples. Figure 4.5 through figure 4.8 show the total color change (ΔE_{ab}) and change in lightness (ΔL) versus number of cycles for the thermoplastic, MMA, and waterborne materials, respectively, under different loading conditions. The ΔL and ΔE_{ab} for all samples tended to follow a logarithmic function similar to that of retroreflectivity. In figure 4.5 through figure 4.8, the zero value in ΔE_{ab} and ΔL is the starting color for each material, and the higher the number, the lower the visibility (drop in color) of the sample. For thermoplastic marking materials, no significant changes in ΔE_{ab} and ΔL were observed under the pneumatic wheel in comparison to the scraper blade and steel wheelsets (figure 4.5a and 4.5b). This drop in color was due to the harsh effect of the steel and scraper blade on the pavement marking, which negatively affected the surface color as the number of cycles increased. The steel and the scraper blade wheelsets were more abrasive than the pneumatic wheelsets, which was consistent with the loss of retroreflectivity and previous findings by Mohamed et al. (2019; 2020).

In general, a gradual change in ΔL and ΔE_{ab} was observed throughout the laboratory experiments. The increase in the total color change (ΔE_{ab}) and lightness change (ΔL) were related to the loss in retroreflectivity. The ΔL of the pneumatic, scraper blade, and steel wheelset followed a trend similar to that of the ΔE_{ab} from 10,000 to 100,000 cycles. The MMA paint experienced the lowest color loss even after 100,000 cycles, irrespective of the exposure and the testing conditions. Also, it was observed that as the number of cycles of the pneumatic wheels increased, the color of each of the pavement markings darkened. The lightness loss could have

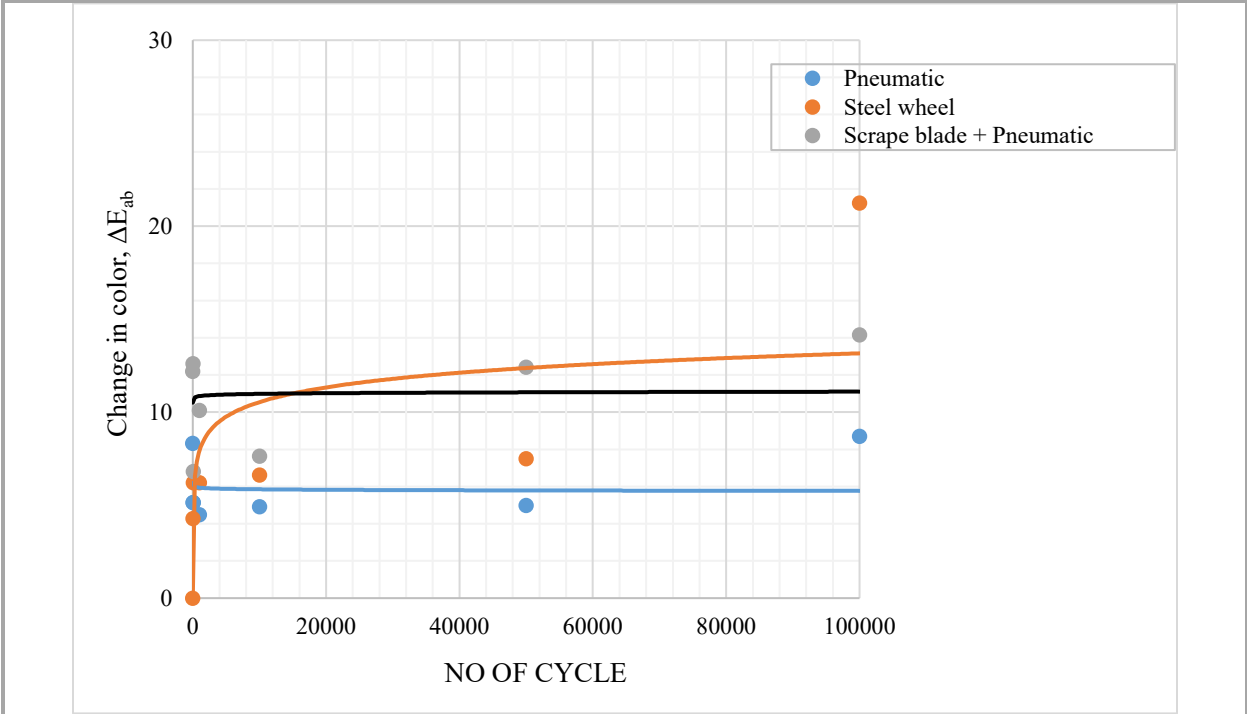
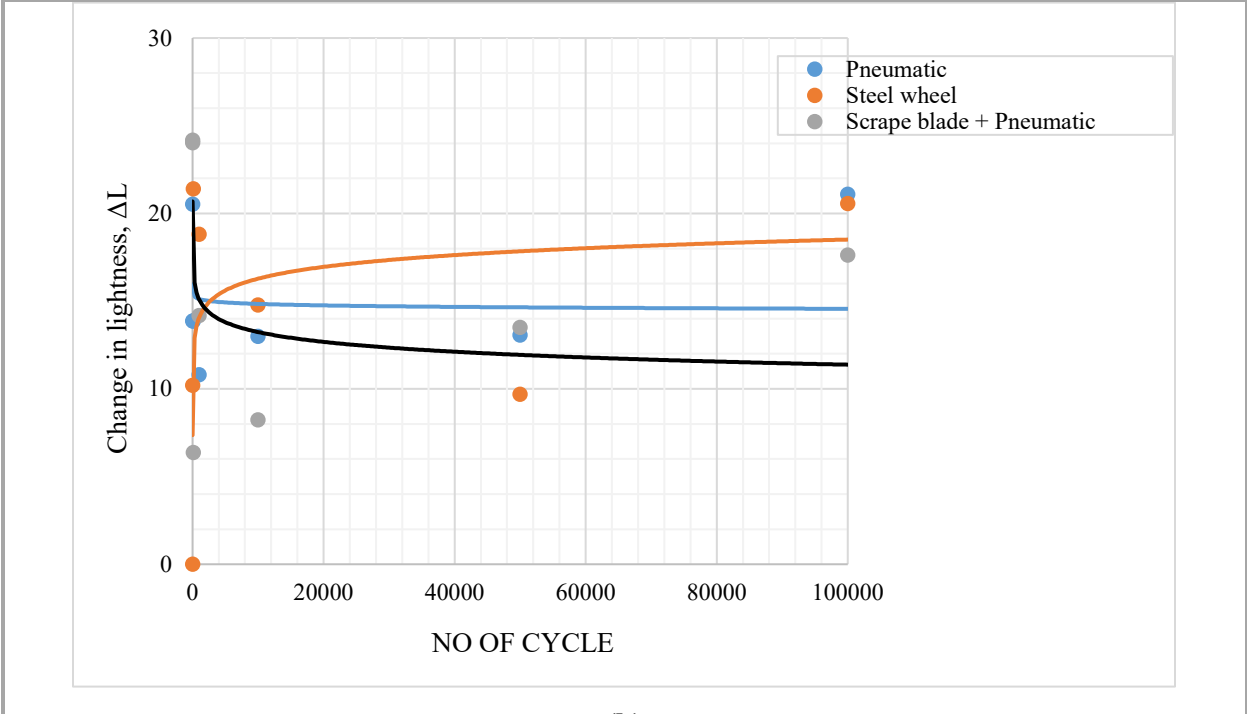
Figure 4.6. Changes of the MMA material due to different loading conditions in (a) color; (b) lightness

No significant change in color was observed for the MMA materials under the three loading conditions, as shown in figure 4.6. No significant color change was noticed after 10,000 cycles, and only a 10 percent loss in color was recorded after 100,000 cycles for the three wheelsets. Such a small reduction in color could have been due to the presence of specific chemicals coupled with the thicker paint of the MMA materials. Furthermore, for the waterborne material (with or without glass beads), there was consistency in the rate of reduction under the three loading conditions, as shown in figures 4.7a and 4.7b. The change in color was obvious after 1,000 cycles (in some cases), which could have been due to thinner green waterborne paint in comparison to that of thermoplastic and the MMA paint materials.

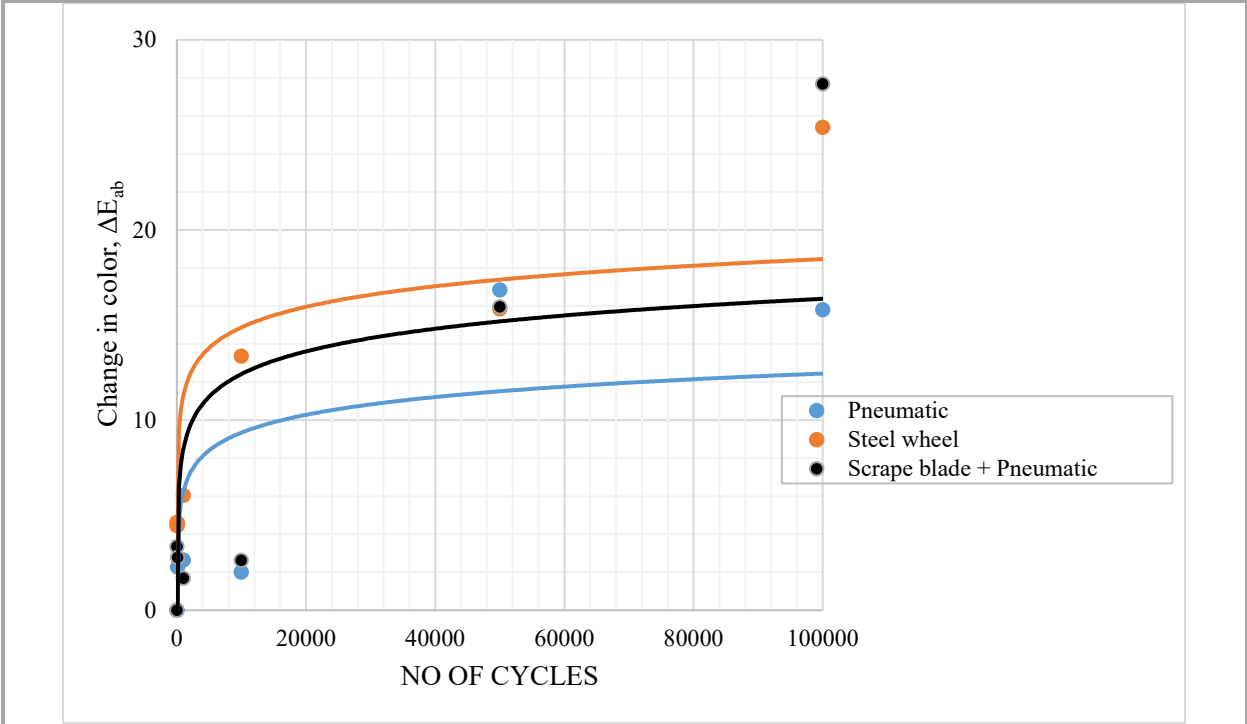
Figure 4.7. Changes of the waterborne (with glass beads) material due to different loading conditions in (a) color; (b) lightness

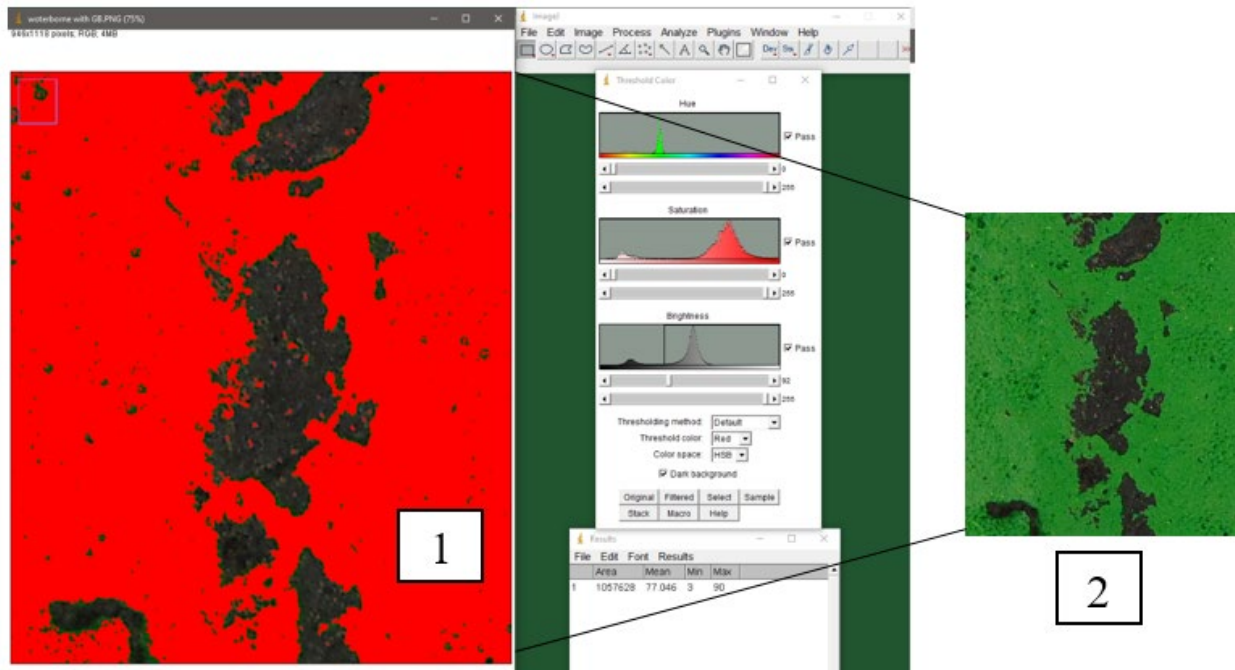
Figure 4.9. Durability calculation using ImageJ software

High-resolution digital images were captured for the surface of the test slabs after a set number of polishing cycles (i.e., 0, 100, 1,000, 10,000, 50,000, and 100,000 cycles). The ImageJ software was used to analyze the captured images and calculate the percentage loss of pavement markings. To ensure accurate and consistent readings, the camera was mounted at a constant height in a fluorescent light environment. The ImageJ software processed and analyzed the images to quantify the worn area on the pavement surface where the paint was lost or fading because of loading and polishing. The durability rating methodology was employed to evaluate the remaining paint materials at the surface (i.e., 100 percent indicated no loss, whereas 0 percent indicated complete loss of paint materials at the surface).

percentage of loss was calculated differently for the two materials (i.e., waterborne and MMA). The durability was calculated on the basis of the percentage of loss of the waterborne materials and on the percentage of polished area for the MMA materials.

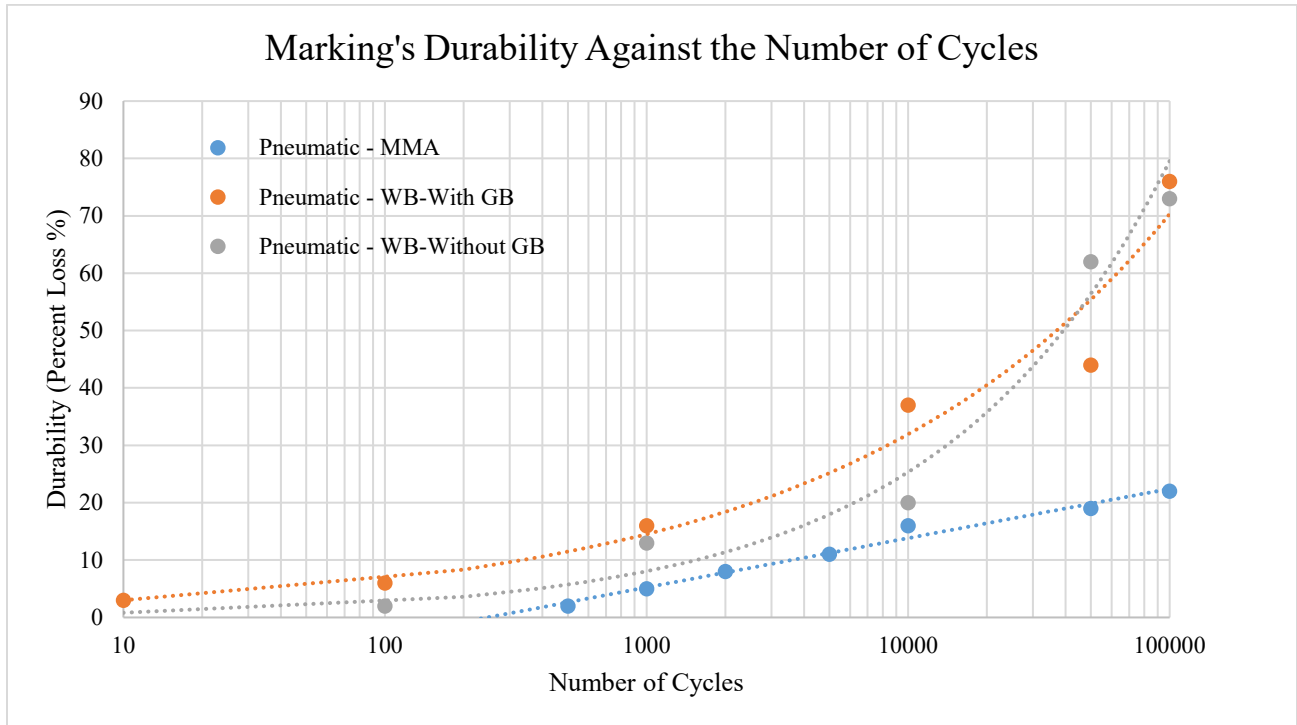
Figure 4.10. Durability of test markings under the pneumatic wheelset.

It has been observed that abraded rubber (eroded from the tire) is the element responsible for surface change, which in turn will affect measurements. Therefore, all substrates were carefully washed and cleaned before pictures were taken. During the installation of the MMA materials, the entire surface was covered with the marking material, and there weren't gaps between the aggregates. During testing, for the MMA materials under the pneumatic wheelset, after 10,000 cycles the characteristics of surface texture started to change, and the green color started to lighten and turn white because of the washing and polishing. As a result, the MMA materials endured more TWPD loadings than the waterborne materials under the pneumatic and

scraper plate wheelsets (figures 4.10 and 4.11). In the meantime, under the steel wheelset there was no significant difference between the waterborne and MMA materials after 100,000 cycles (figure 4.12). This could have been due to the harsh loading conditions of the steel wheelset. Note that there was no noticeable loss of thermoplastic material under different loading conditions.

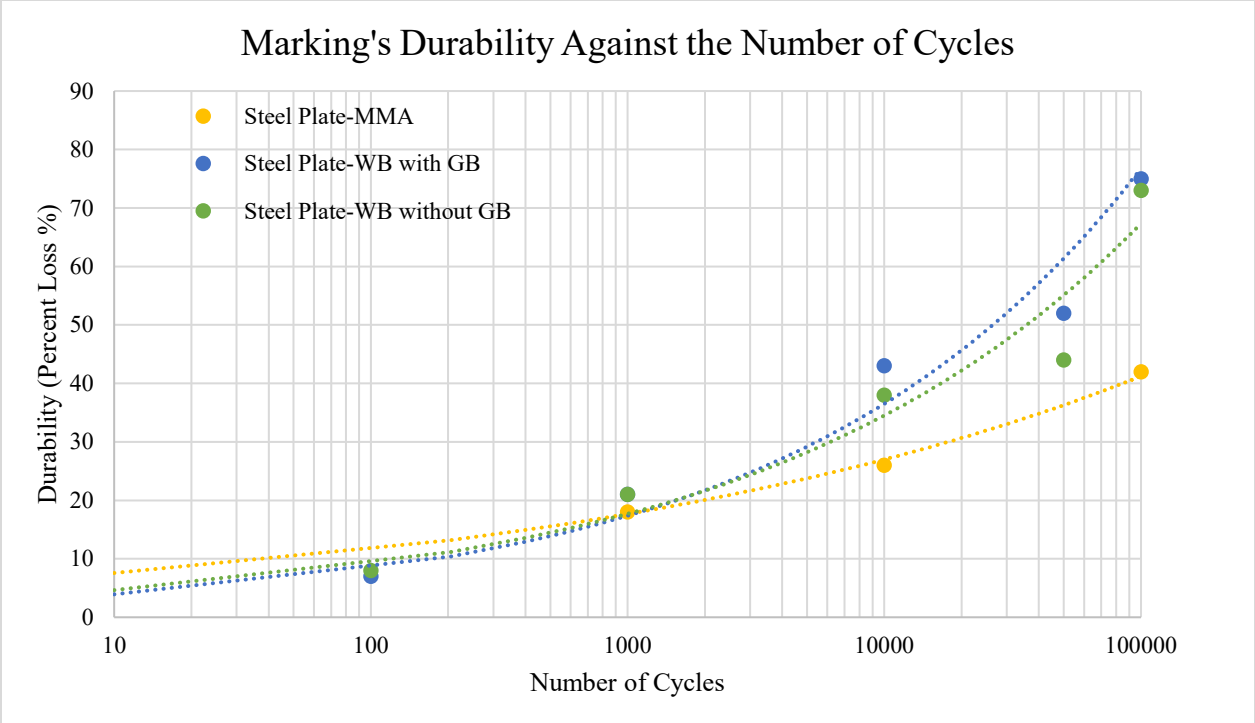
Figure 4.11. Durability of test markings under the scraper plate wheelset.

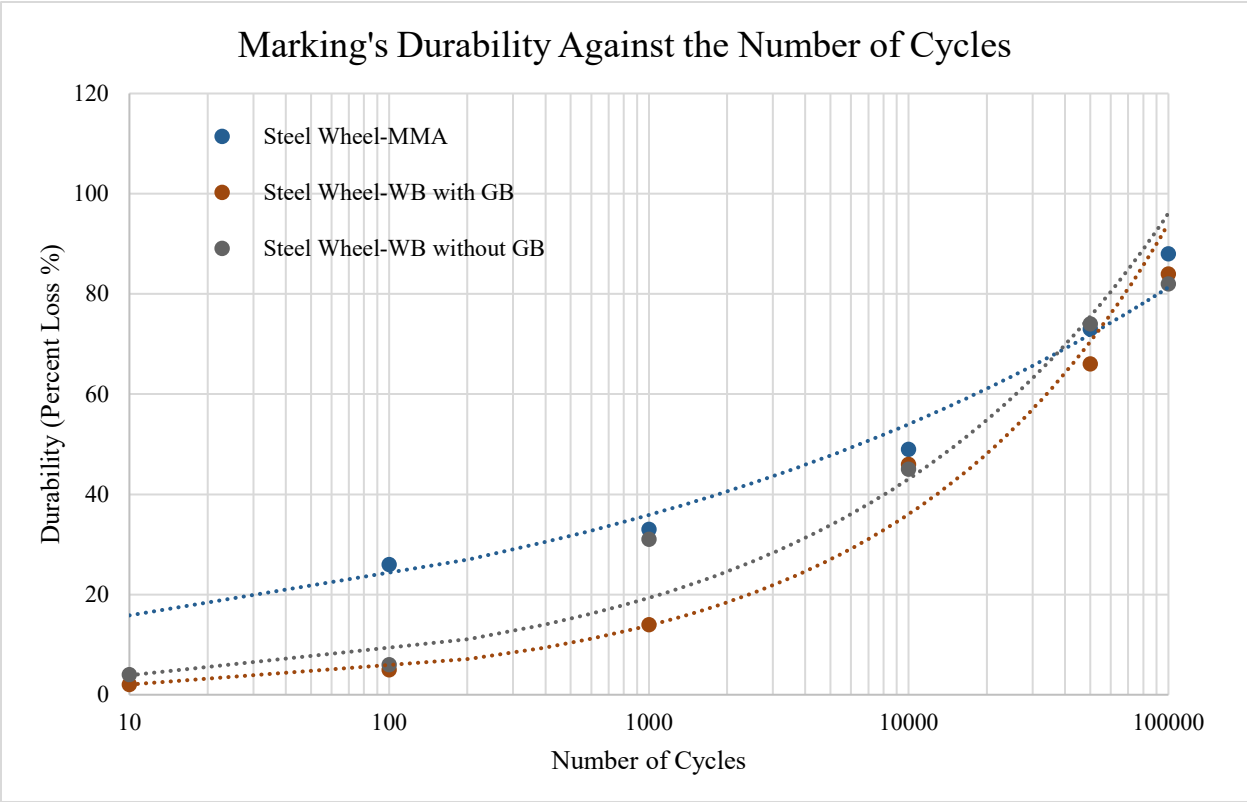
Figure 4.12. Durability of test markings under the steel wheelset.

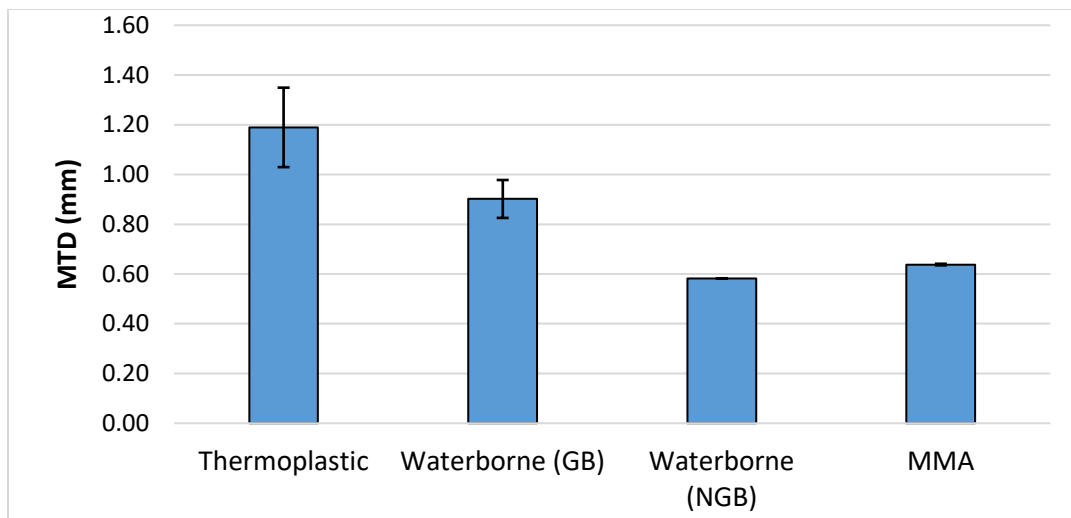
Figure 4.13. Mean texture depth (MTD) for the test surfaces

Figure 4.13 shows the mean texture depth (MTD) for the test substrates with different marking materials. The thermoplastic substrates had a relatively higher texture than the waterborne and MMA substrates. The thermoplastic had higher irregularities than the other surfaces, which resulted in a higher macrotexture or MTD.

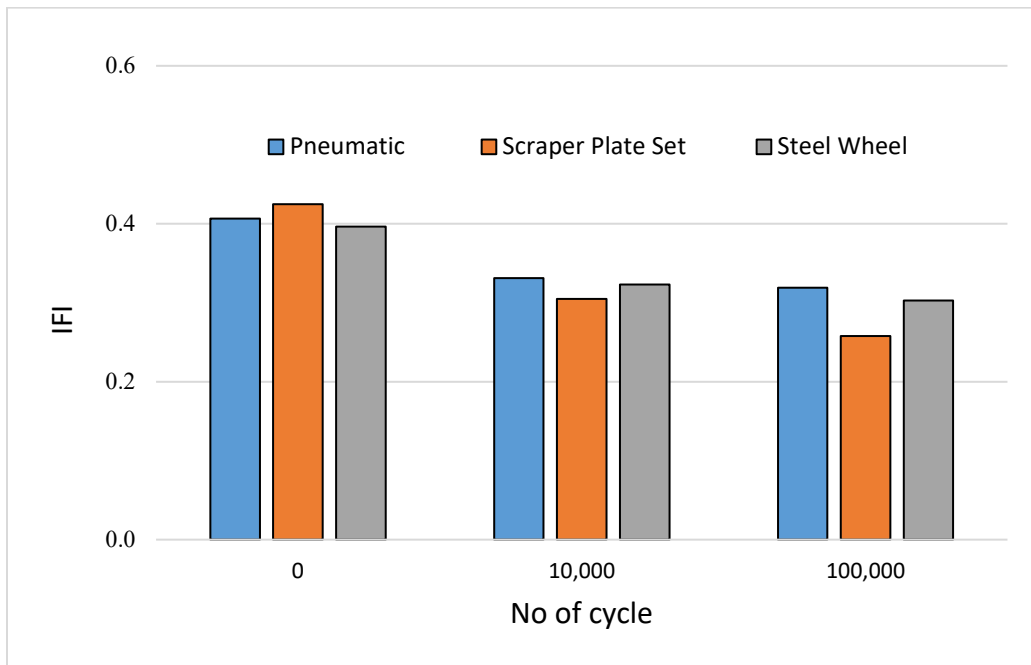
Figure 4.14. International Roughness Index (IFI) with number of loading cycles for the MMA materials

Figures 4.14 to 4.16 show the International Friction Index (IFI) at different numbers of loading cycles for the MMA, thermoplastic, and waterborne marking materials, respectively. The results revealed that the MMA surfaces had the highest friction, whereas the thermoplastic

had the lowest friction. A higher IFI is associated with better traction and less slippery surfaces in wet conditions. The IFI decreased with the number of cycles under different loading conditions (pneumatic, scraper plate, and steel wheel set) for the MMA. This was due to polishing of the surface. The IFI didn't change much with the number of cycles for the thermoplastic surfaces, as the thermoplastic materials had not been worn or polished even after the terminal number of loading cycles (i.e., 100,000 cycles). Interestingly, the IFI for the waterborne material increased slightly with number of cycles, and this could have been due to a loss of the waterborne paint and exposure of the asphalt surface underneath the paint, which had higher friction than the paint.

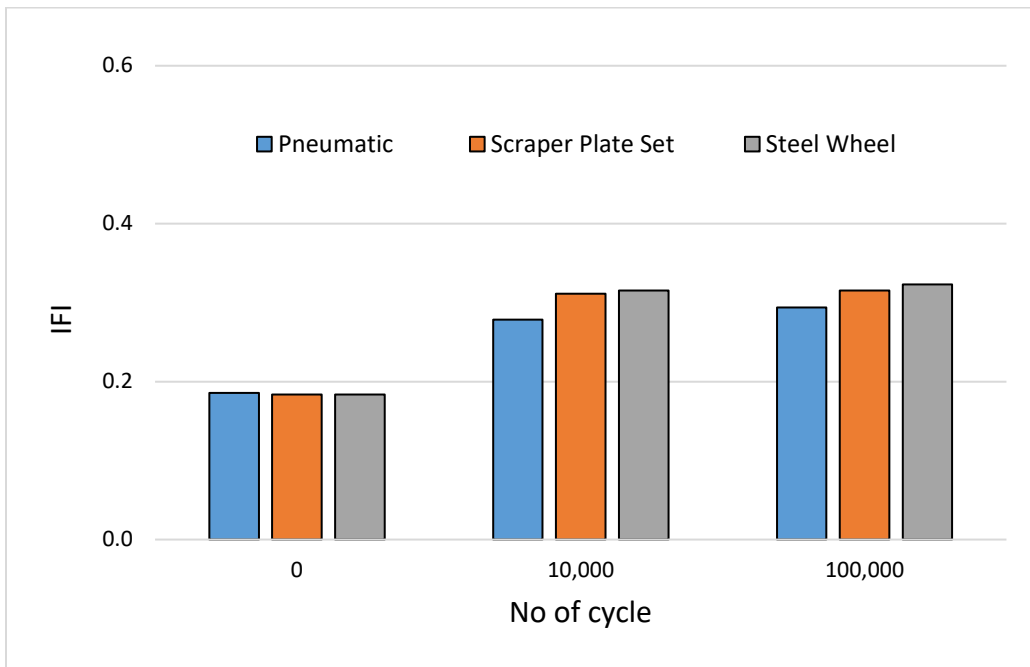
Figure 4.16. International Roughness Index (IFI) with number of loading cycles for the waterborne materials
