Large woody debris and river morphology in scour pool formation, dam removal, and delta formation

A dissertation

University of Washington

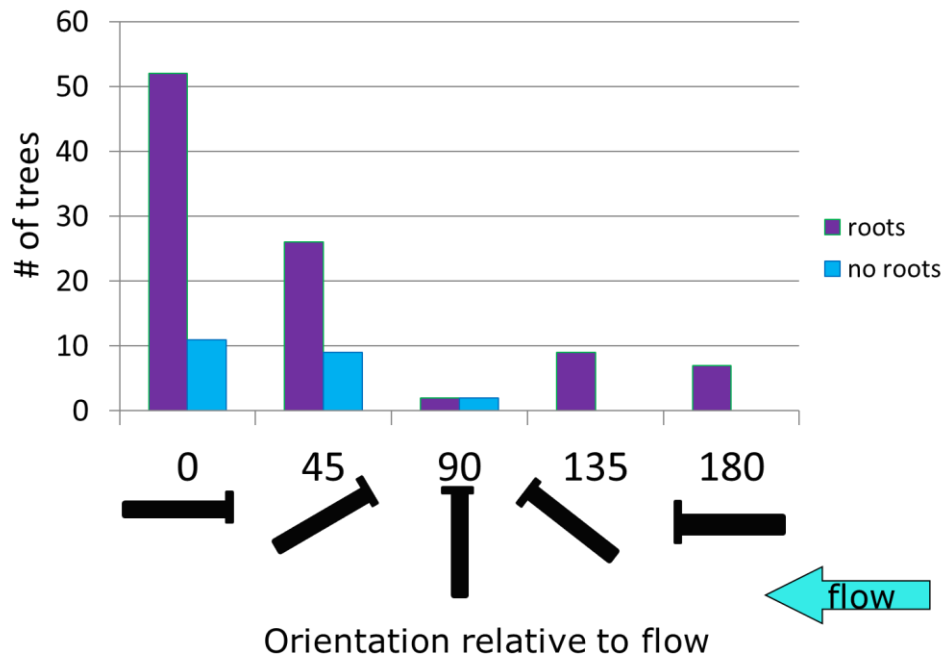
Fig. 3 Wood debris orientation relative to flow, for all individual pieces of wood debris on four bars in the Hoh River.

While individual pieces of woody debris on the Hoh River were deposited in all possible orientations, wood at 0° (parallel to flow with roots pointing upstream) and 45° were most common by far. Abbe and Montgomery (2003) hypothesized and Davidson and Eaton (2015) found that these preferential orientations occur since woody debris travels during floods with the roots on the downstream end, but as floodwaters recede and flow shallows, the roots act as an

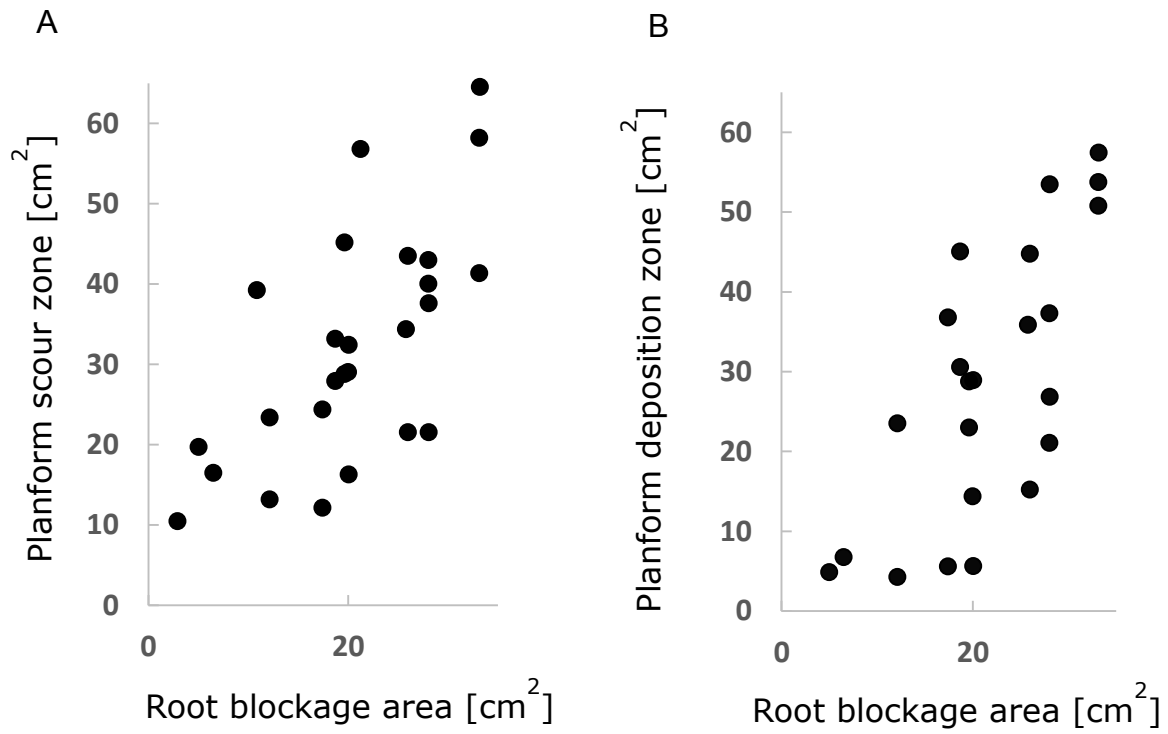
Fig. 6 Planform scour zones (A) and deposition zones (B) plotted against root cross-sectional area relative to flow.

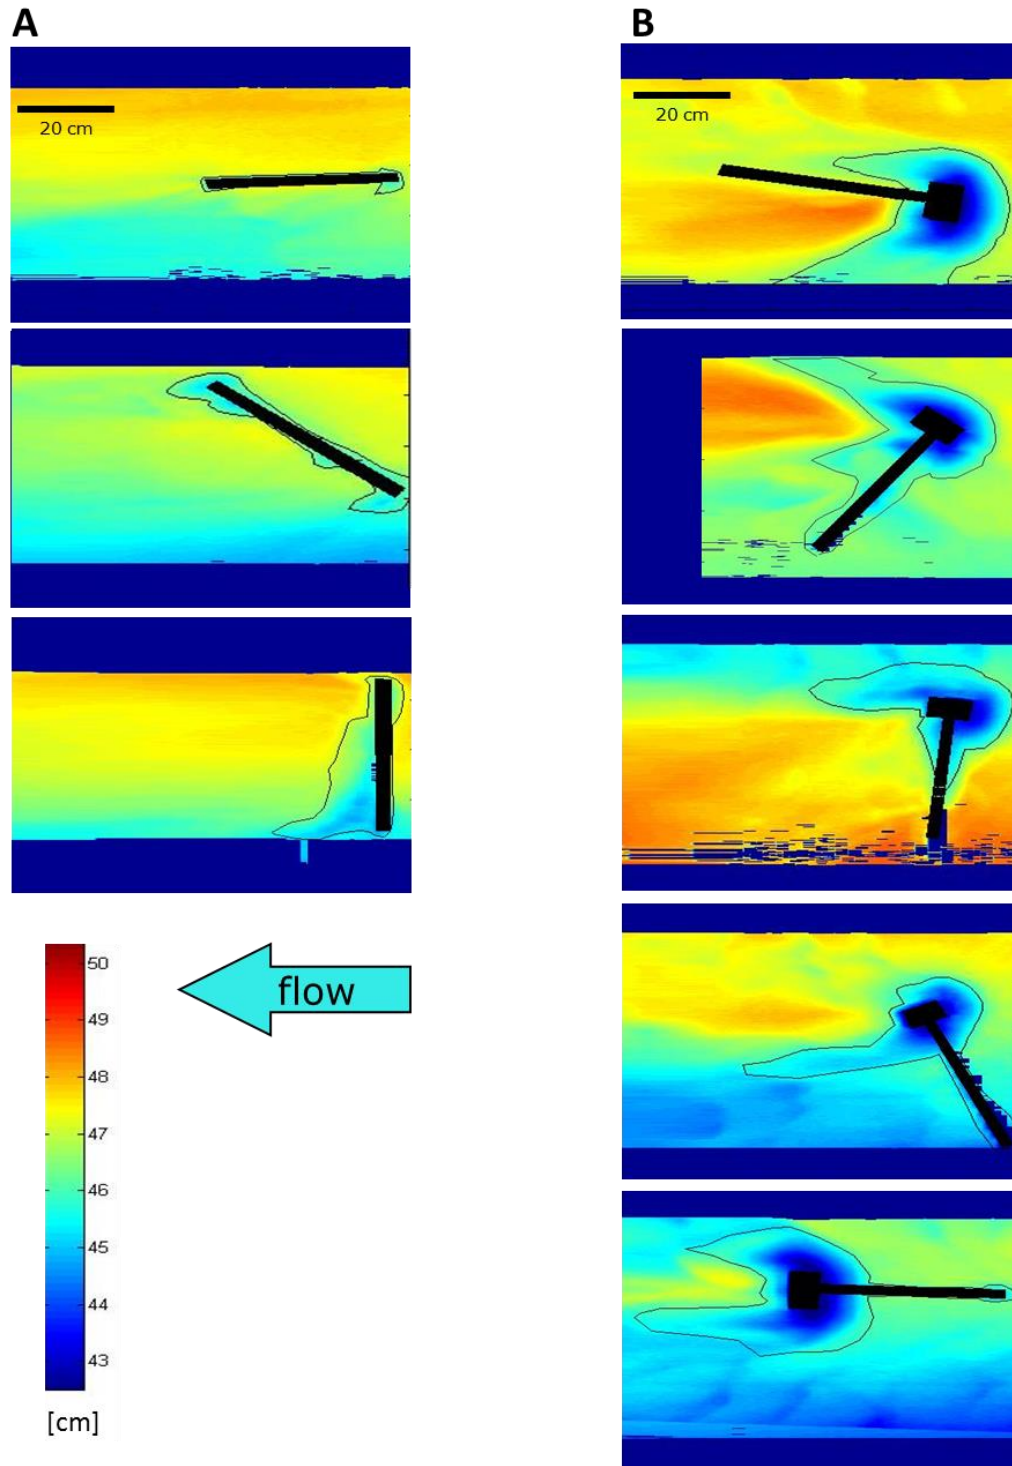
Fig. 7 Bed topography from streambed morphology experiments with wood debris without roots (A) and with roots (B) in a range of orientations. Flow is from right to left. Scour zones are outlined in black. Wood debris without roots (A) has significantly shallower sediment scour and deposition over a smaller area as compared to wood debris with roots (B). Wood debris orientation relative to flow affects the size and shape of scour and sediment deposition.

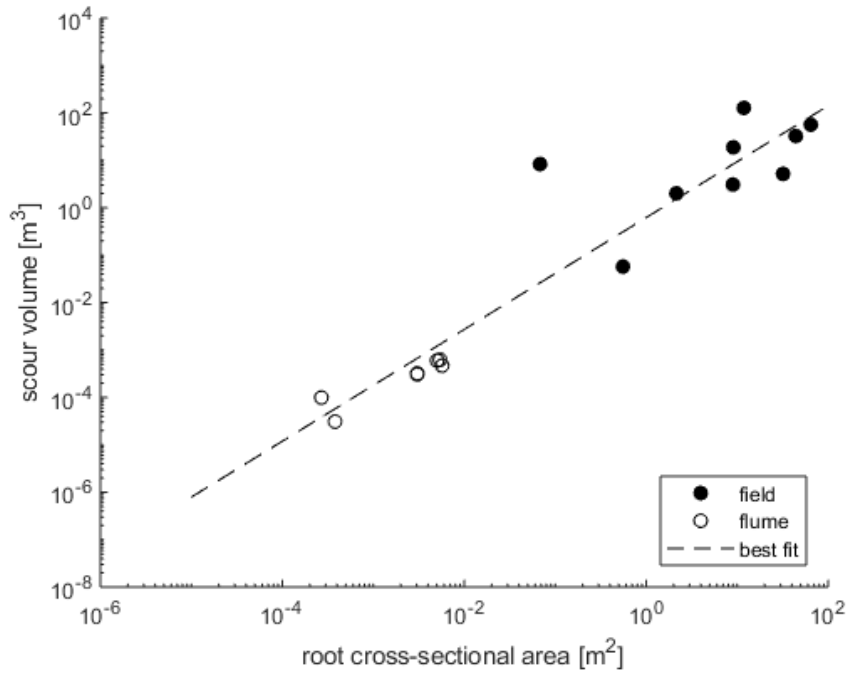
Fig. 9 Scour volume plotted against root cross-sectional area relative to flow, for flume experiments and field measurements. Dashed lines show best fit line, $y = 0.6192x^{1.179}$, calculated by fitting points on a log-log plot.

Discharge variability appears to exert a limited effect on scour pool size. The streambed morphology experiments had a very narrow range of flow conditions and the scour measurements in the field were taken after unknown flow velocities and flow depths, with an unknown sequence of flood events. However both the flume experiments and the field data show a similar relationship between scour volume and root cross-sectional area (Fig. 9).

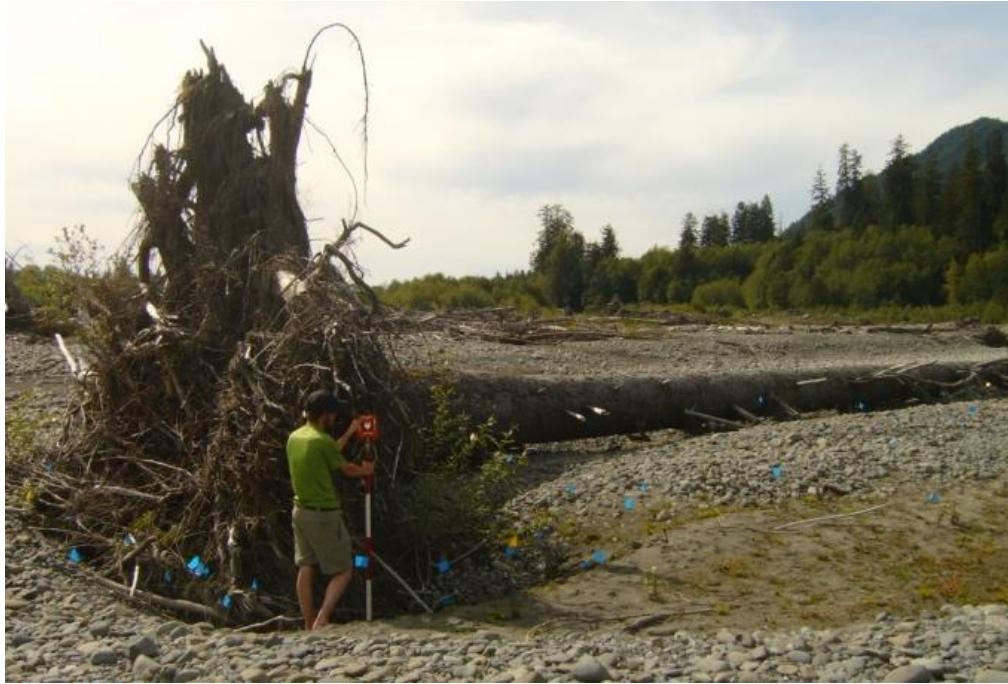
A.2 Topography measurements were using a laser theodolite. 30-100 points topographic points were taken around each piece of wood debris (blue flags).

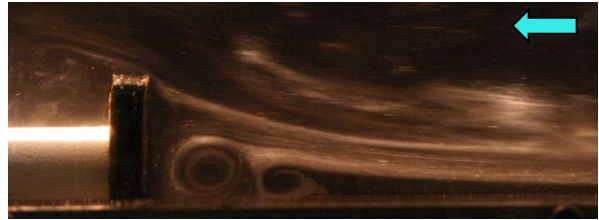
A) Solid root, overhead view

B) Solid root, side view

C) Porous root, side view

A.3 Flow structure around model trees, shown with powdered fish scales and a light plane. A) & B) show a horseshoe vortex around a solid root. C) shows a porous root without a horseshoe vortex.

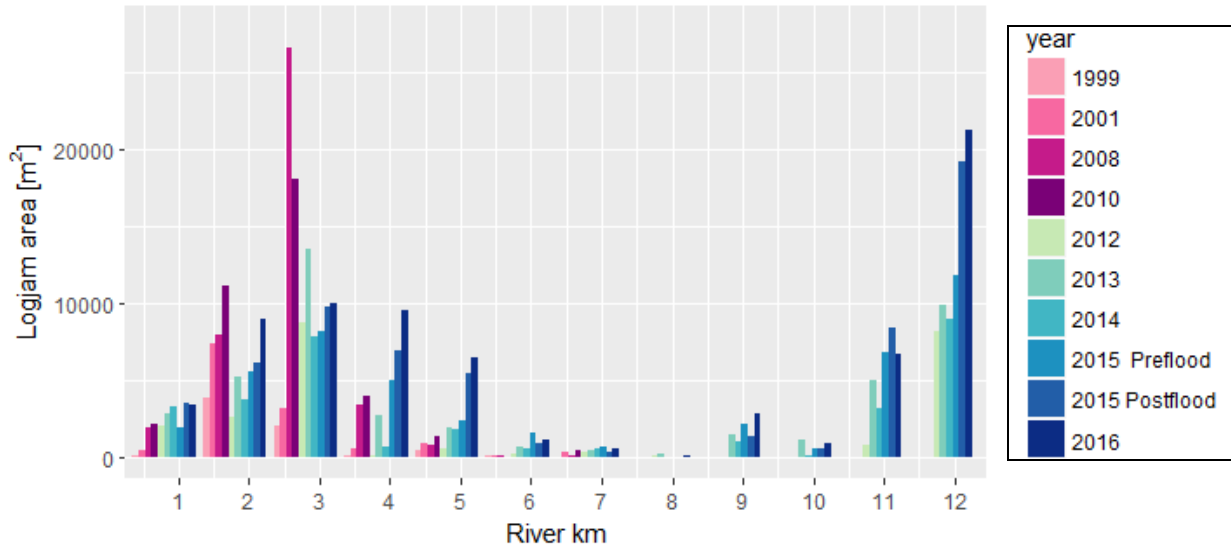
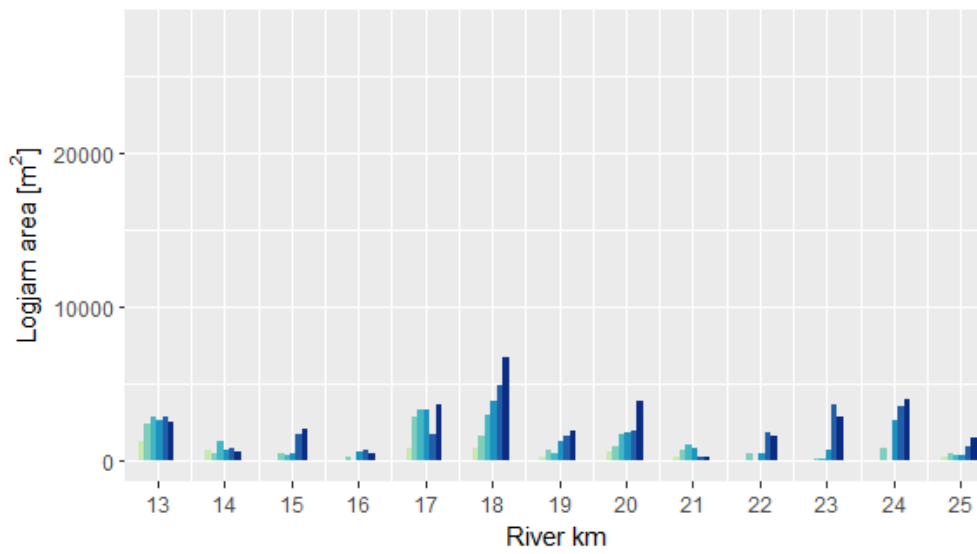
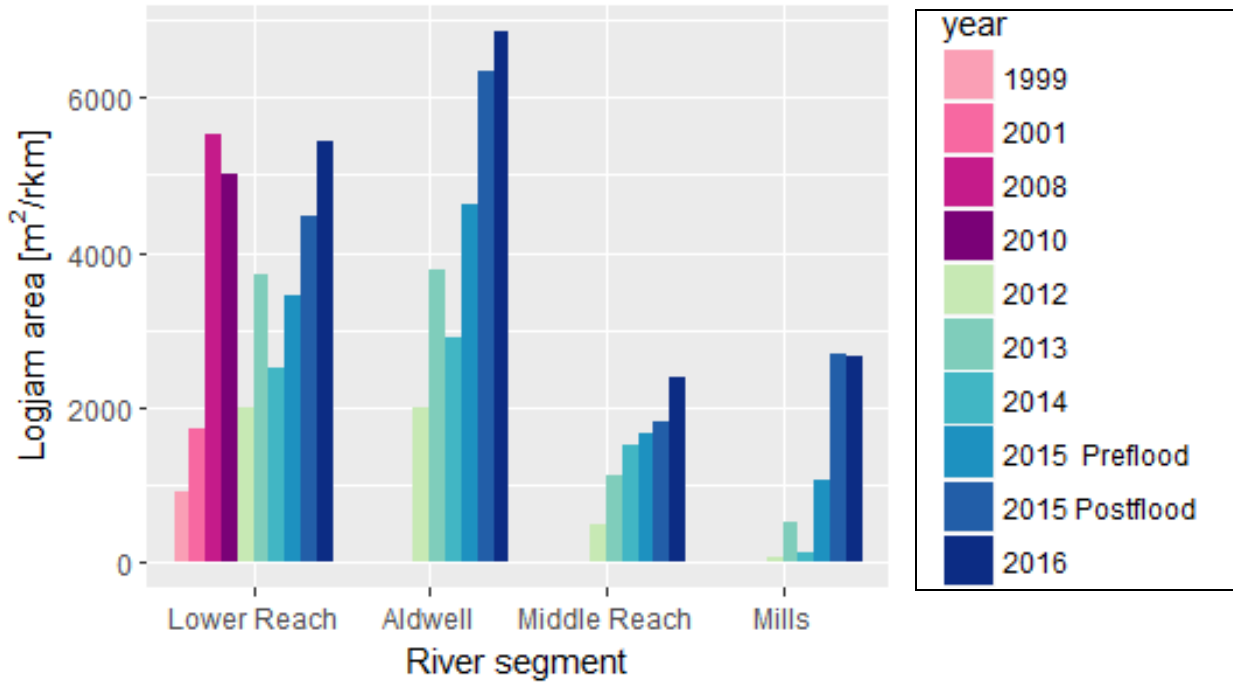
Fig. 5 Logjam area by river kilometer before (pink/purple) and after dam removal (blue/green). Data before dam removal only exists for the Lower Reach. The rapid logjam area increase in rkm 3 in 2008 was related to an avulsion of the main channel and side channels that widened and developed channel-spanning logjams. After dam removal, all rkms in the Lower Reach showed a gradual increase in logjam area. The largest accumulations of logjams after dam removal occurred in rkm 11 and 12, on the upstream end of Aldwell.

After dam removal wood flux was expected to increase for most sources of LWD, including wood from the upstream watershed, tributaries, exhumed wood, local recruitment and floodplain wood (Randle and Bountry, 2010; Ward et al., 2008). This is consistent with the observed logjam area increases in all four study sections after dam removal (Fig. 5). The trend of

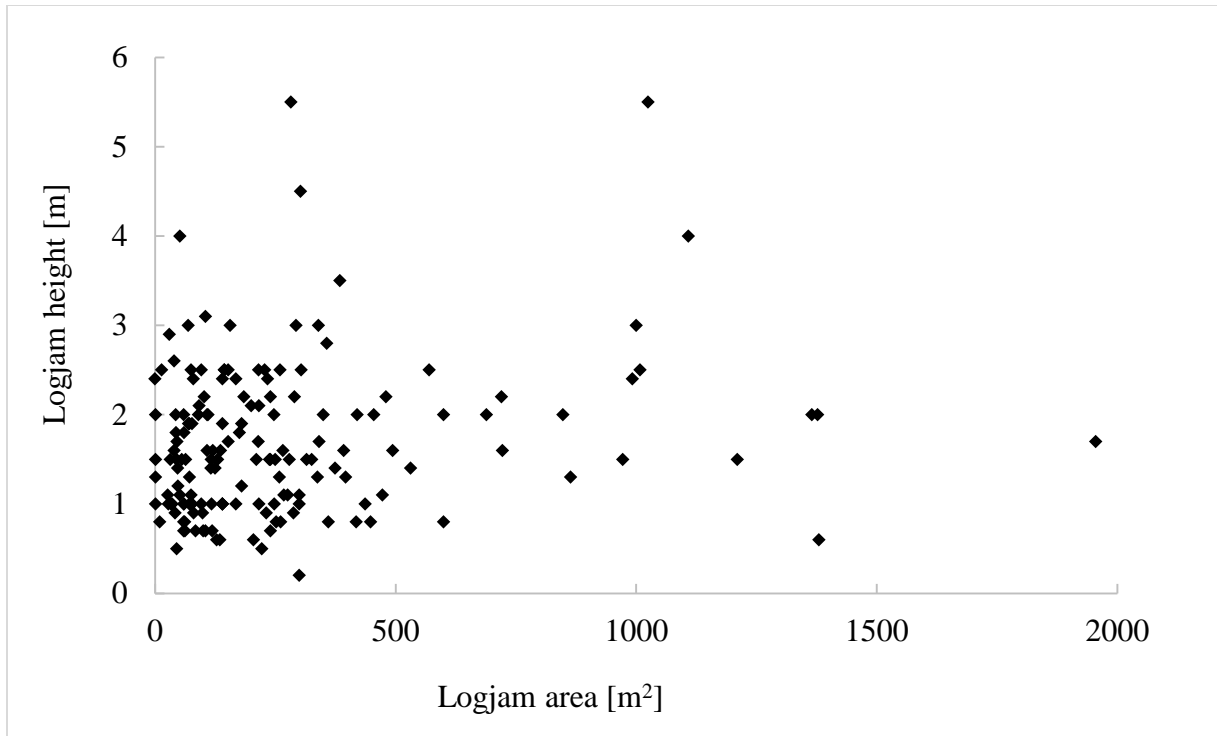
Fig. 6 In the 2012 and 2014 field data, logjam area ranged from 10 – 1955 m², with the majority of logjams under 400 m². Logjam height ranged from 0.2 – 5.5 m, with the majority of logjams between 0.5 and 3 m in height. There was no discernible relationship between logjam area and logjam height.

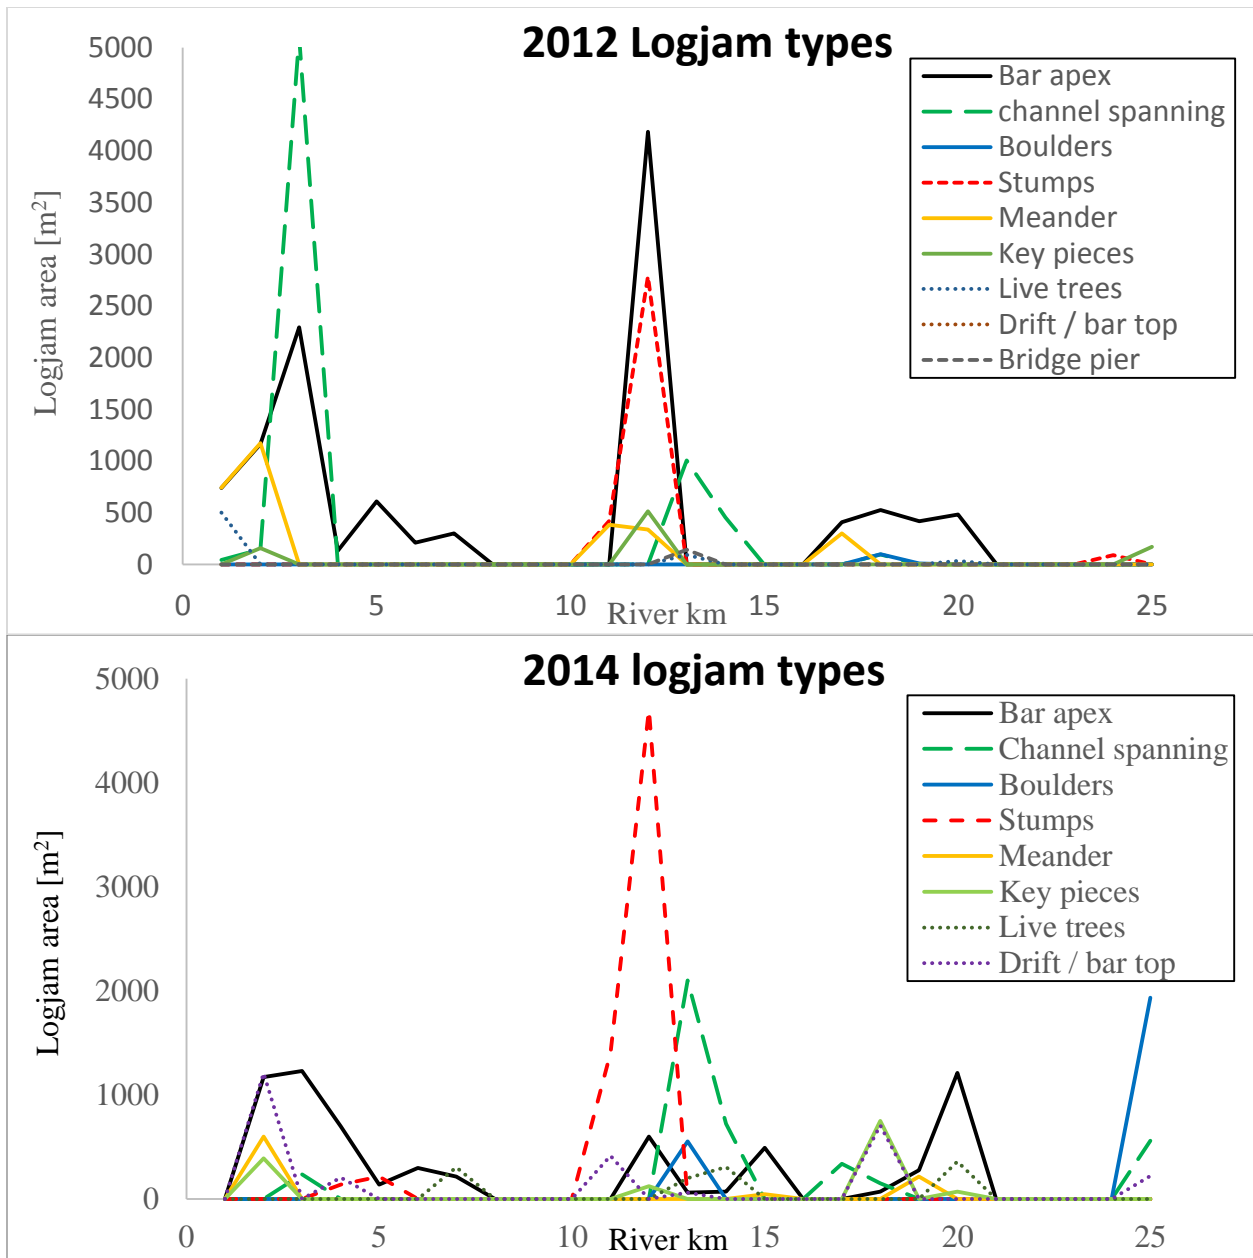
Fig. 8 Logjams area by type and position in the study area. Channel spanning logjams are most common in rkm 3 and logjams anchored by stumps are most common in rkm 11 and 12. In 2014, logjam area increased for logjams anchored by stumps and decreases in channel spanning logjams.

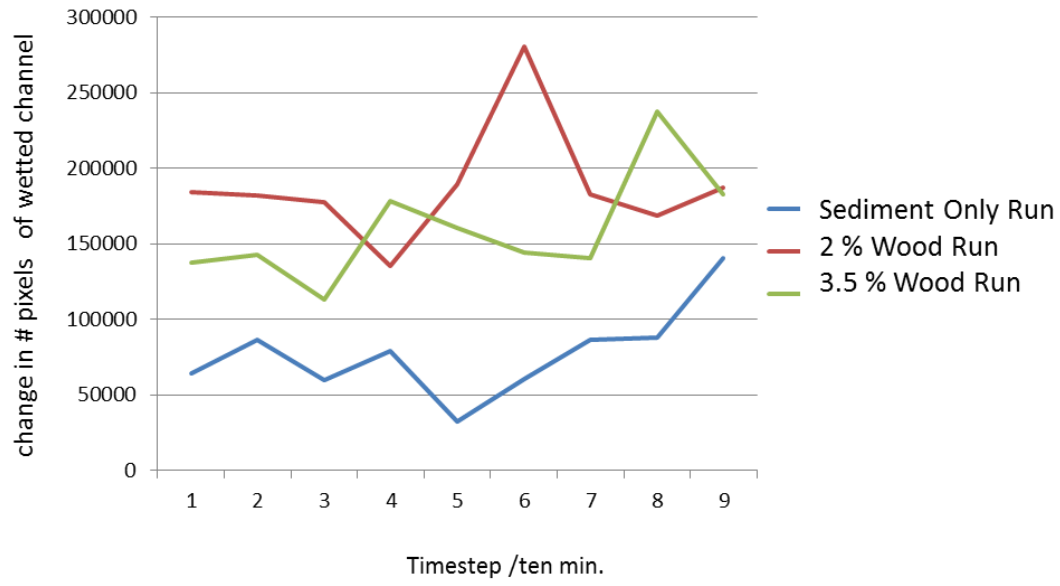
Fig. 6 Channel mobility during the last 90 minutes of the 2nd hold period showing greater channel mobility in the two experimental runs with exhumed wood debris. Change in wetted channel area (by pixels) is plotted against time.

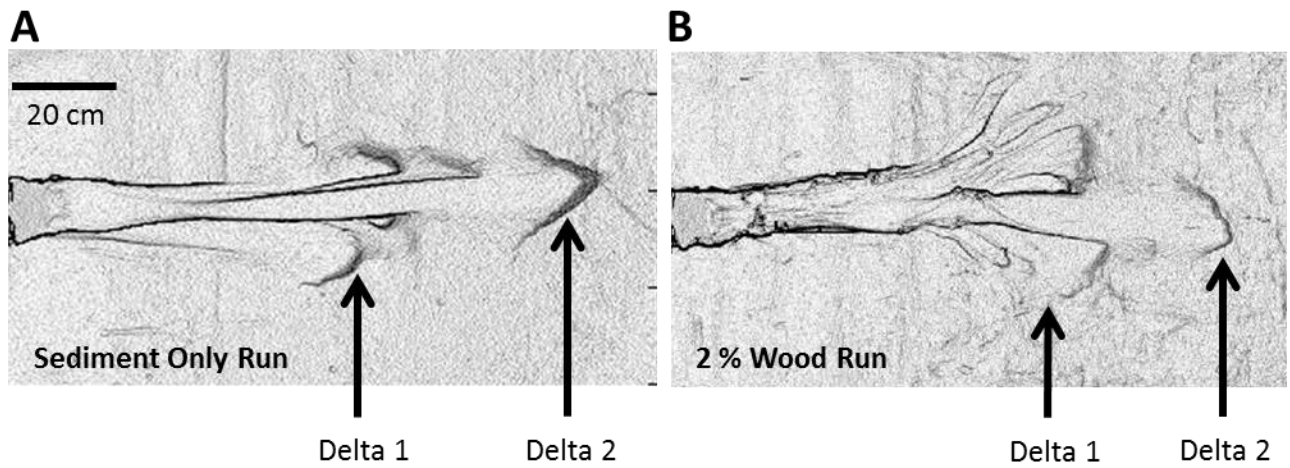
Fig. 9 Slope-maps of the (A) Sediment Only Run and (B) the 2 % Wood Run at the end of the 2nd hold period showing increased channel roughness in the 2 % Wood Run. Delta 1 is the delta formed during the 1st dam segment removal and 1st hold period and Delta 2 is the delta formed during the 2nd dam segment removal.

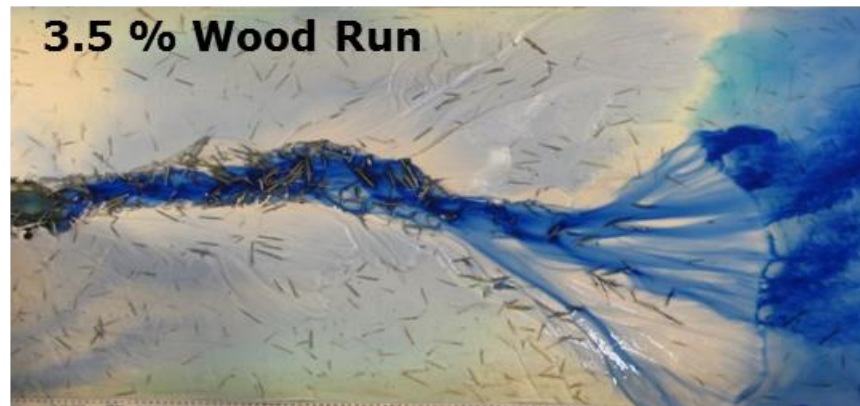
Fig. 10 Overhead photos during the 2nd hold period showing increased bifurcations and multiple simultaneously occupied channels on the delta for the experimental runs with exhumed wood debris. Experimental runs with exhumed wood show more pools, more logjam complexity, more topographic depth variability, more channel edge lengths and more delta shoreline length.
