MEASURING THE IMPACT OF A LANDSLIDE ON TRANSPORTATION INFRASTRUCTURE TO IMPROVE MOBILITY AND SAFETY

FINAL PROJECT REPORT

Margaret M. Darrow, Ph.D., P.E. and Jaimy Schwarber, E.I.T.
University of Alaska Fairbanks

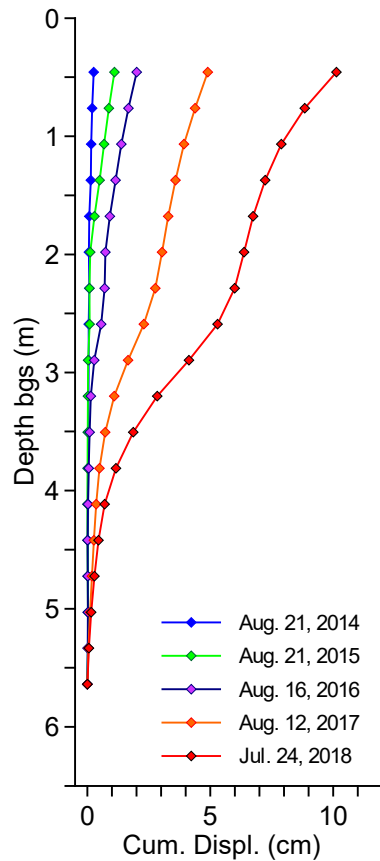
Figure 1.2. Manual inclinometer measurements of the casing installed between FDL-A and the Dalton Highway embankment (TH12-9000; see figure 1.1c for location).

As part of the 2012 subsurface investigation, we installed an inclinometer casing between FDL-A and the highway embankment toe (TH12-9000 in figure 1.1c). At this location, we intercepted the bedrock surface at approximately 3 m below ground surface (bgs). Unfortunately, the upper portion of this critical casing was broken at the surface sometime before June 2013. Therefore, the current analysis includes only movement since “resetting” of the inclinometer readings in August 2013 (figure 1.2). Between 2013 and 2015, movement was confined to the upper 3 m. Over the next three years, however, movement progressively penetrated deeper into the subsurface. The data collected in 2018 indicated movement as deep as 4.8 m below the surface (bgs), with a notable increase in deformation at 3 m bgs. These measurements are significant since 1) at this casing location, the bedrock surface is approximately 3 m bgs, and 2)

there is no break in slope downhill of this casing. In other words, *FDL-A is shearing deeper than the ground surface, providing enough stress in the subsurface to deform the weathered bedrock.*

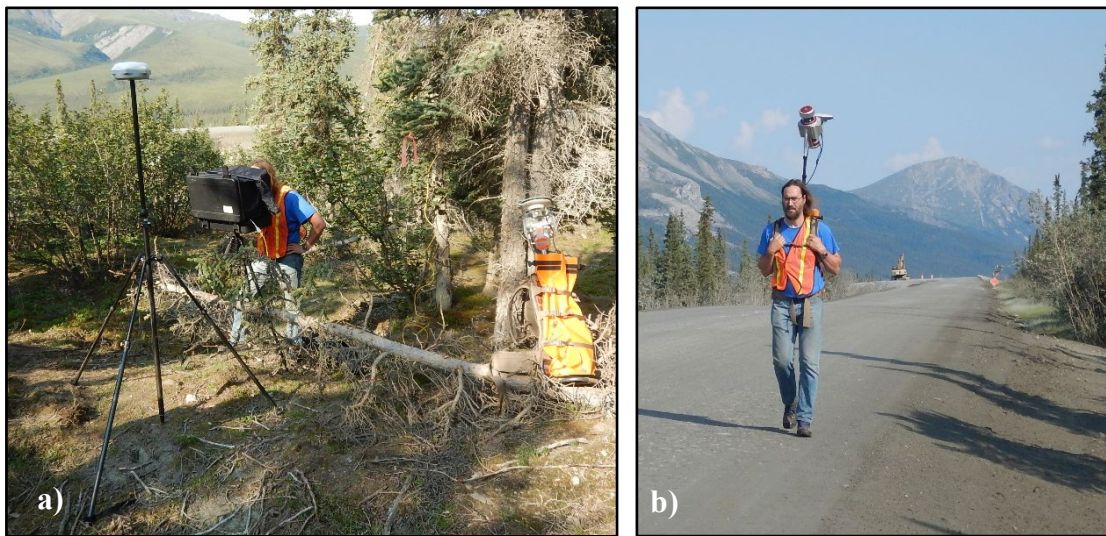
Figure 2.3. LiDAR data collection: (a) setting up the LiDAR system; (b) acquiring LiDAR data along the old Dalton Highway embankment in July 2018.

LiDAR system by Phoenix LiDAR (figure 2.3). For the purpose of this study, we used a backpack to transport the LiDAR system, which allowed high-resolution scanning of a small area. The system was set up with RTK-GPS for accurate location information at 10 points per second. Between RTK-GPS readings, the system relied on a Northrop Grumman Inertial Momentum Unit (IMU) at a rate of 100 times per second. The combination of RTK-GPS and IMU devices made it possible to know the location and orientation of the LiDAR system with an accuracy of about 1 cm.

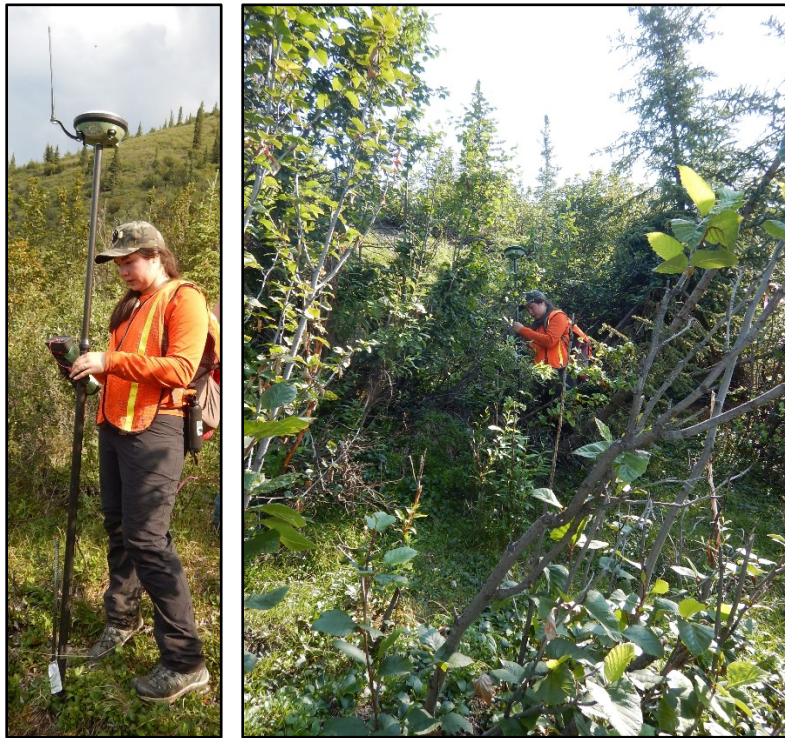
Figure 2.4. Collecting data with the RTK-GPS system in varying vegetation conditions.

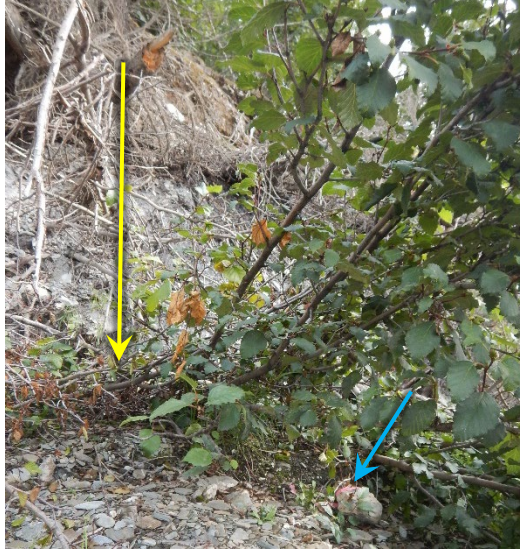
Figure 3.6. Proximity of FDL-A’s toe to the north installation on July 31, 2019. Yellow arrow indicates FDL-A toe, and blue arrow indicates position of north installation.
