CFT Column-to-Cap Beam Connections for  
Accelerated Bridge Construction in Seismic Regions

Master of Science in Civil Engineering

University of Washington

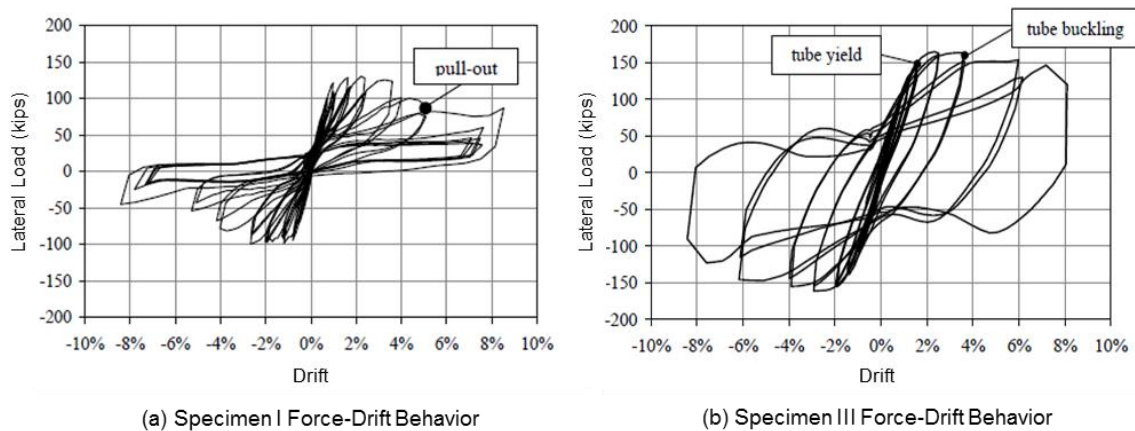
The force-drift hysteretic behavior of Specimens I and III is presented in Figure 3.8. By comparing the two hysteresses, it can be seen that the overall strength and ductility of the connection is greatly influenced by the embedment depth of the column.

**Figure 3.8:** Force-Drift Response from adequately and inadequately embedded specimens (Kinsley, 2005)

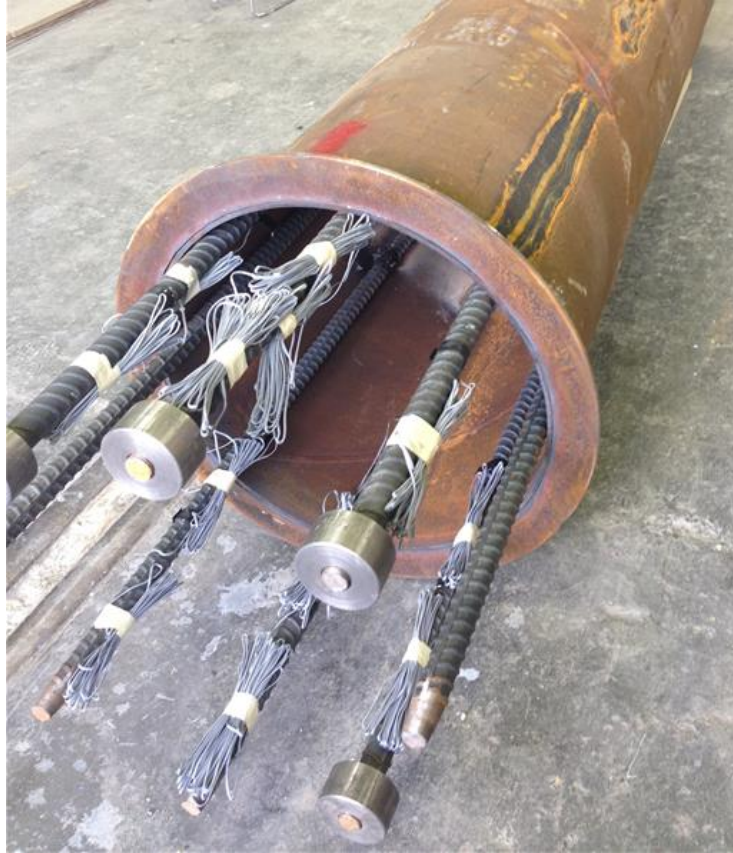
As the concrete cured, the annular ring was welded to the base of the steel tube using a ¼-in. fillet weld, and the longitudinal reinforcing bars were welded to the inside of the steel tube such that the heads of the bars projected 15.5-in. from the end of the column. This projection accounts for the 14-in. embedment into the cap beam, as well as the 1.5-in. grouted soffit. Figure 4.11 shows Specimen WRC after the annular ring and reinforcing bars had been welded to the steel tube.

**Figure 4.11:** Specimen WRC annular ring and reinforcing bars

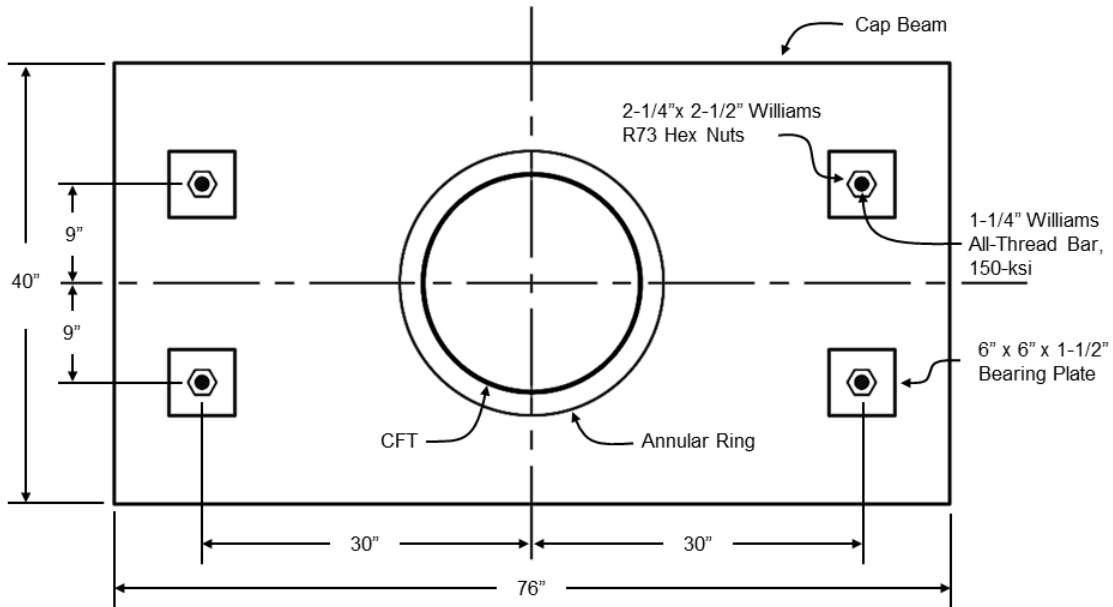
post-tensioned to 120-kips to prevent any uplift or slip from occurring during testing. A layer of hydrostone was placed between the surface of the reaction block and the underside of the cap beam to ensure a level bearing surface.

**Figure 4.15:** Williams Rods Layout

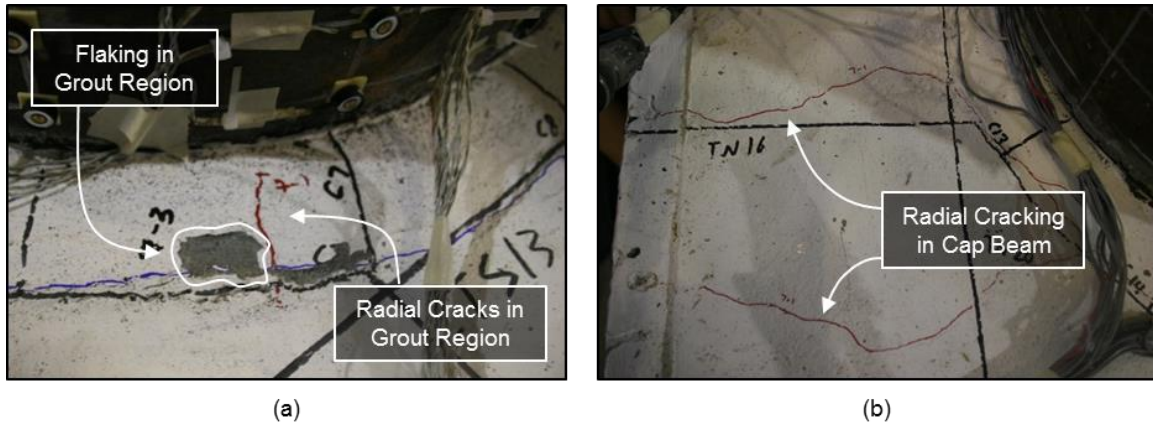
grout that flaked off ranged between 1/2-in. and 1-in. in diameter, and were less than 1/4-in. in thickness.

**Figure 5.6:** EMB80 Radial cracking at 1.45% drift in (a) grout region, and (b) cap beam

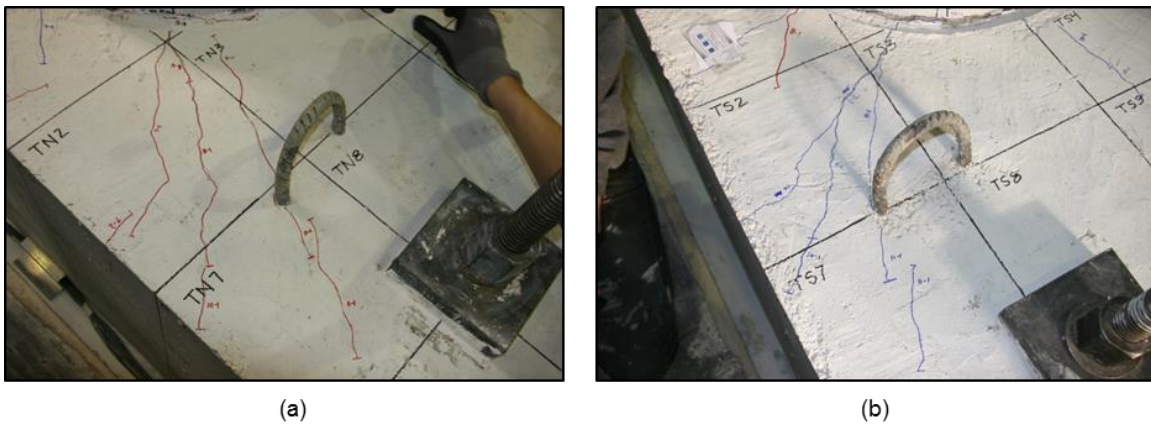
During the 11<sup>th</sup> cycle level, new hairline cracks developed radially from the column towards the rebar lifting loops located in the four corners of the cap beam, shown in Figures 5.23a and 5.23b.

**Figure 5.23:** WRC cap beam cracking during the 11<sup>th</sup> cycle level (a) North side of specimen, (b) South side of specimen

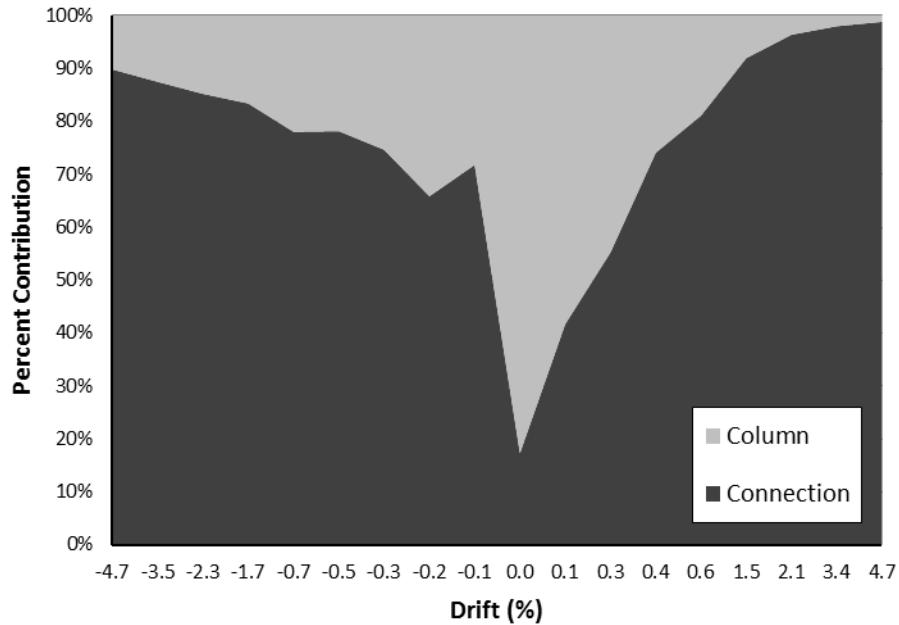
**Figure 6.38:** RC Rotation Contributions from column & connection

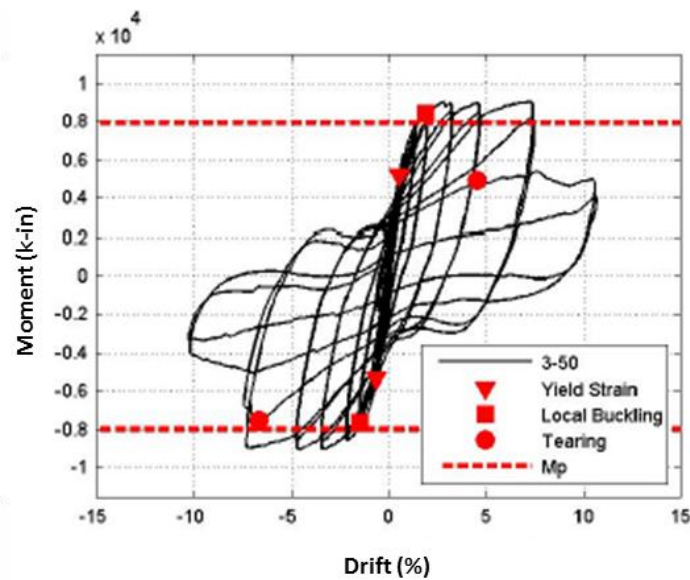
**Figure 6.52:** Moment-drift behavior of Specimen 3-50 (Adapted from Lee, 2011)
