# ASSESSMENT, RESTORATION, AND MANAGEMENT OF THE N PUYALLUP TRAIL, MOUNT RAINIER NATIONAL PARK

Taylor R Kenyon

A report prepared in partial fulfillment of the requirements for the degree of  
Master of Science  
Earth and Space Sciences: Applied Geosciences

University of Washington  
December 2016

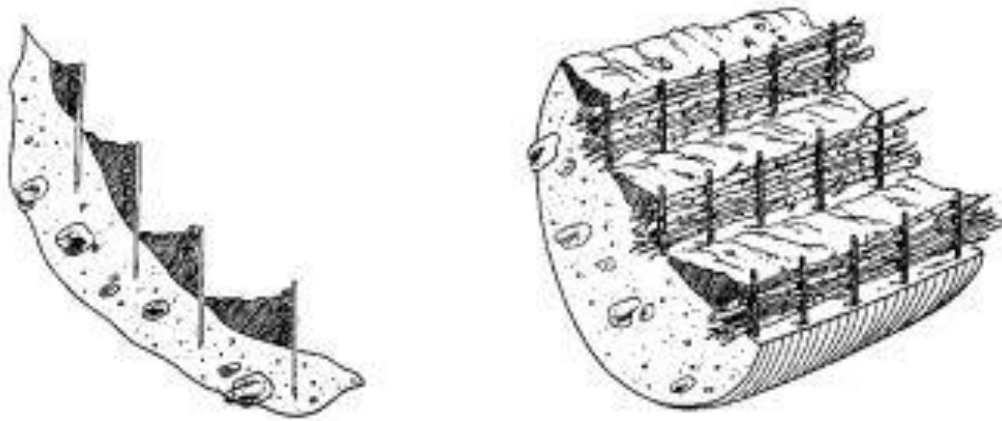
Figure 8: Wattle Fence Schematic. Figure detailing the general design of wattle fences in both side and front views. These plans are scalable and can be built with a variety of vegetation. Figure taken from Polster, 2002.

Instabilities in the trail fill slope would benefit from soil bioengineering. This was done with trees along the trail to fortify the fill slope during construction (Owens, 2006). Live staking and installation of wattle fences using native species would be best, and must be performed during the appropriate growing season (Polster, 2002; Figure 8). Areas with a low risk of mass wasting that experience continuous surface erosion would benefit by reducing erosive forces and adding cohesion, allowing for the possibility of progression to a fully stable state. This would also allow areas with more significant trail narrowing to be widened somewhat while promoting stability along the outer slope (Polster, 2002). This does not ensure immediate stability, as root cohesion must be built over years.
