**Using the Rockfall Activity Index to assess the impact of scaling on rock fall activity
at Glitter Gulch, Alaska**

Master of Science
Earth and Space Sciences: Applied Geosciences

University of Washington

May, 2019

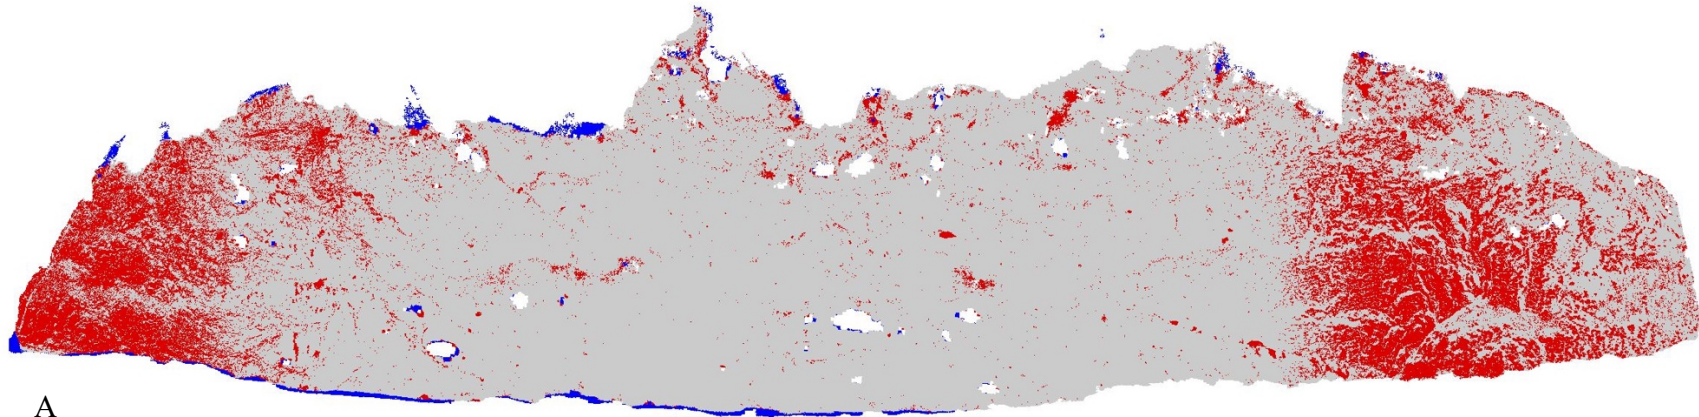
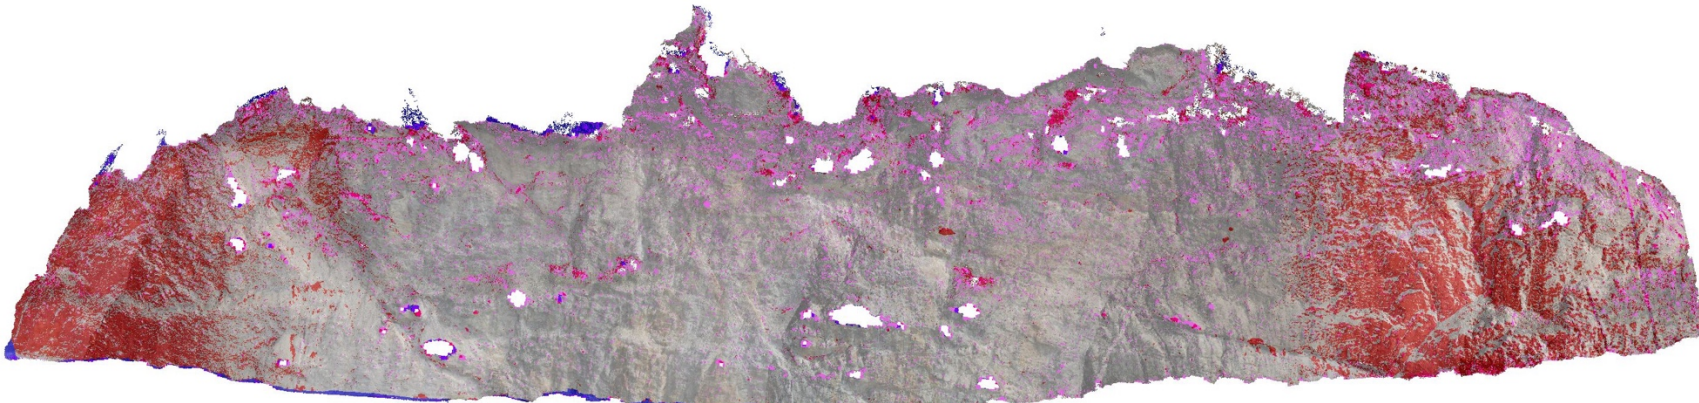
Similar to Epoch 1, there are expected areas of loss based on discontinuities and morphology types in the center of the slope, but there is significant loss identified to the left and right reaches on the scan due to a misalignment of the scans (Figure 15). Gains at the upper reaches of the slope align with points that were assigned an “Unclassified” morphology by the RAI software in 2013 and were absent (due to cropping) in 2014; while gains at the base of the slope were classified as “Talus” by the RAI software.

Figure 15: Change detection for Epoch 2 (2013-2014) of the study slope near MP 241 on the George Parks Highway near Denali, AK. The change from August 2013 to August 2014 is highlighted, with red representing apparent volume loss and blue representing apparent accumulation. Points created by a hole-filling algorithm are fuchsia while significant data gaps are white. Image A shows the change data overlying the point cloud in grey, while image B shows the change data overlying a true color point cloud from 2013 data. Red areas at north and south margins of the outcrop are likely the result of misregistration of the point clouds. Gains around the perimeter of the slope may represent differences in cropping of the point cloud data.

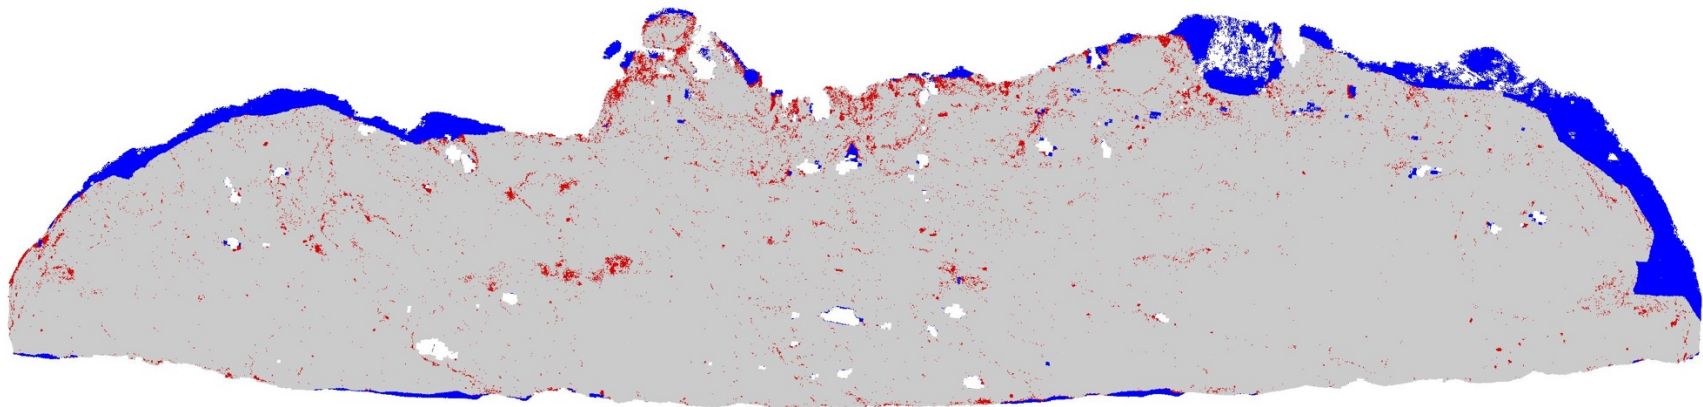
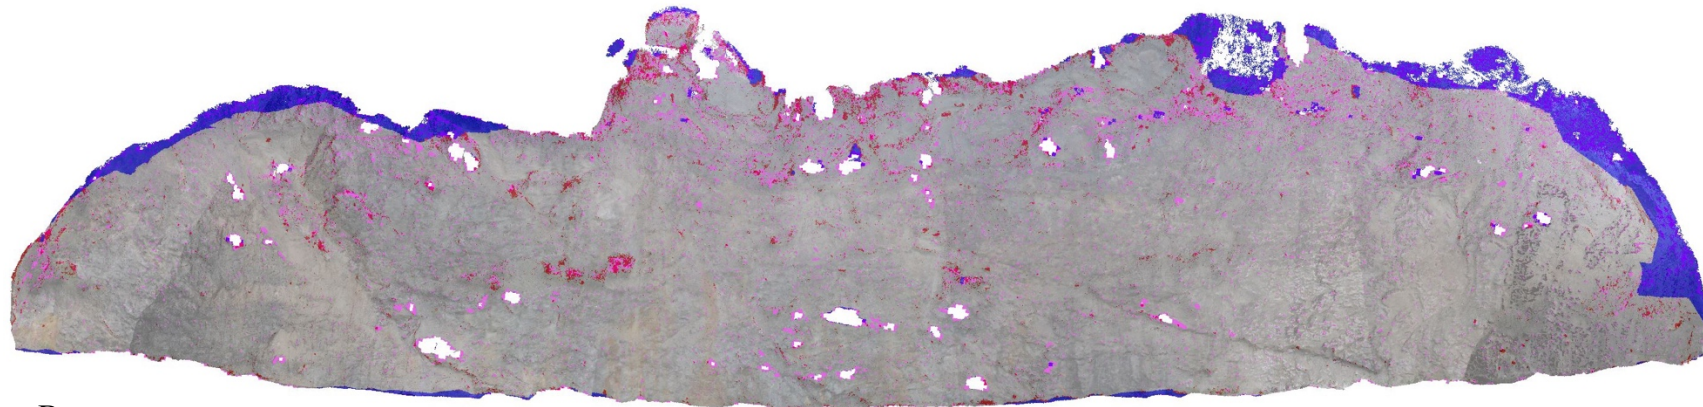
Losses in this epoch follow the pattern of losses in the previous two; most of the clusters are in locations where there are discontinuities, overhangs, and ledges (Figure 16). The perimeter shows extensive gains and there are patches of gains mainly encircling data holes. These apparent gains do not represent slope processes, but result from slight changes in extent of the data.

Figure 16: Change detection for Epoch 3 (2014-2015) of the study slope near MP 241 on the George Parks Highway near Denali, AK. The change from August 2014 to August 2015 is highlighted, with red representing apparent volume loss and blue representing apparent accumulation. Points created by a hole-filling algorithm are fuchsia while significant data gaps are white. Image A shows the change data overlying the point cloud in grey, while image B shows the change data overlaying a true color point cloud from 2014 data. Gains around the perimeter of the slope may represent differences in cropping of the point cloud data.

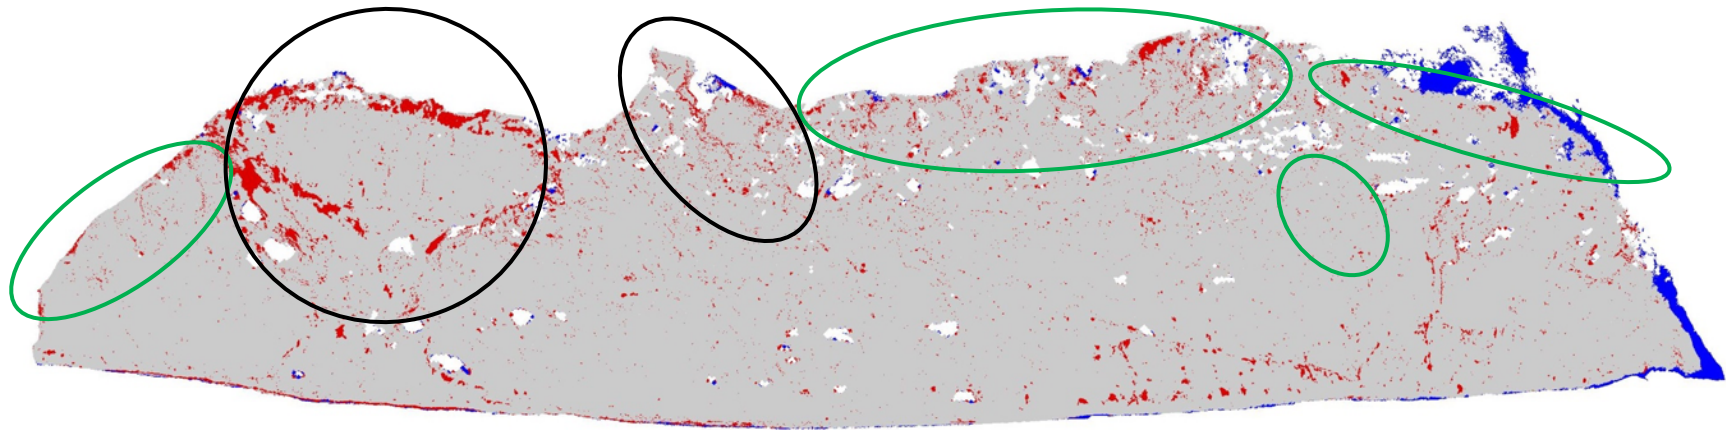
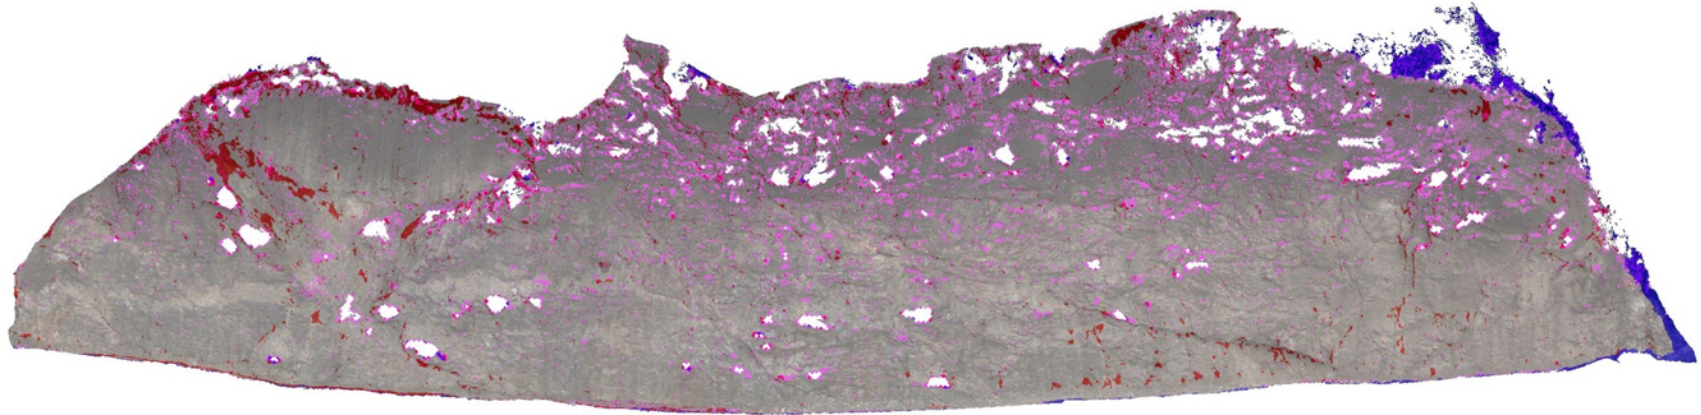
Though recently scaled, which should have reduced rock fall, significant losses appear around the perimeter of the large wedge that was removed on the upper left section of the slope as well as on the discontinuities below, on the lower left (Figure 18). Small, losses are scattered across the slope face with a slight concentration on the upper third of the slope and along the major

Figure 18: Change detection for Epoch 5 (2017-2018) of the study slope near MP 241 on the George Parks Highway near Denali, AK. The change data from August 2017 to August 2018 is highlighted, with red representing apparent volume loss and blue representing apparent accumulation. Points created by a hole-filling algorithm are fuchsia while significant data gaps are white. Image A shows the change data overlying the point cloud in grey, while image B shows the change data overlying a true color point cloud from 2017 data. The planned areas for work during the 2016 scaling project are circled in green: scaling and black: trim blasting. Gains around the perimeter of the slope may represent differences in cropping of the annual data.
