Rockfall Reconnaissance and Stability Assessment: Frenchman Coulee, WA

A report prepared in partial fulfillment of  
the requirements for the degree of  
Master of Science  
Earth and Space Sciences: Applied Geosciences  
University of Washington

March, 2019

MESSAGe Technical Report Number: 071

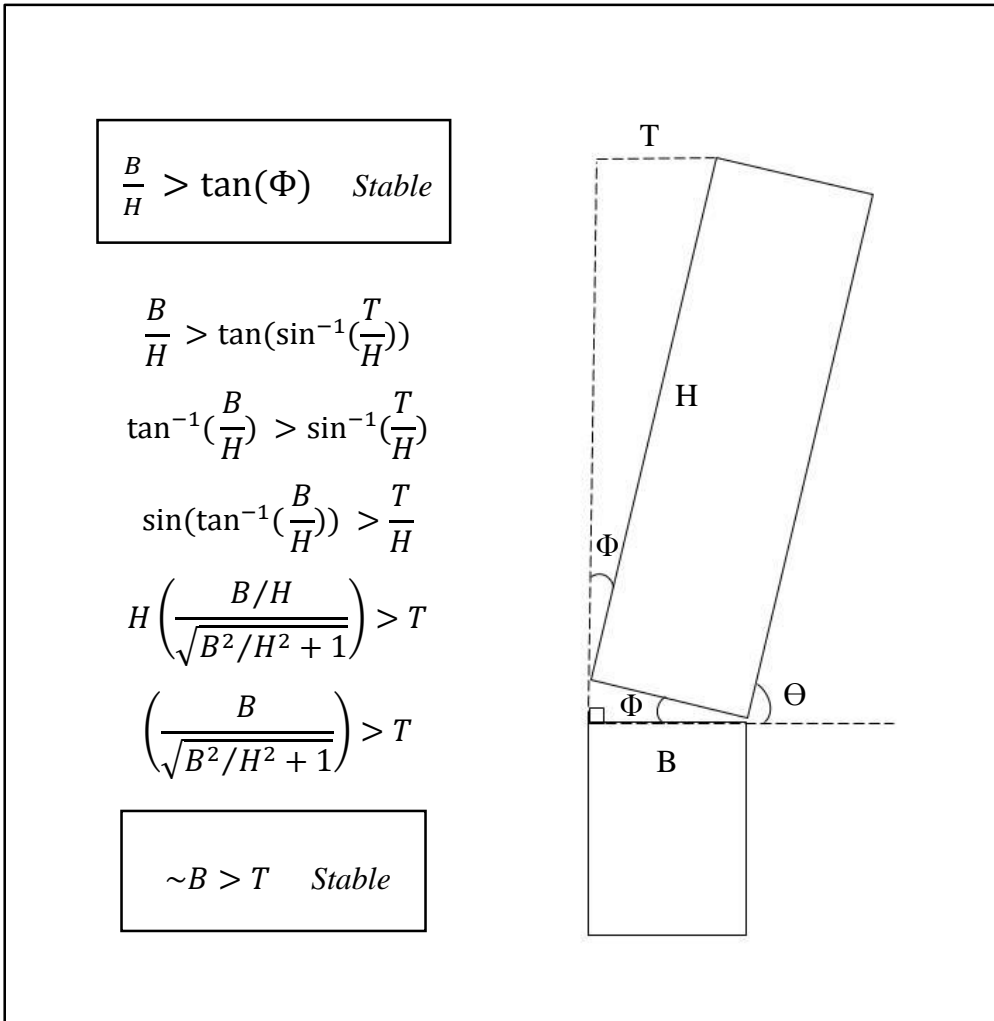
were dipping at 90 degrees. Factors of safety were directly calculated using the two end-type equations (boxes on Fig. 7) with field and digital measurements used for the critical variables.

Assuming the geometric conditions shown in Figure 7 were met, the measured parameters were back-calculated to produce indirect measurements of basal plane angle and column separation using the 2 end type equations. This was done to assess the validity of the proposed-simplified comparison.

**Figure 7:** Topple Analysis. This diagram shows the equations and geometry describing center-of-mass problem for individual columns with regard to direct topple failure. B is the diameter of the base of the column; H is the column height; T is the width of the column separation (tension crack) at the top of the slope. Angles theta (Θ) and phi (Φ) are the plunge of the column and the dip of the base, respectively. They are assumed to be complementary (sum to 90°). The final equation assumes that the height of the column is significantly larger than the width, which is the case for the majority of the columns. The sin of inverse tangent was simplified to reach the second to last equation. Since H is generally much larger than B, the first item in the denominator was approximated to equal zero, which is key in arriving to the final equation.

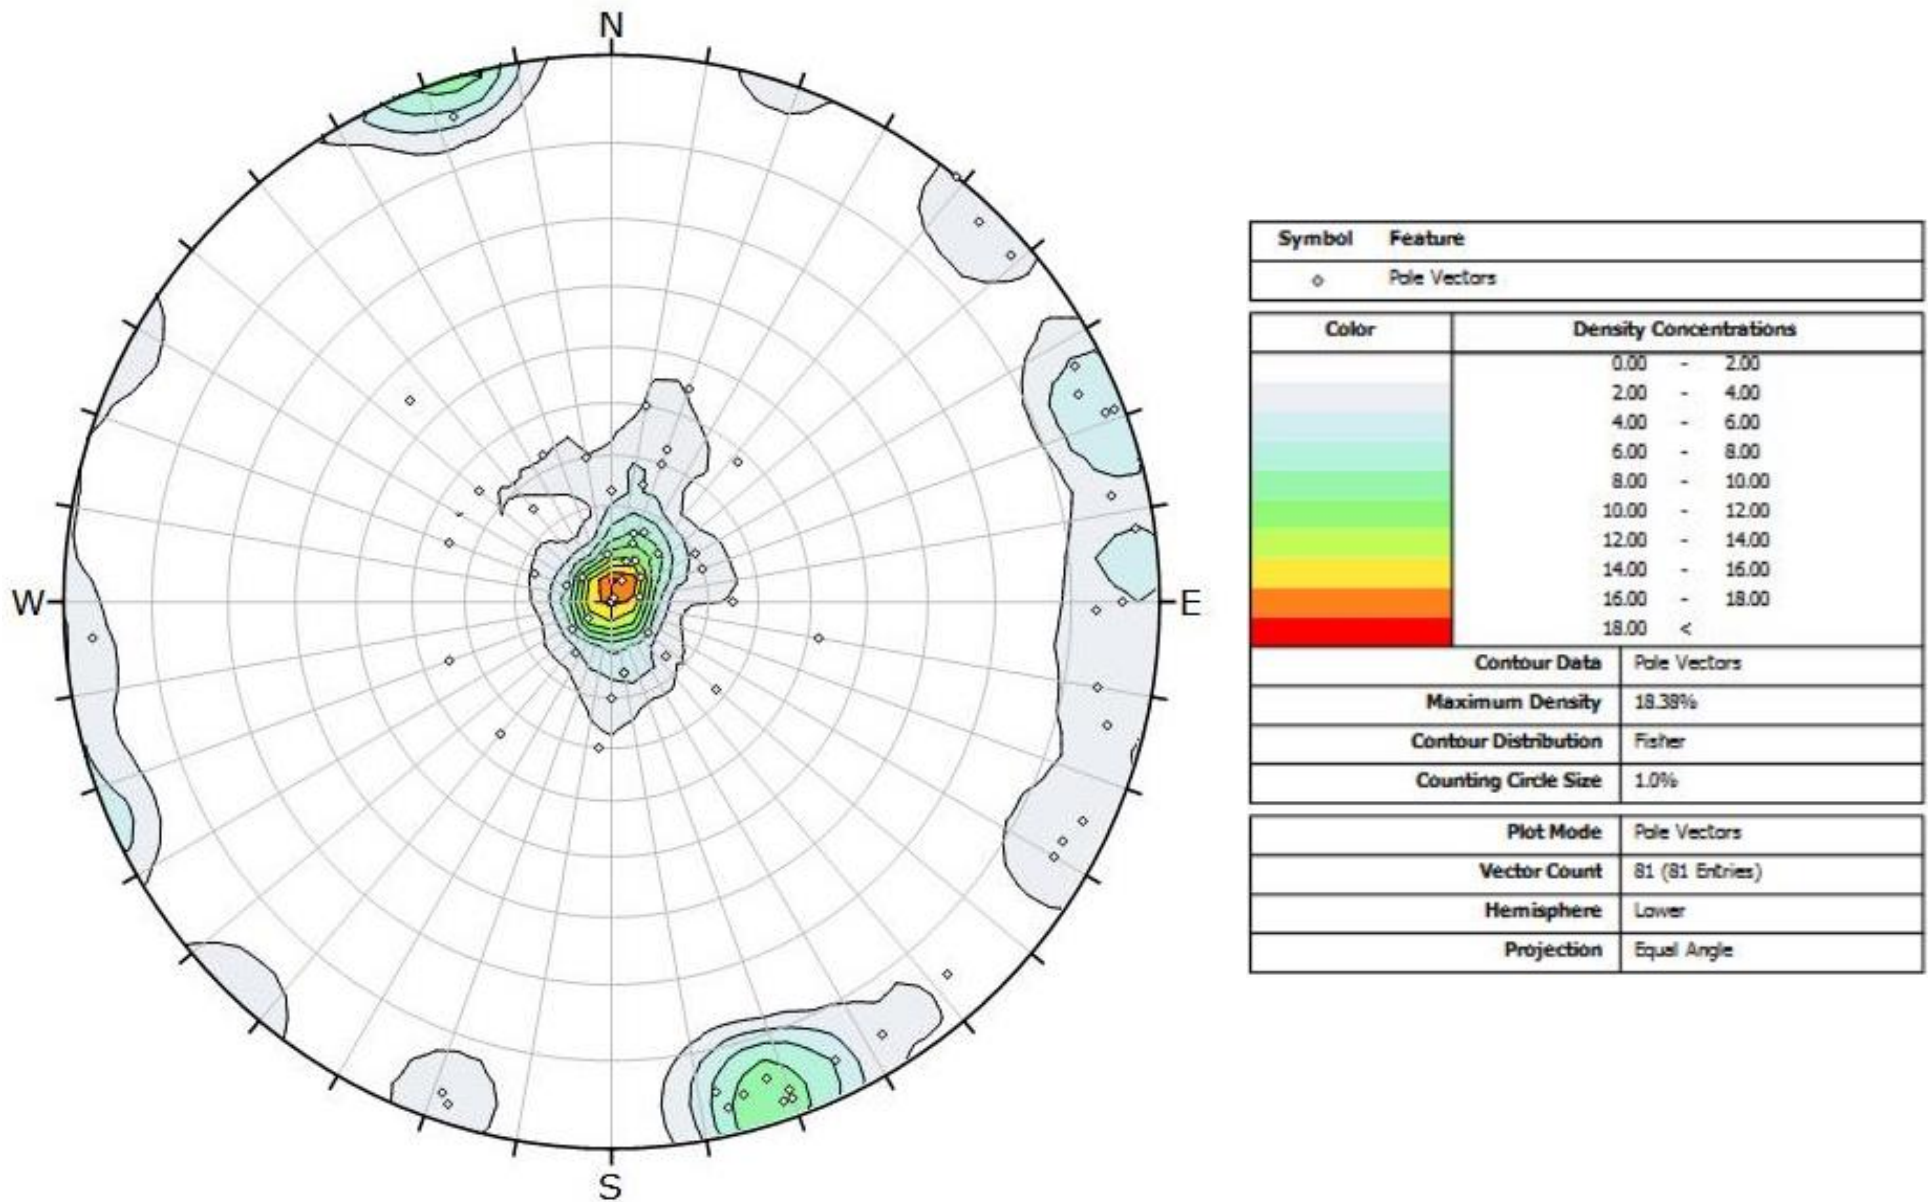
The results from the discontinuity survey are summarized in Figures 10 and 11. Randomly striking vertical joints separate the hexagonal columns (Figure 11a). The joints generally have open to very wide aperture (0.25-10 cm) with no infilling, and are widely spaced (0.6-2 meters). The joints are persistent for 20-30 meters and are undulating with rough surfaces. The lower extent of the joints is not visible, while the visible end terminates at the top of the climbing wall.

**Figure 10:** Summary of Discontinuities in the Colonnade. Lower hemisphere projection stereonet displaying discontinuities near the most popular routes across the Sunshine Wall. Points represent poles to joints and fractures measured in the field. Points clustered near the center of the stereonet are representative of through-going discontinuities that cut across the columns. Points along the perimeter represent column-bounding joints.

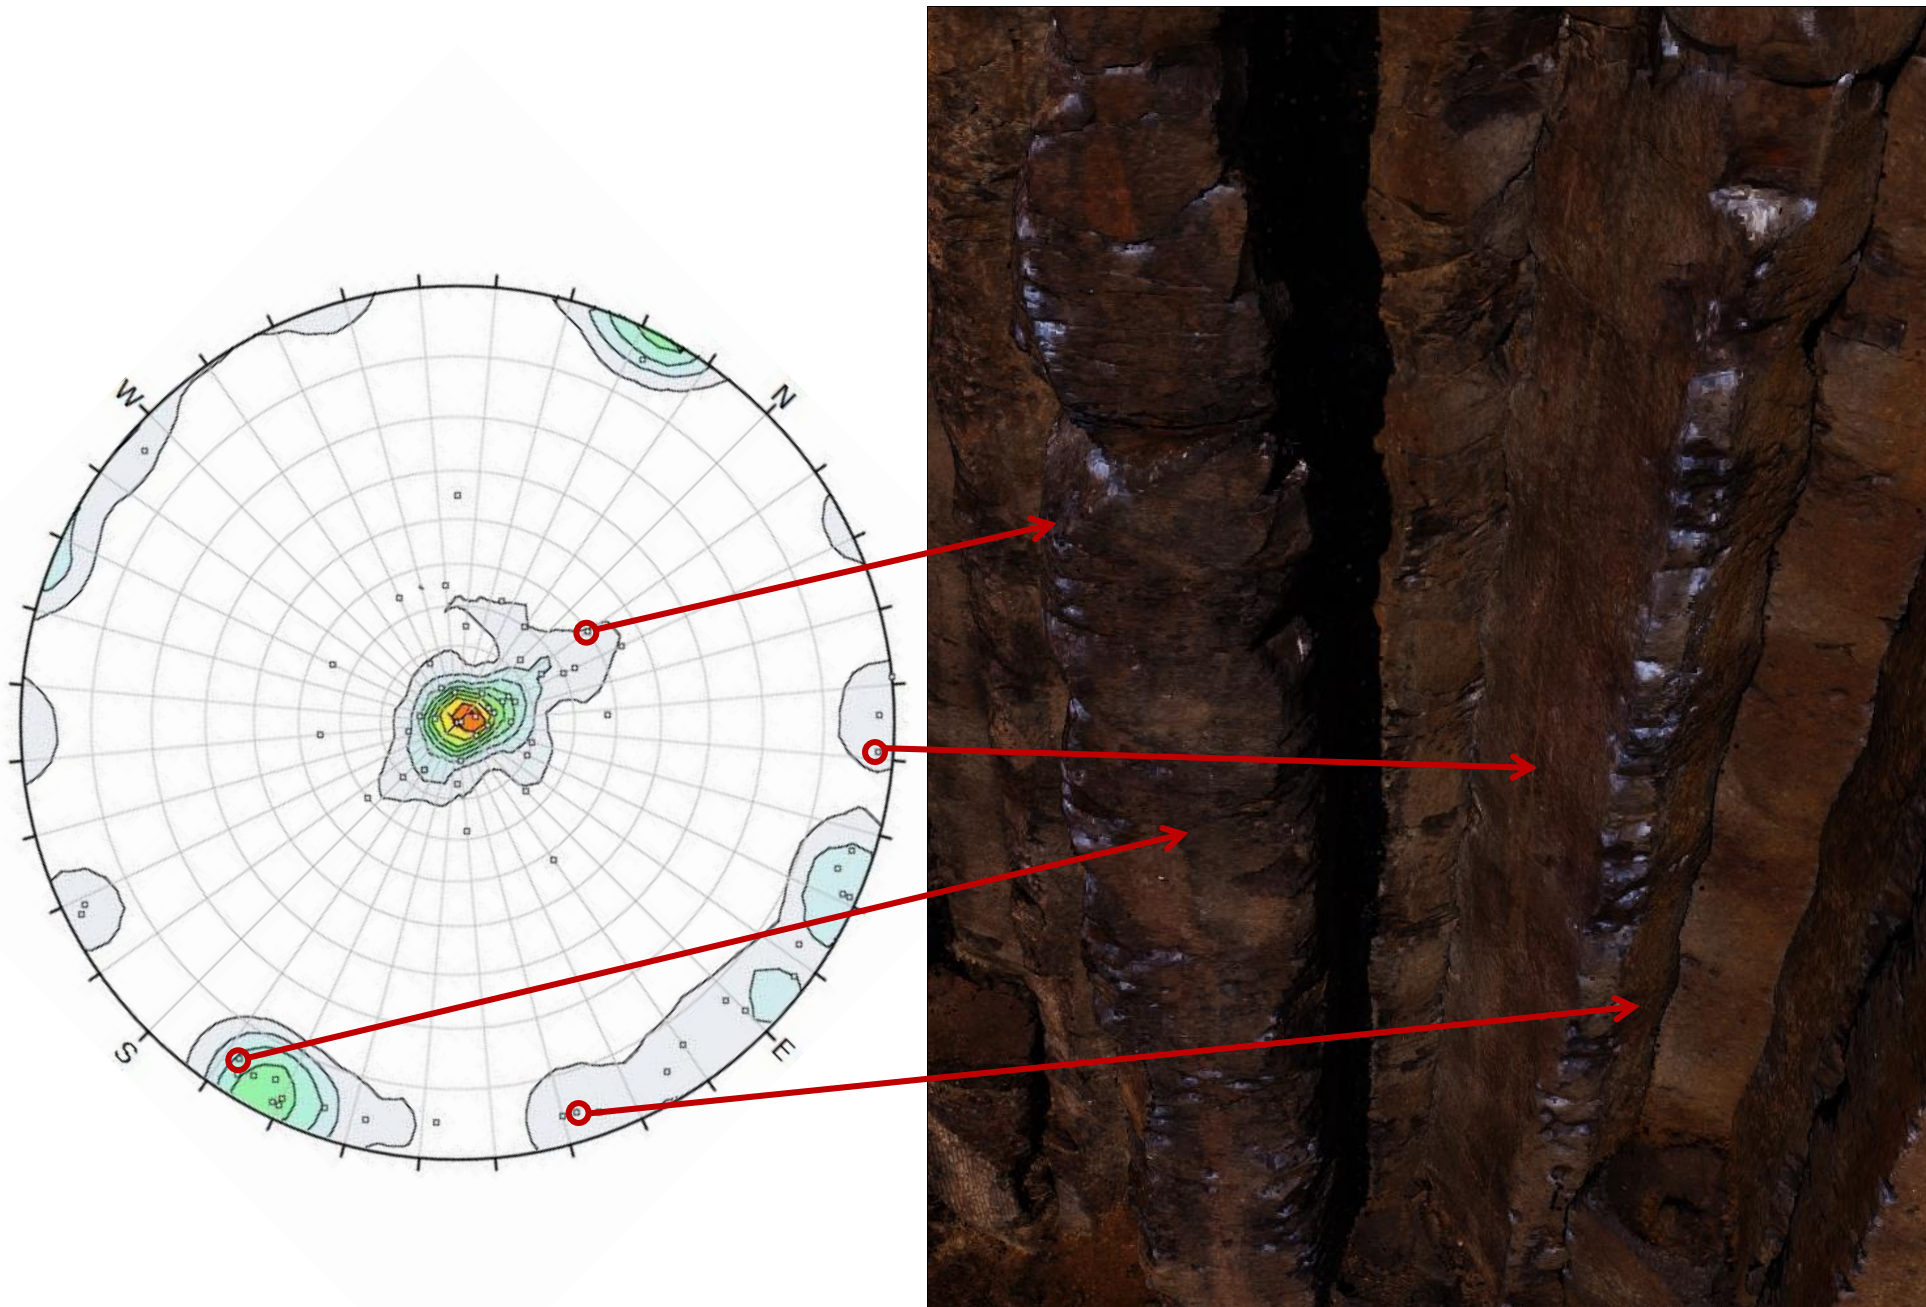
**Figure 11. A:** Mapping of Discontinuities. Specific poles related to the surfaces measured using the 3D digital model. Image at the right is a screen capture from Pix4D showing the climbing routes Steel Pulse on the left, and Narlux on the right.

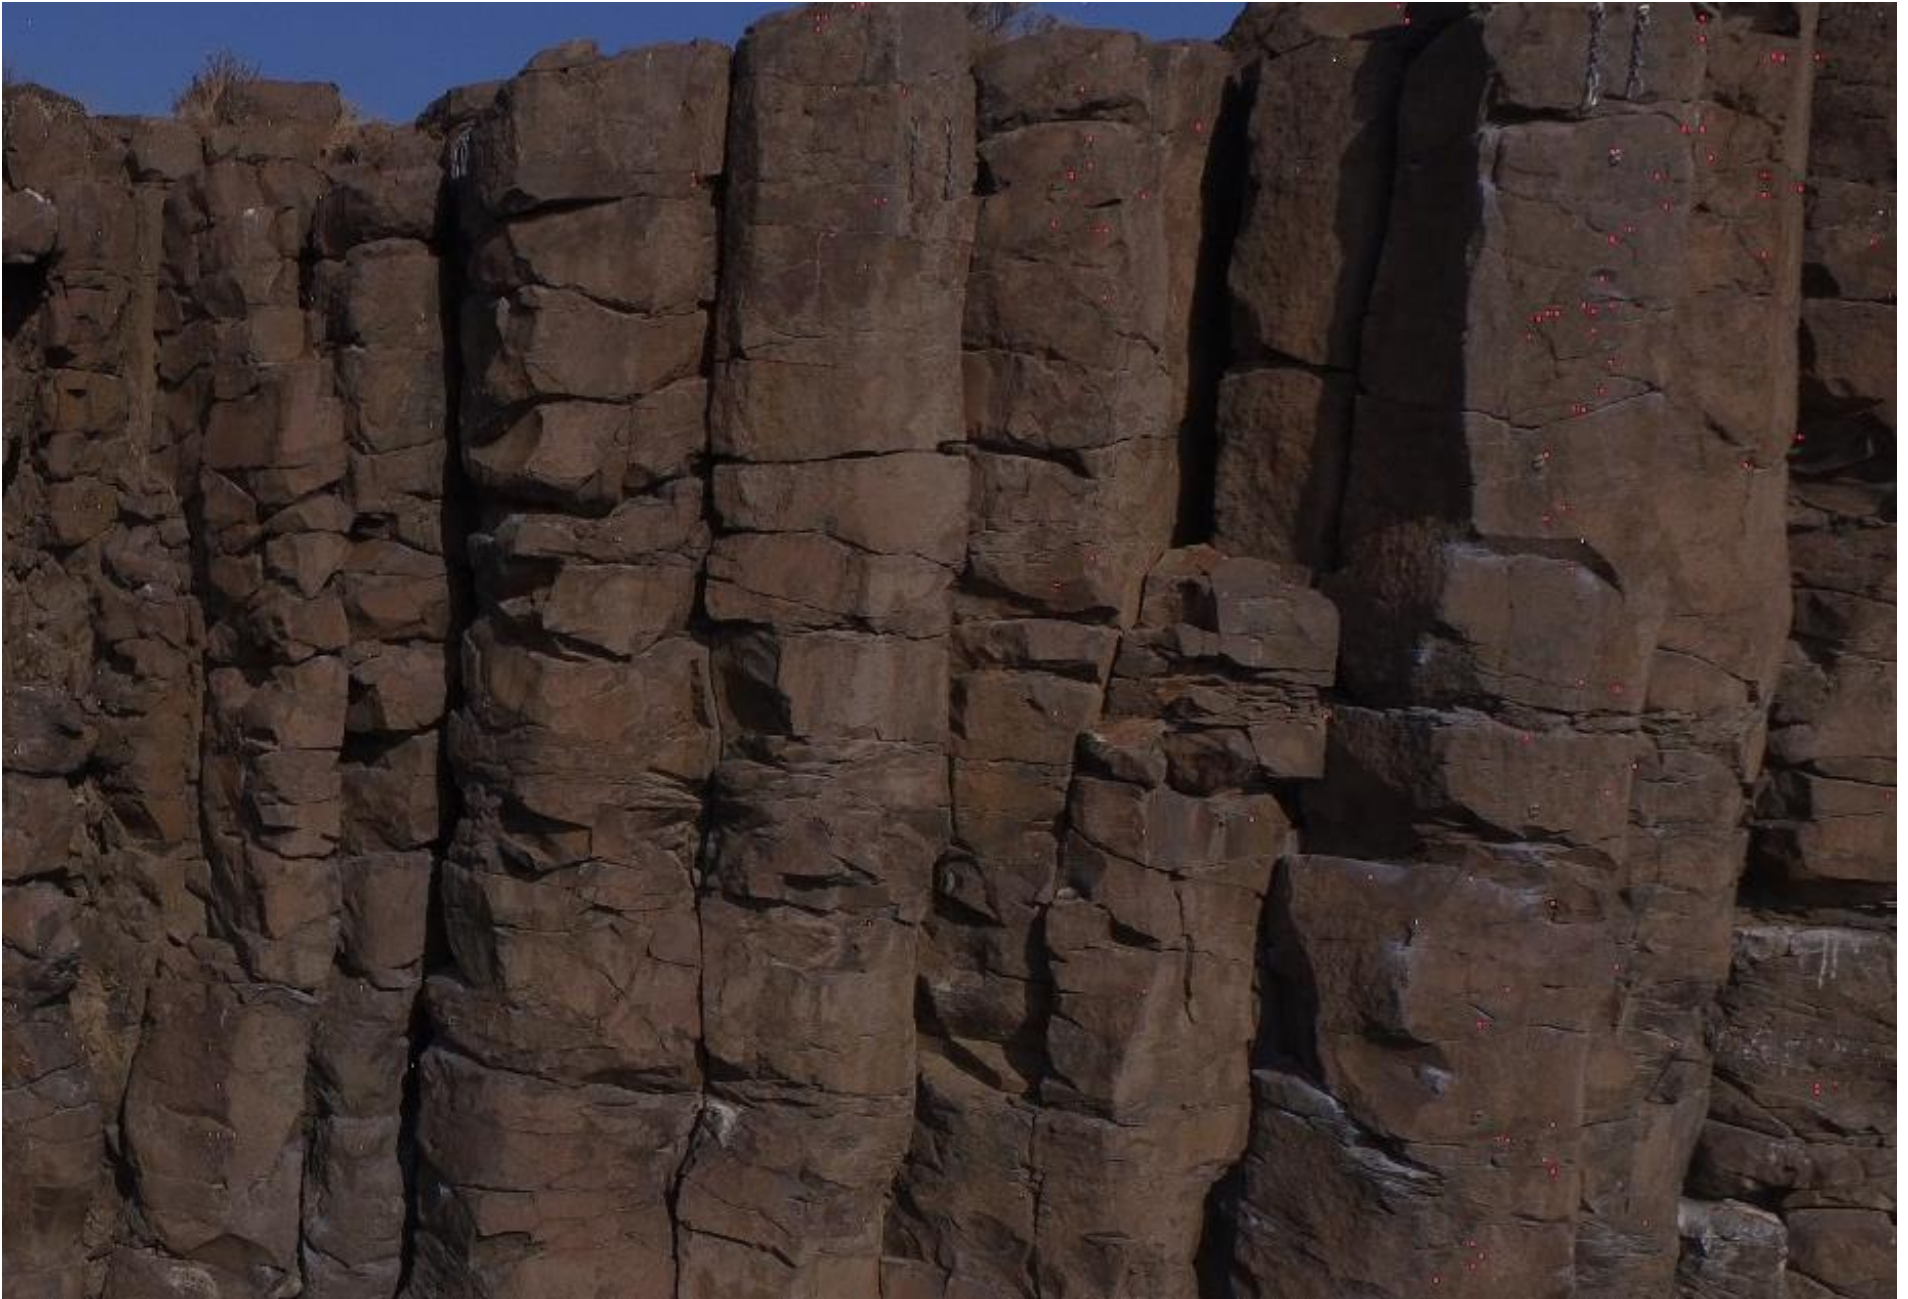
There are also non-systematic discontinuities which are persistent across the widths of the columns and have very tight aperture. Many of these discontinuities are nearly horizontal, although the average dip is 18 degrees (Figure 11b). The surfaces are also very rough and irregular in shape which adds to the effective friction angle.

**Figure 11b:** This image shows a number of sub-horizontal fractures that are represented by poles plotting in the center of the stereonet. In the upper right corner of the image a set of chains are present, which are used by climbers to descend off the route.

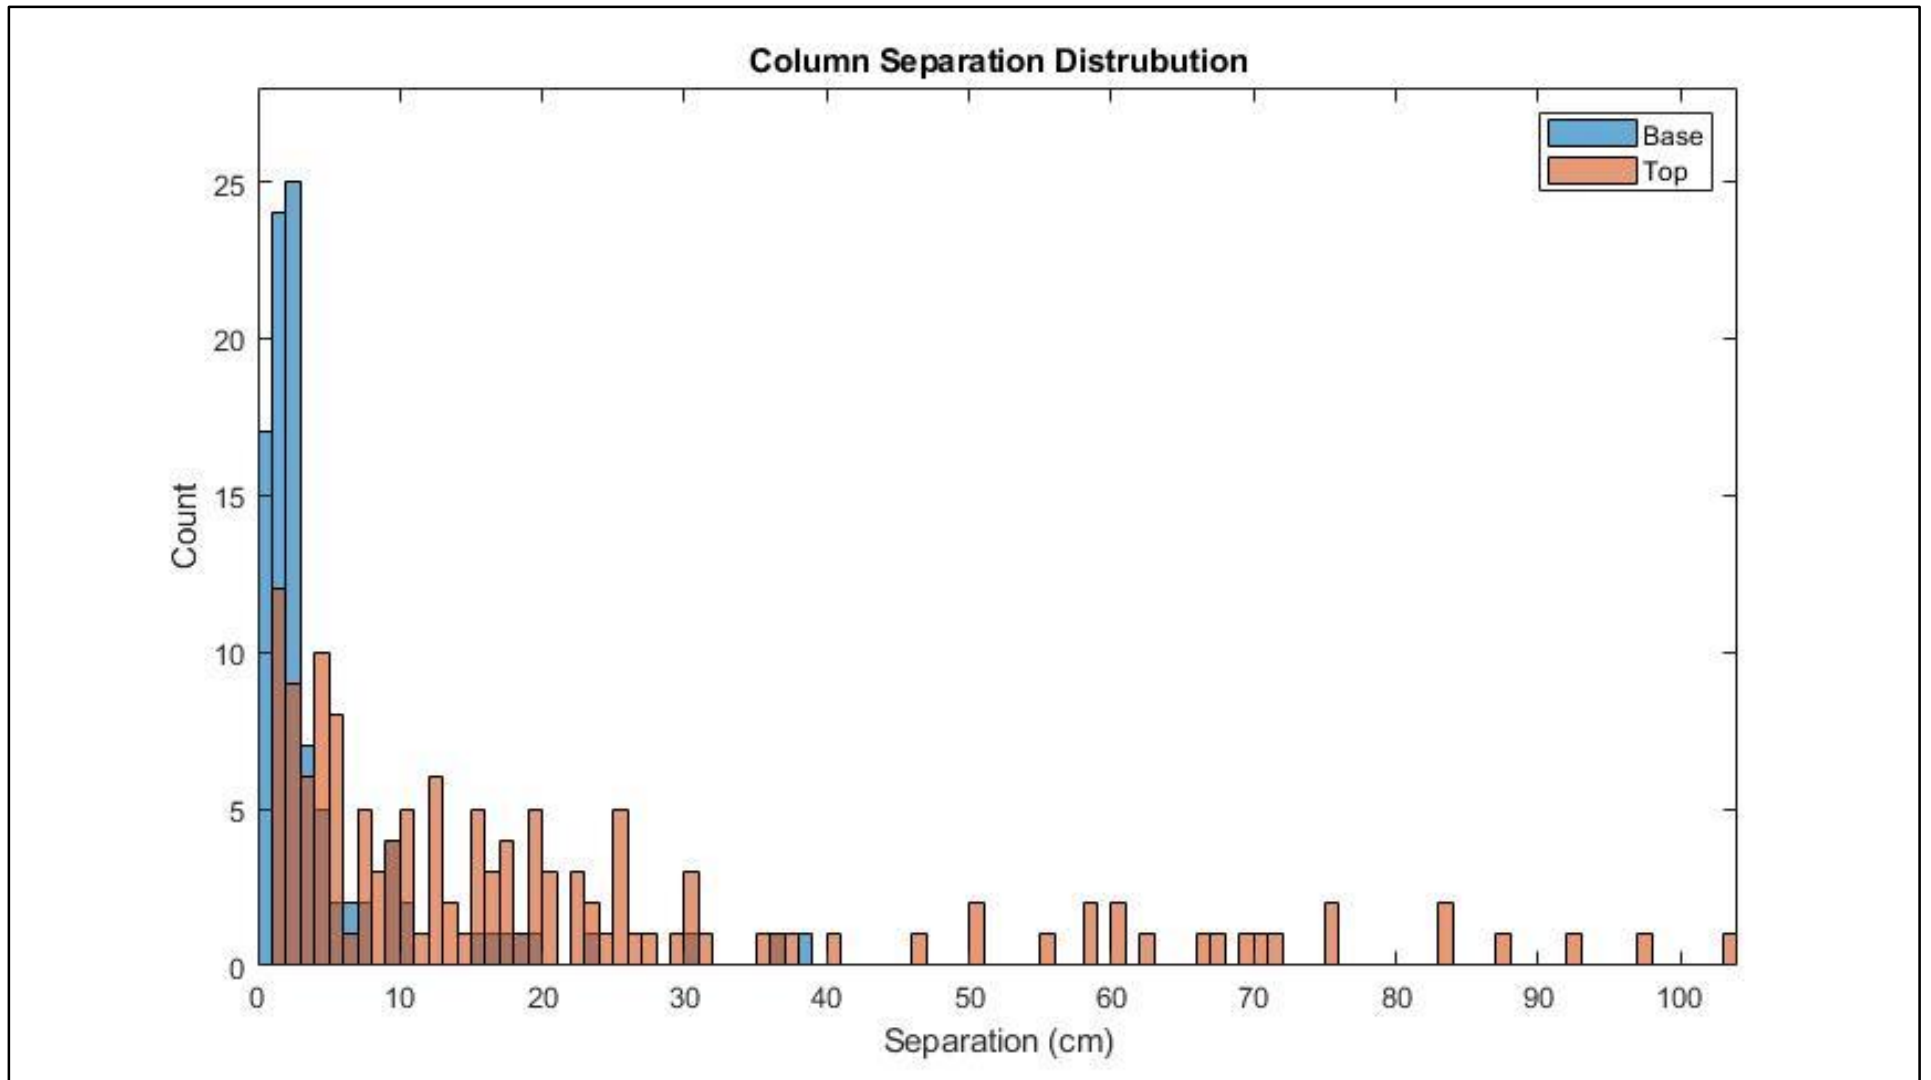
On average, the column separations are greater at the top of the colonnade than at the base by 20 cm, although in some areas they differed by as much as a meter (Figure 12). Along the top of the colonnade separations are generally greater toward the slope face (Figure 13a). Some column separations are greater than a meter at the top of the colonnade while the separations at the base are mostly less than 10 cm, indicating a significant amount of differential movement (Figure 13b; Table 1). At locations where separations at the top of the colonnade are large, column faces dip into the slope.

**Figure 12:** Differential Column Separations. Distribution of column separations at the bottom and top of the colonnade at the Sunshine Wall. Bars that appear darker represent overlapping bar plots.

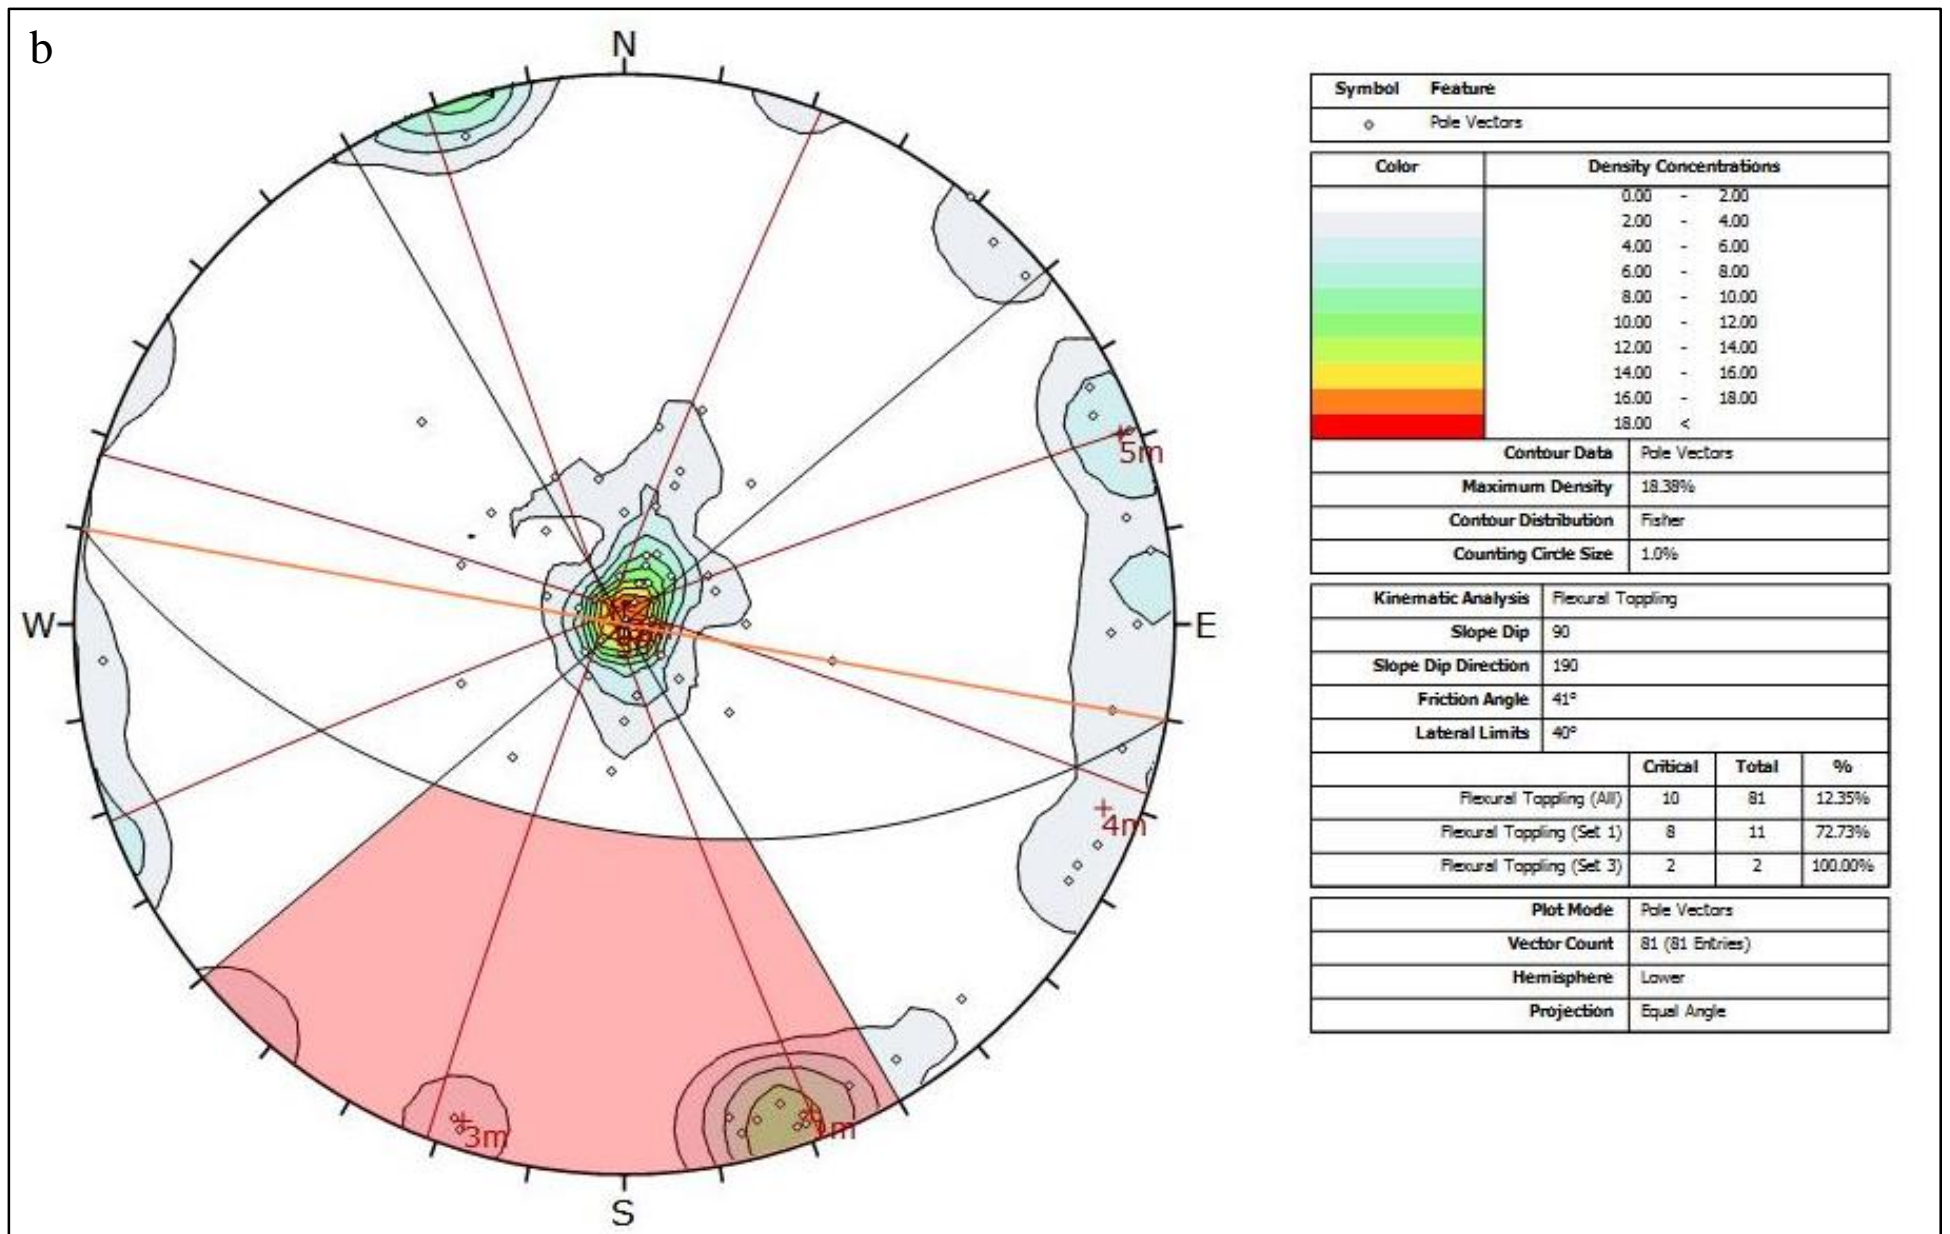
The other failure modes (slide, wedge, and flexural toppling) were assessed as well but did not demonstrate the same likelihood of failure (Figures 14b-d). This is due to a lack of intermediately dipping joints between sub-horizontal and vertical. Chances of slide failure are not as high because the dip of the majority of column-cutting fractures were well below the angle of friction, although there were several discontinuities that had dips measuring close to the angle of friction. A prominent discontinuity cuts across the column associated with the climbing route Steel Pulse at an angle of 38 degrees (upper surface highlighted in Figure 11a). Since the dip of this surface is just one degree less than the standard deviation of the mean friction angle, the factor of safety for sliding on this surface is close to one.

**Figure 14 (continued).** (b) Flexural Topple, assuming a friction angle of 41° and lateral limits of 40°.

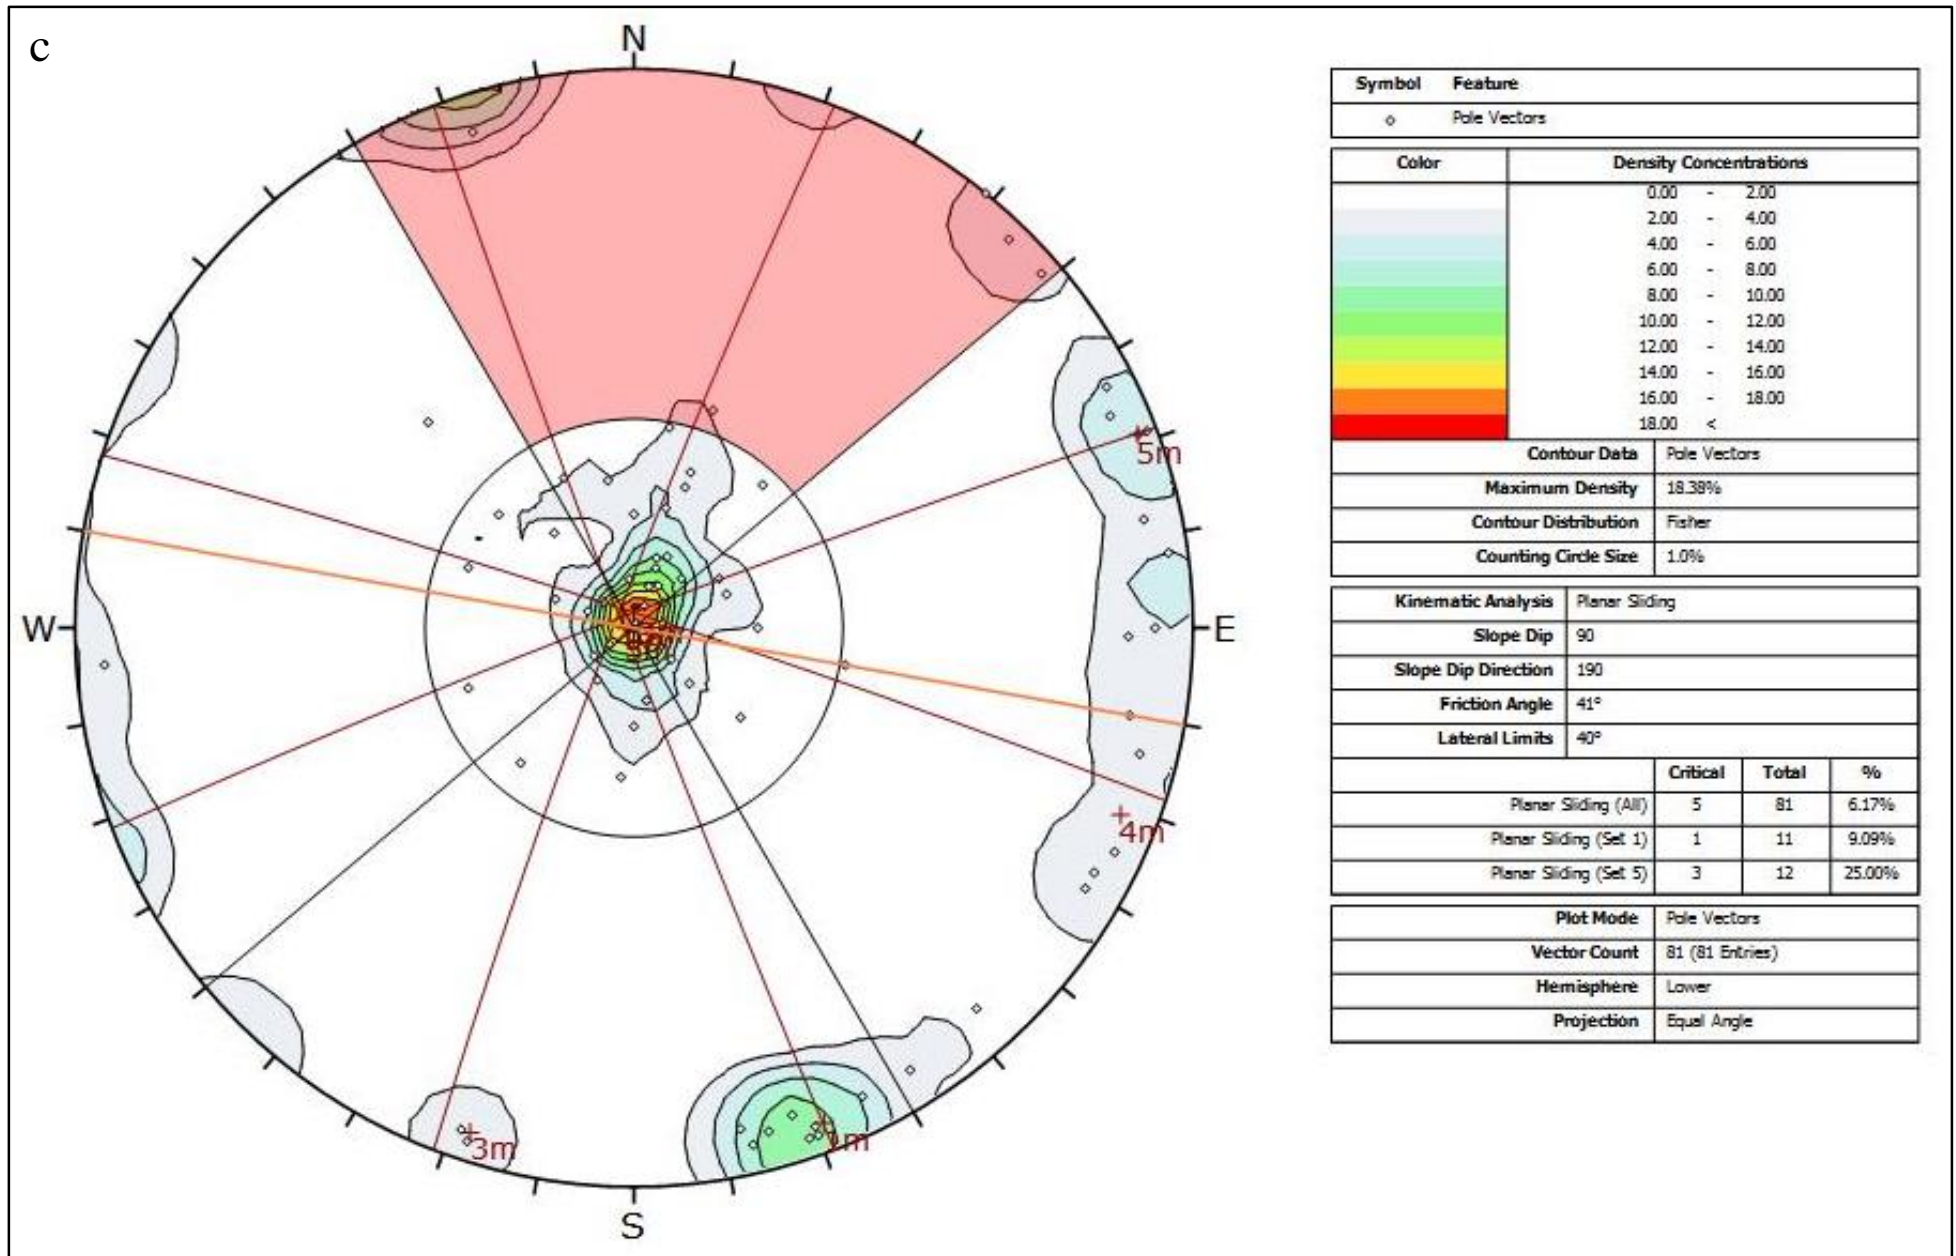
**Figure 14 (continued).** Kinematic analysis for sliding failure assuming friction angle of 41° shows few potential slide planes.

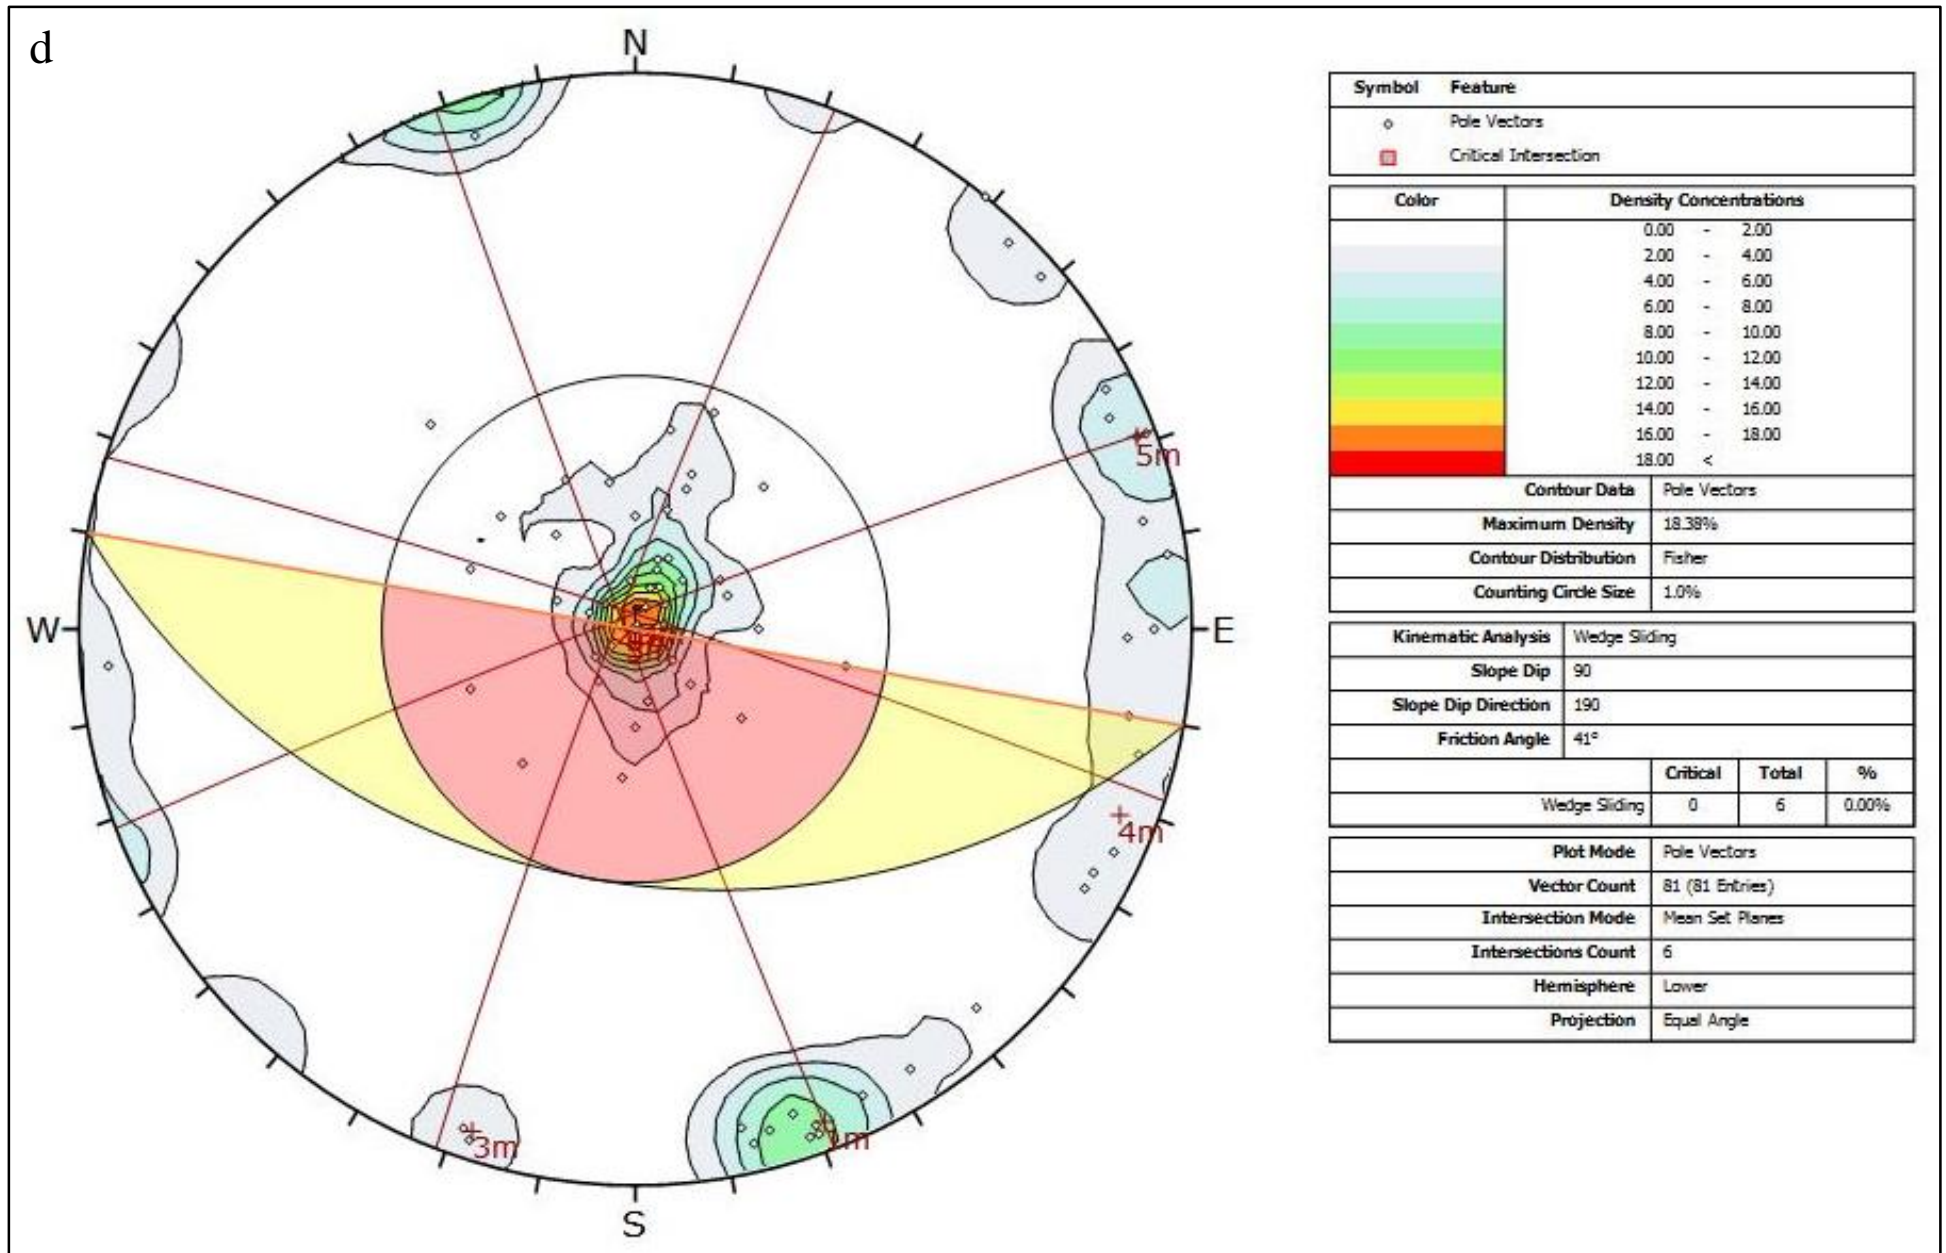
**Figure 14 (continued).** Kinematic analysis for wedge failure. No intersection lines fall in the red area, indicating wedge failure is not likely.
