Processing and Analysis of Lidar Derived Point Cloud Models of Low-Rise Large-Volume Steel
Frame Buildings Damaged in Hurricane Michael

A thesis

Master of Science in Civil Engineering

University of Washington

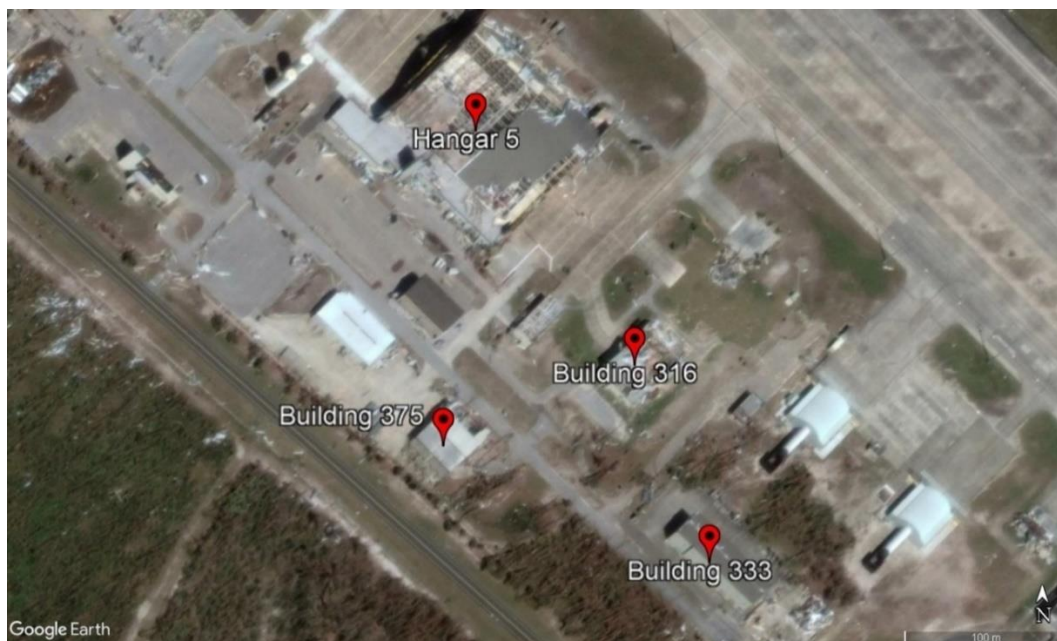
Due to the proximity of the buildings at Tyndall Air Force base to each other, aerial photographs were used to show the alignment. Figure 3.3 shows the area before Hurricane Michael and Figure 3.4 shows the extents of the damage directly following the hurricane.

Figure 3.4. A closer look at Tyndall Air Force Base on October 12, 2018 (Google, 2018)

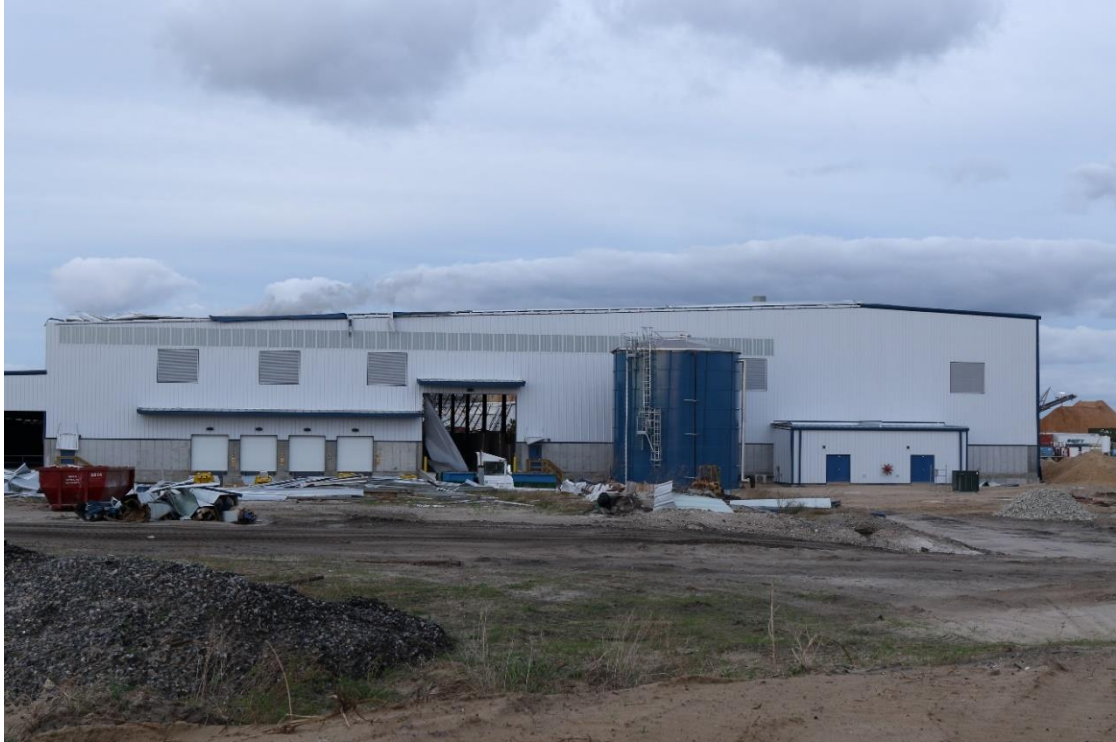
For the purpose of this thesis, building A is the main focus, and can be described as a single open space with no division into rooms. The roof is spanned laterally with non-prismatic, wide flange beams that are supported on both longitudinal sides with columns and in a centrally offset row towards the south side of the building as can be seen in Figure 3.6. The ridge of the roof is centrally offset too, and the slope of the roof is the same on both sides, so the difference is made up with different roof heights on either side which can be seen in Figure 3.5.

Figure 3.5. A view of the intact face of Westrock East Terminal demonstrating the off-center roof pitch.

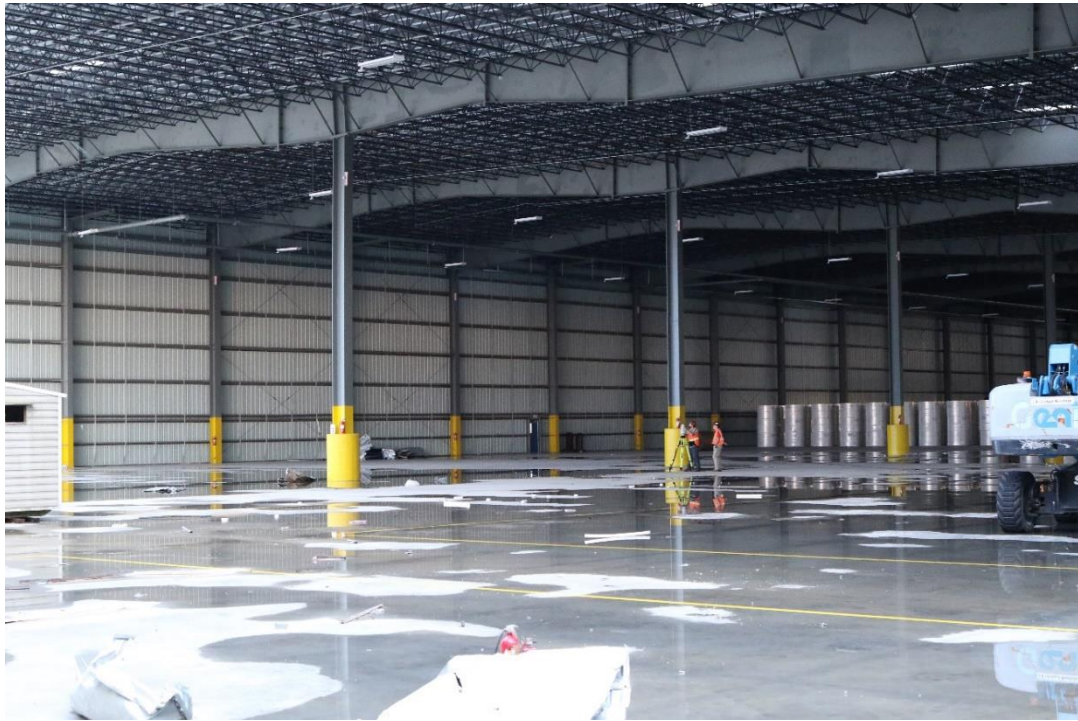
Figure 3.6. A view from inside Westrock East Terminal showing the framing and columns.

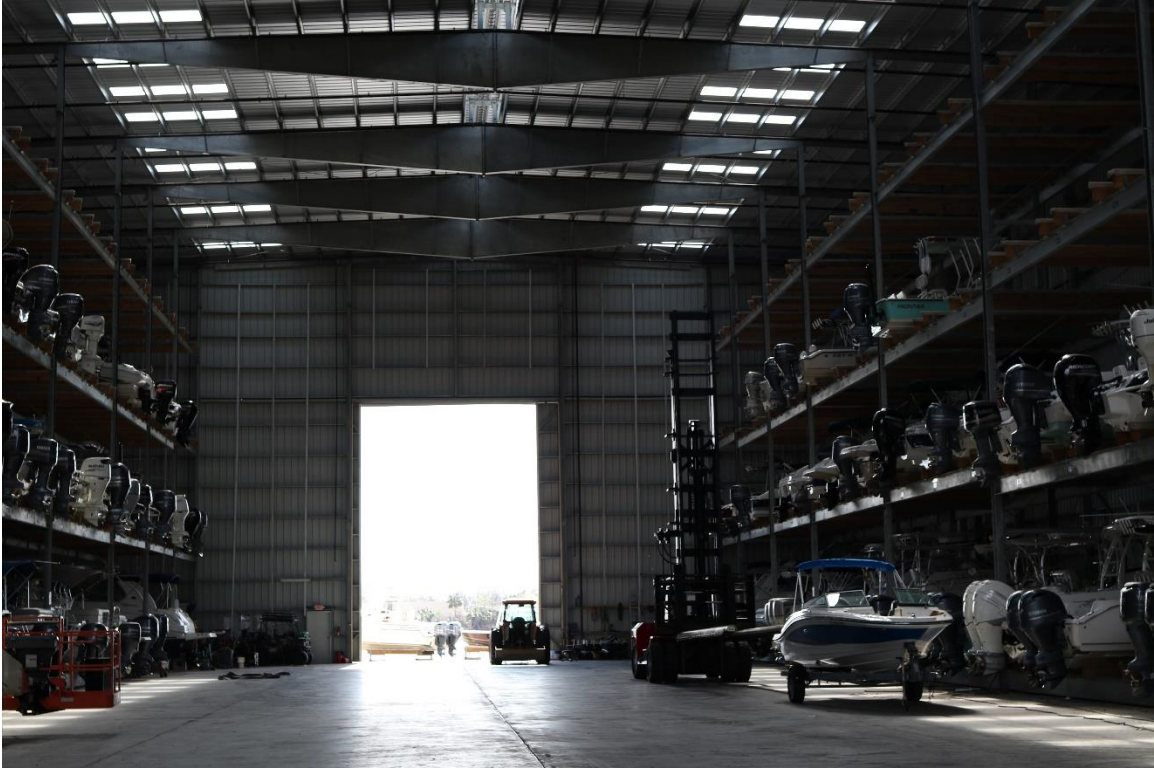
Outside the boat racks the system is relatively straightforward, as there are columns all along the edge, with large non-prismatic beams spanning the lateral direction of the roof and purlins between them as can be seen in Figure 3.9 and Figure 3.10. The ridge of the roof is central and the slope towards the center is equal from both sides.

Figure 3.9. A view of the undamaged side of Watson Landings Marina.

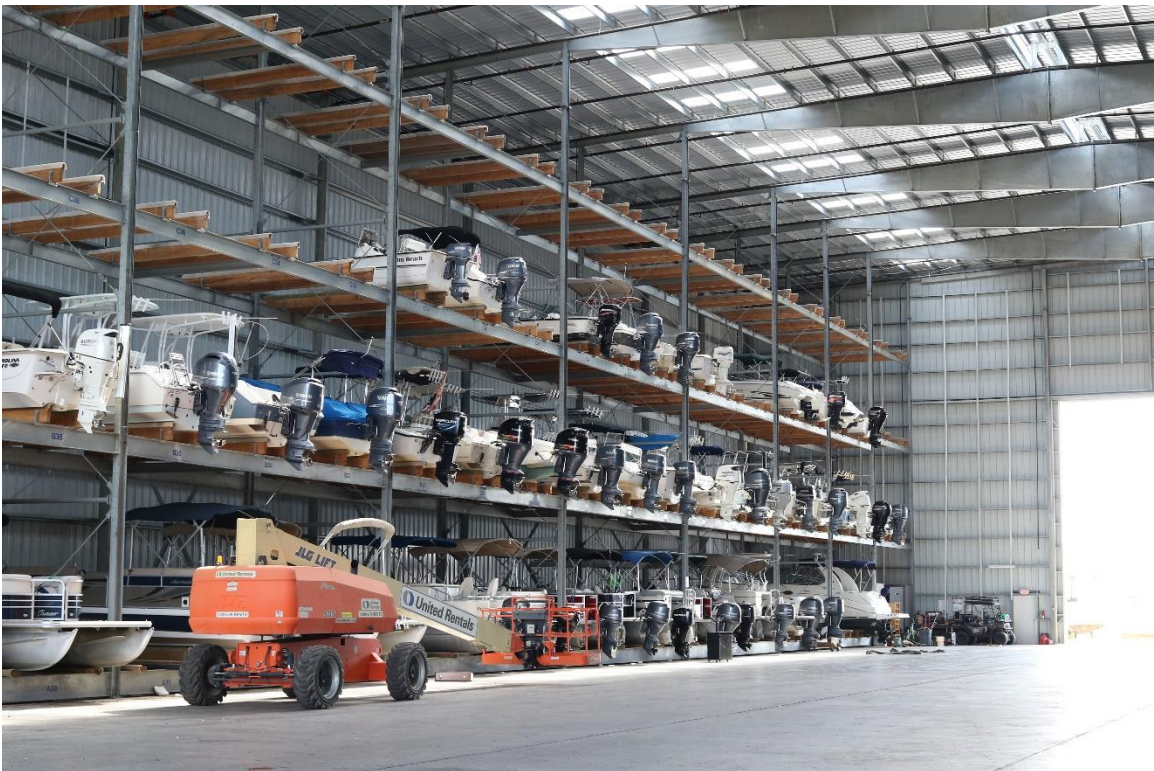
Watson Landings Marina is a relatively symmetric steel frame LRLVB that is used as a marine storage building. It consists of a single open space with four story boat racks, seen in Figure 3.10, along both longitudinal walls that are an integral part of the structural system. The structural system and racks are a proprietary design from Roof & Rack Products, Inc. so the dimensions gathered from the scans cannot be compared directly to anything found in the drawing set. All that is known is that they consist of wide flange beams and columns, with slender cross bracing.

Figure 3.10. A view of the boat racks of Watson Landings Marina.

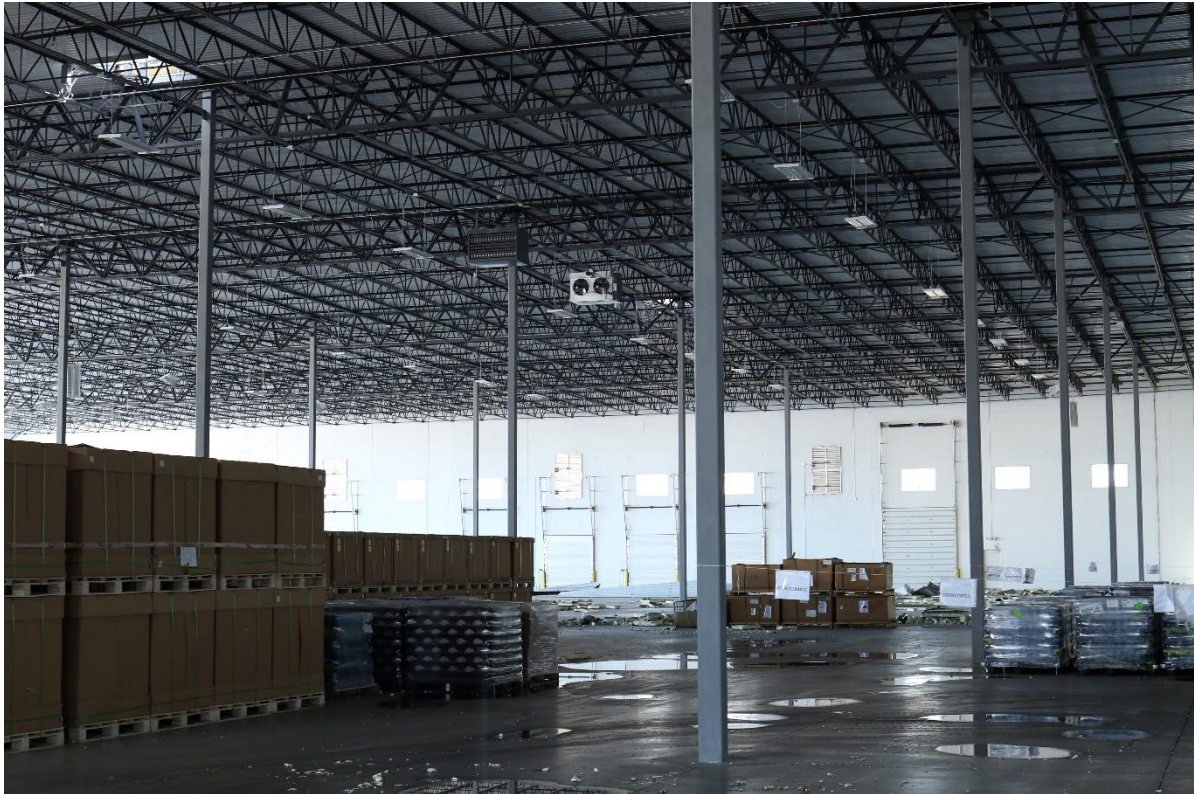
The roof consists of truss girders in both directions and is supported by five rows of columns in addition to columns at the tilt-up walls along the edge. These elements can all be seen in Figure 3.14, which is taken from the westernmost corner of the building towards the southeast facing wall. The scanned area is a single open space with no dividing elements other than the rows of columns.

Figure 3.14. Column setup and roof framing from the IDC.

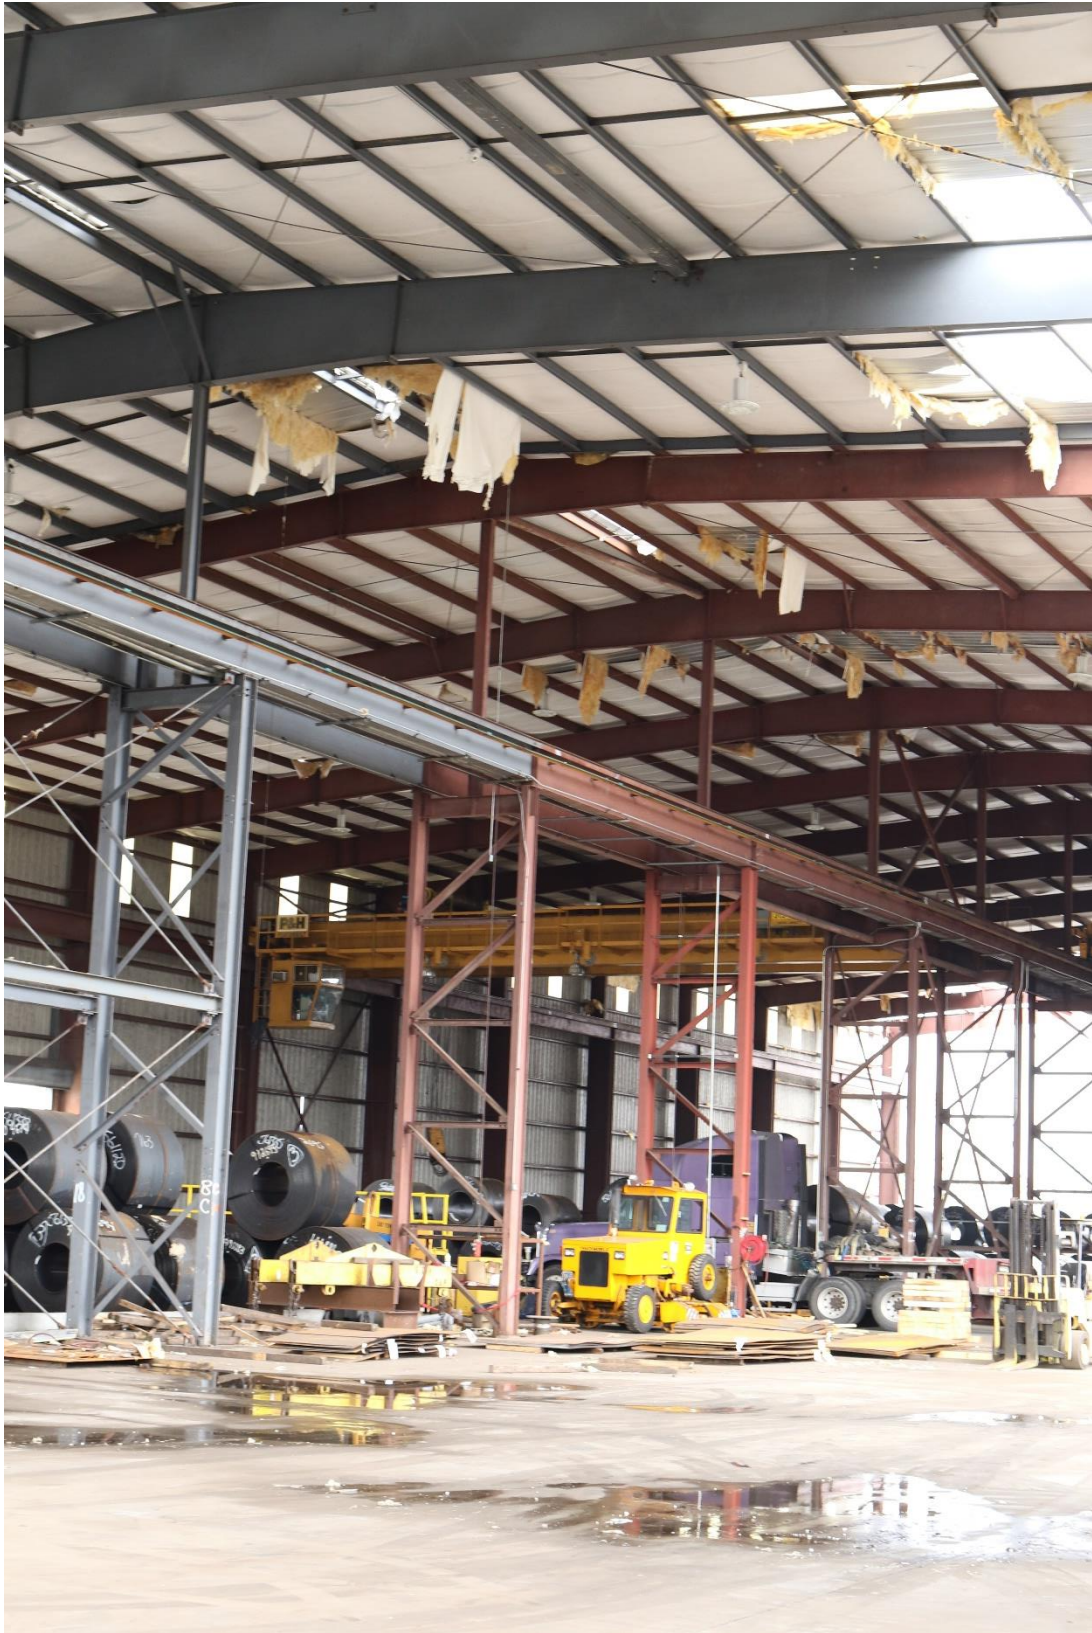
Cargill Distribution Center is another storage facility that falls neatly into the LRLVB category. It is supported by wide flange columns along the edges and beams run laterally towards the ridge of the roof, which is central in this case. A truss girder runs along the whole ridge and supports the beams spanning the roof, along with lifting machinery used within the facility shown in Figure 3.17. The building consists of one open space, divided only by the truss girder in the middle.

Figure 3.17. The framing system of Cargill Distribution Center.

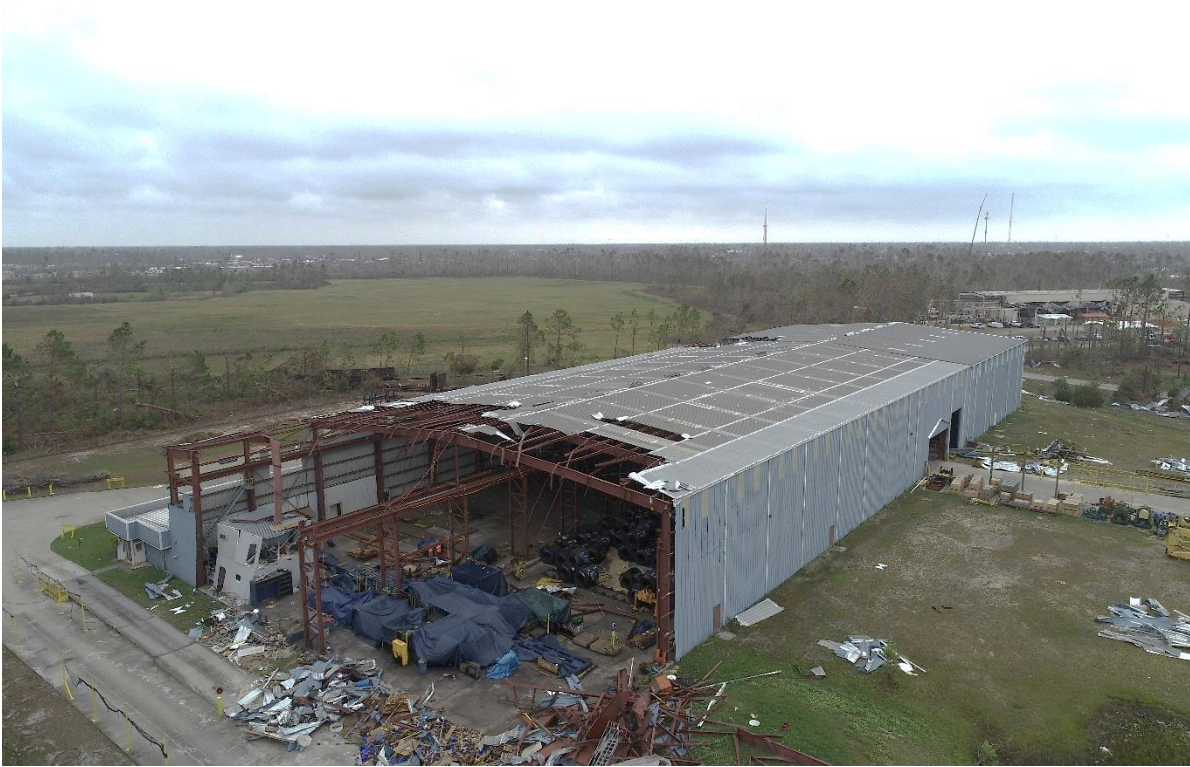
The first two bays from the northernmost side collapsed completely, along with the wall on the west side spanning those same bays, while the central truss system and the eastern facing longitudinal wall did not collapse. Roof cladding was torn off one bay further into the building and slight damage to the cladding can be observed further into the building. These damages can be seen in Figure 3.18.

It is worth noting that some clean-up work had been done on the collapsed north side without any documentation, so the damage could have been exaggerated by that work.

Figure 3.18. The collapsed side of Cargill Distribution Center.

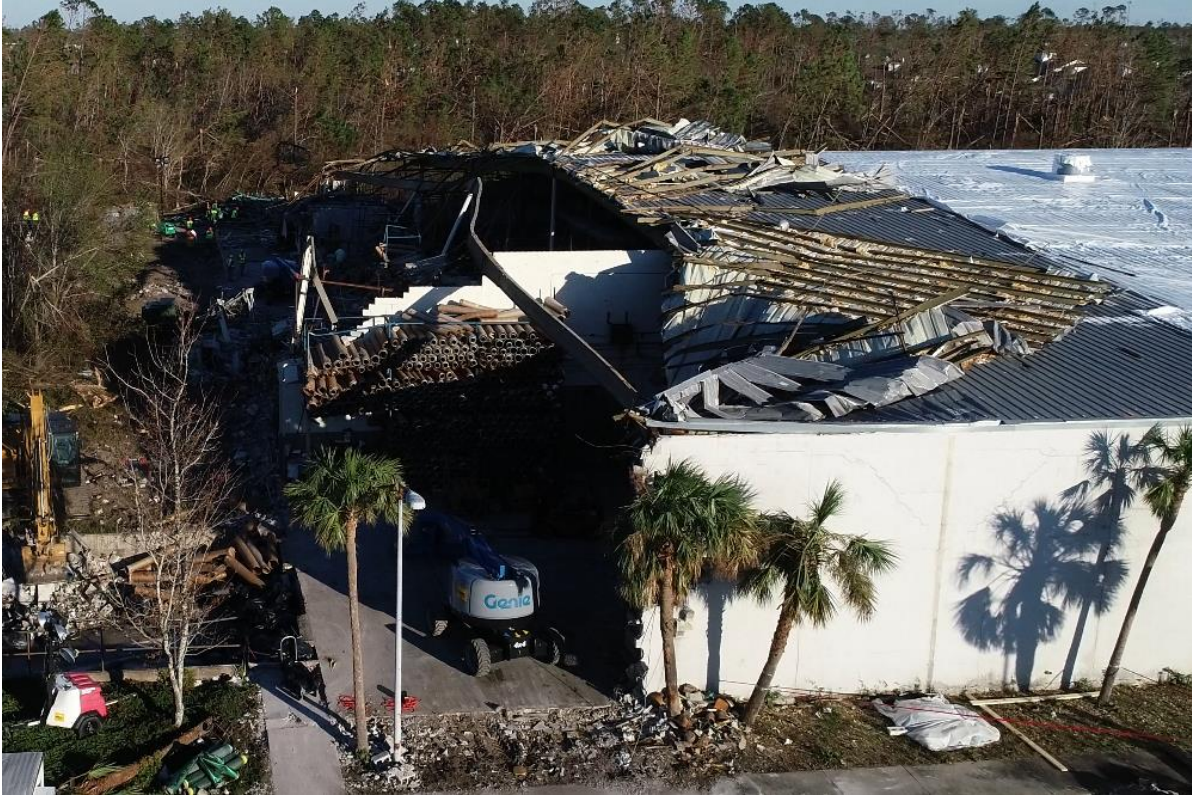
The damages to Parthenon included the collapse of the north facing wall shown in Figure 3.32 and large deformations to the roof-spanning beam along the second column line demonstrated in Figure 3.33. In addition, the roofing was torn off in the second bay and damages to the concrete side walls were recorded towards the north side, shown in Figure 3.34.

All the information about the structural failures gathered from Parthenon should be taken with a grain of salt, as the demolition process was well under way and therefore it is unclear what damages were caused by the hurricane and what was collateral damage in the clean-up process.

Figure 3.32. The collapsed side of Parthenon.

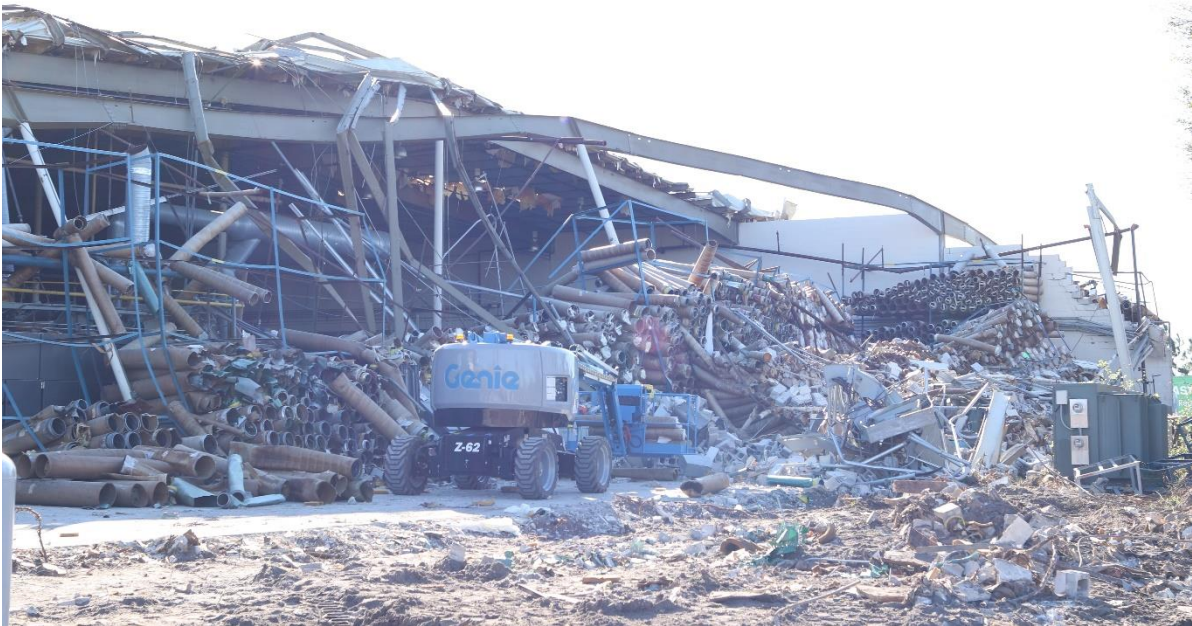
Figure 3.33. View of the collapsed beam in Parthenon.

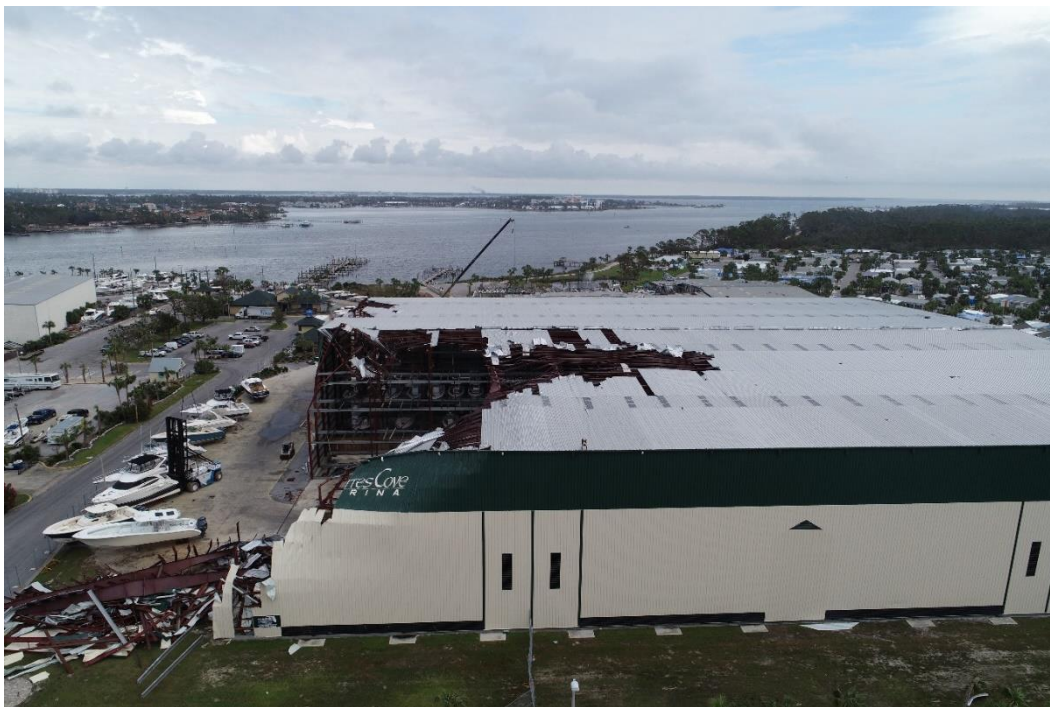
The roofing suffered a complete collapse between the westernmost side and the central row of columns, approximately five bays in from the north along with more minor cladding damages between bays five and nine as demonstrated in Figure 3.37. In addition, there were signs of buckling of roof purlins in the first bay between the easternmost side and the central row of columns which can be seen in Figure 3.39.

Figure 3.37. Pirates Cove Marina seen from the west.

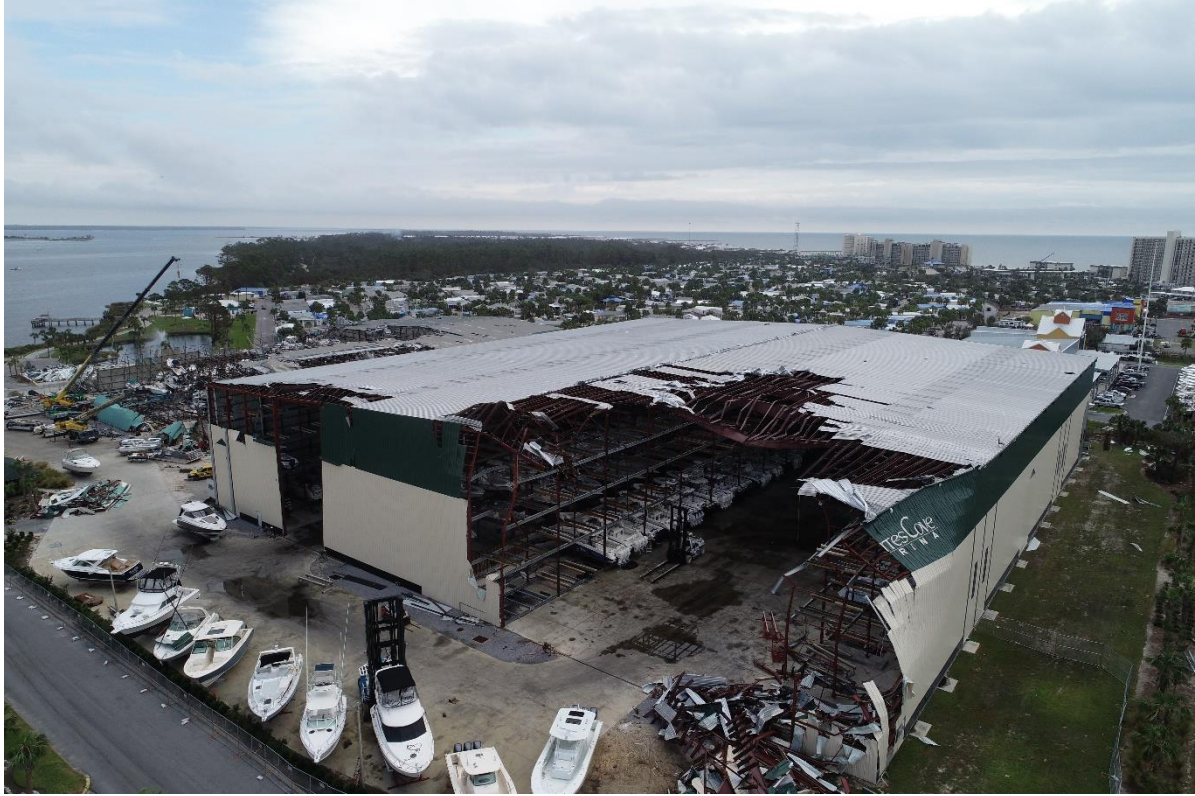
It is a steel frame building, and much like Watson Landings Marina, boat racks appear to be an integral part of the structural system. There is a single file of racks on either edge along with two rows in the middle. The roof is spanned by wide flange beams which are interconnected by purlins, and they connect to the central boat rack along with rows of columns on either side. The roof appears to have a gentle pitch towards the center, but due to the quality of scans it is difficult to tell. The framing system is most clearly demonstrated in Figure 3.38.

Figure 3.38. Pirates Cove Marina seen from the northwest.
