**Assessment of Stream Restoration Efforts and Development of  
Effectiveness Monitoring Protocol  
Ohop Creek, Pierce County, Washington**

Master of Science  
Earth and Space Sciences: Applied Geosciences

University of Washington

June 6, 2018

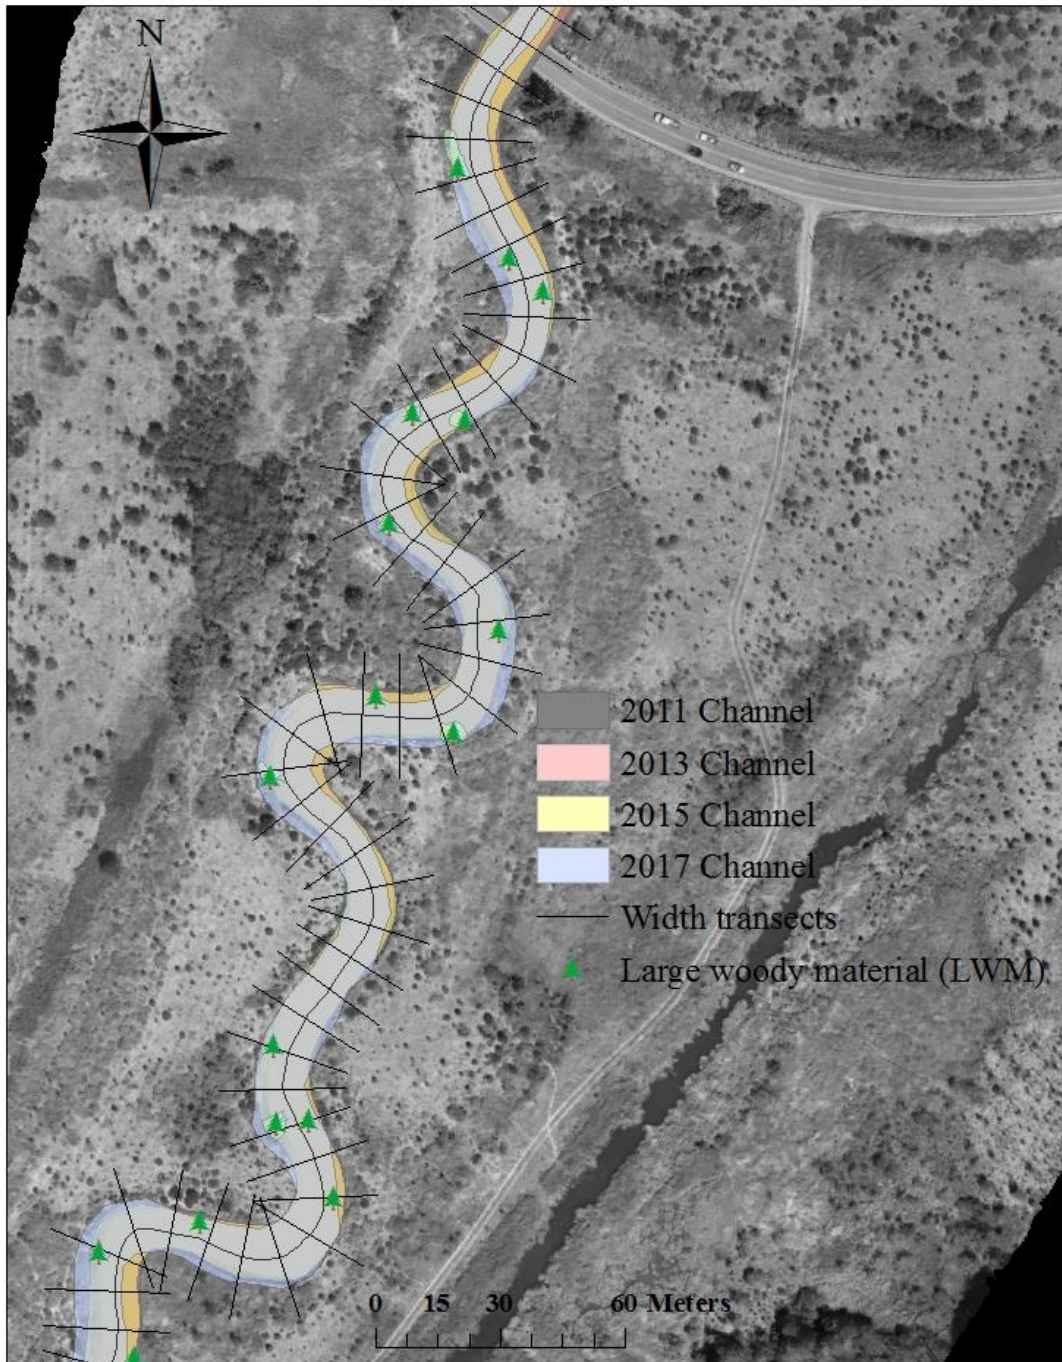
changes between 2011 and 2017 for the Phase I channel, and between 2015 and 2017 for the Phase II channel (Figure 2). An interval spacing of 10 m between transects was chosen in order to ensure that enough transects intersected LWM structures, making it possible to determine the magnitude of widening provided by in-channel wood.

Figure 2. Channel widening in the Project reach was measured from active channel polygons, digitized at 1:500 scale, and width transects created using the Channel Migration Toolbox. Pictured is a section of the Phase I reach.

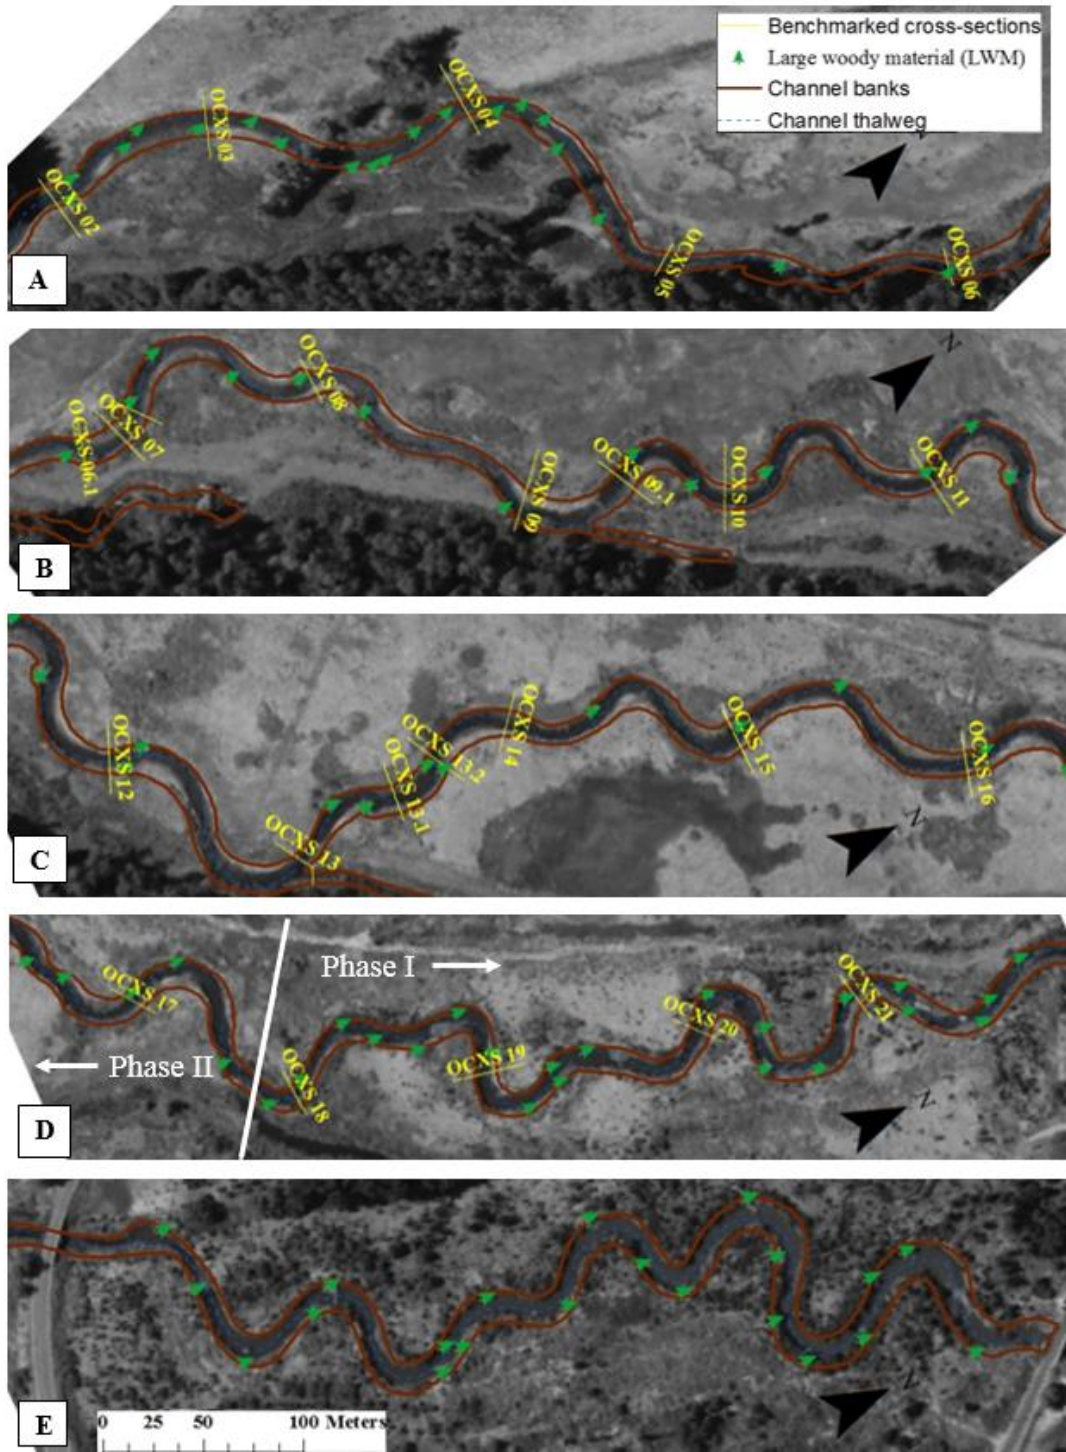
During August and September of 2017, I installed permanent benchmarks and surveyed 25 cross-sections in the Project reach (Figure 3; Appendix A1). The benchmark locations were recorded using a Trimble Geo7X GPS unit connected to the Washington State Reference Network (WSRN) to achieve real-time field corrections. I used the North American Datum (NAD) 1983 as the horizontal datum and NAVD 1988 as the vertical datum. The horizontal and vertical accuracies of the coordinates was 0.02 m and 0.03 m, respectively.

Figure 3. Five-cm orthographic images created in Agisoft Photoscan showing location of permanently benchmarked cross-sections and LWM structures in the Project reach. Images are oriented from downstream (A) to upstream (E). Transition between Phase I and II is shown in image D.

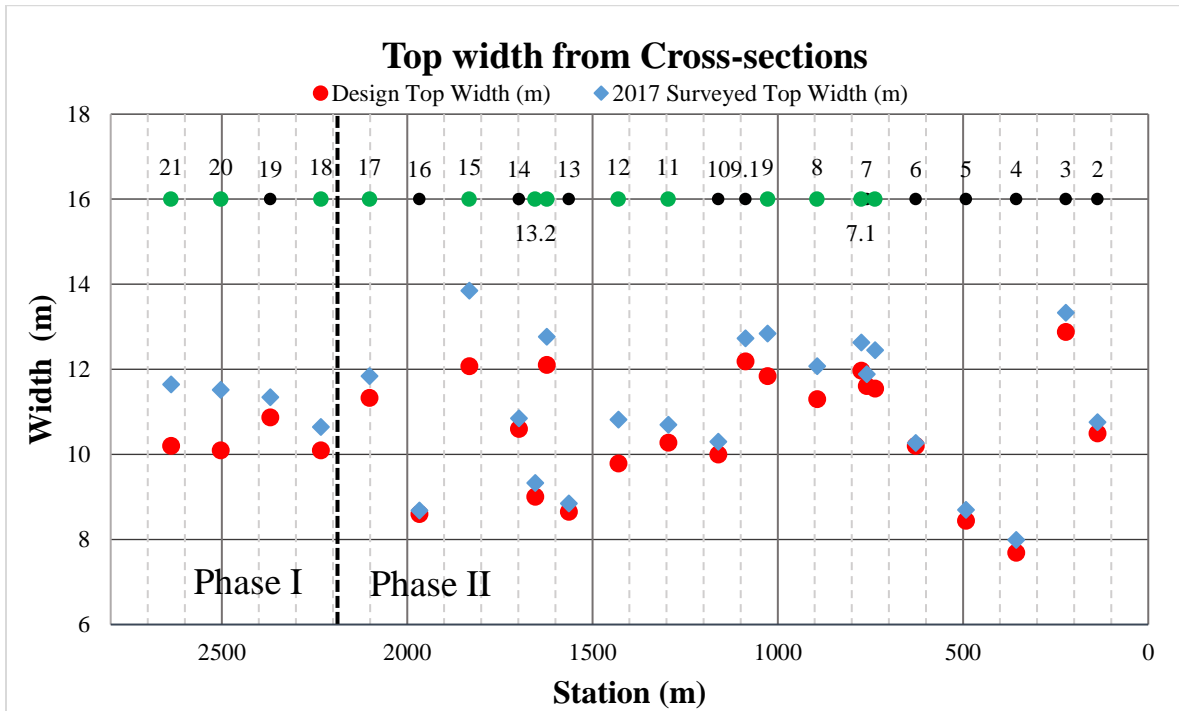
Channel widening measured from comparing the 2017 surveyed cross-sections with the as-built and design cross-sections is similar in magnitude to the NAIP image analysis and also indicates that widening is greatest for cross-sections located at or near LWM structures (Figure 7). Phase I widening averaged 1.2 m (N = 3, SD = 0.5) around wood structures from 2010 to 2017. Of the four cross-sections in the Phase I reach, OCXS 19 was the only one not located near an LWM structure. Widening at this location was measured at 0.5 m. Widening in the Phase II reach between 2015 and 2017 averaged 0.6 m (N = 10, SD = 0.4) at or near wood structures and 0.2 m (N = 11, SD = 0.1) for other cross-sections.

Figure 7. Summary of top width comparisons from design and 2017 surveyed cross-sections. Cross-section locations and numbers are shown at the top of plot for reference. Cross-sections located at or near LWM structures are marked in bright green.

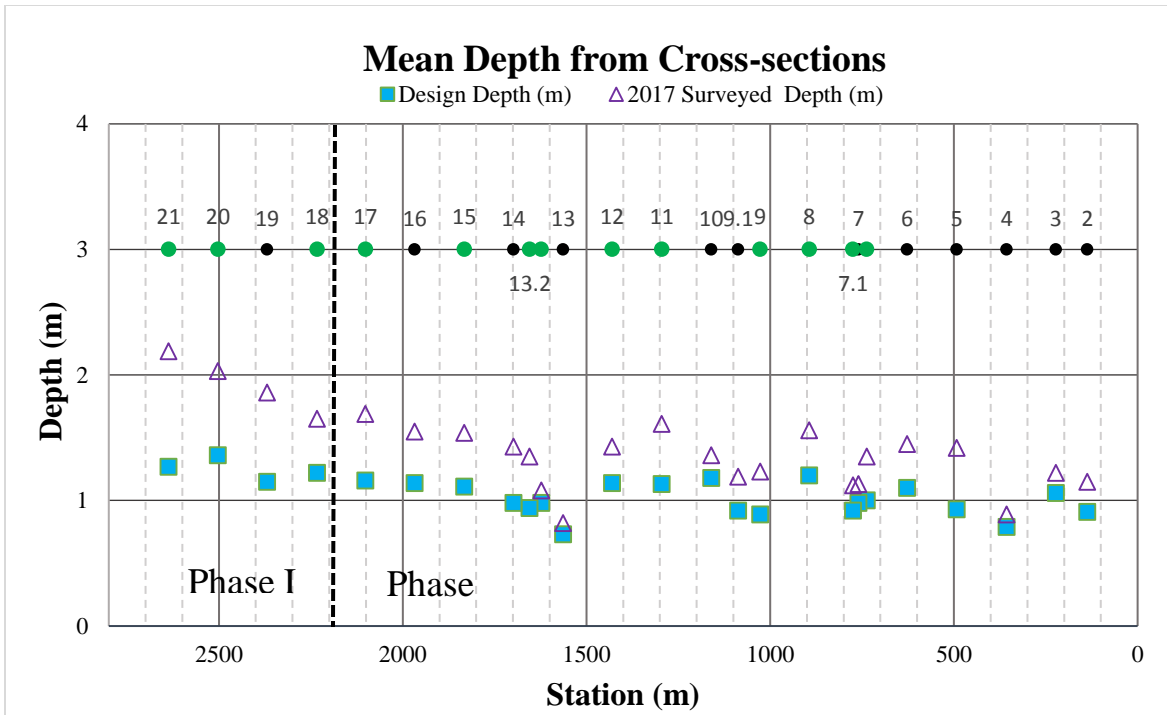
Comparison of the surveyed and the design cross-sections show that the Phase I average channel depth increased from 1.2 m (N = 4, SD = 0.1) to 1.9 m (N = 4, SD = 0.2) and the average cross-sectional w/d ratio decreased by 29% since 2010 (Figures 8 and 9). However, this magnitude of incision seems unreasonable when considering that the channel bed in this section is firm, cohesive material. Only four cross-sections are located in the Phase I reach and three of them are located in deep LWM scour pools. It is likely that the large magnitude of incision is biased because of the scour pools and does not reflect reach-wide channel incision so much as localized deepening from wood-induced bed scour.

Figure 8. Summary of mean depth comparisons from design and 2017 surveyed cross-sections. Cross-section locations and numbers are shown at the top of plot for reference. Cross-sections located at or near LWM structures are marked in bright green.

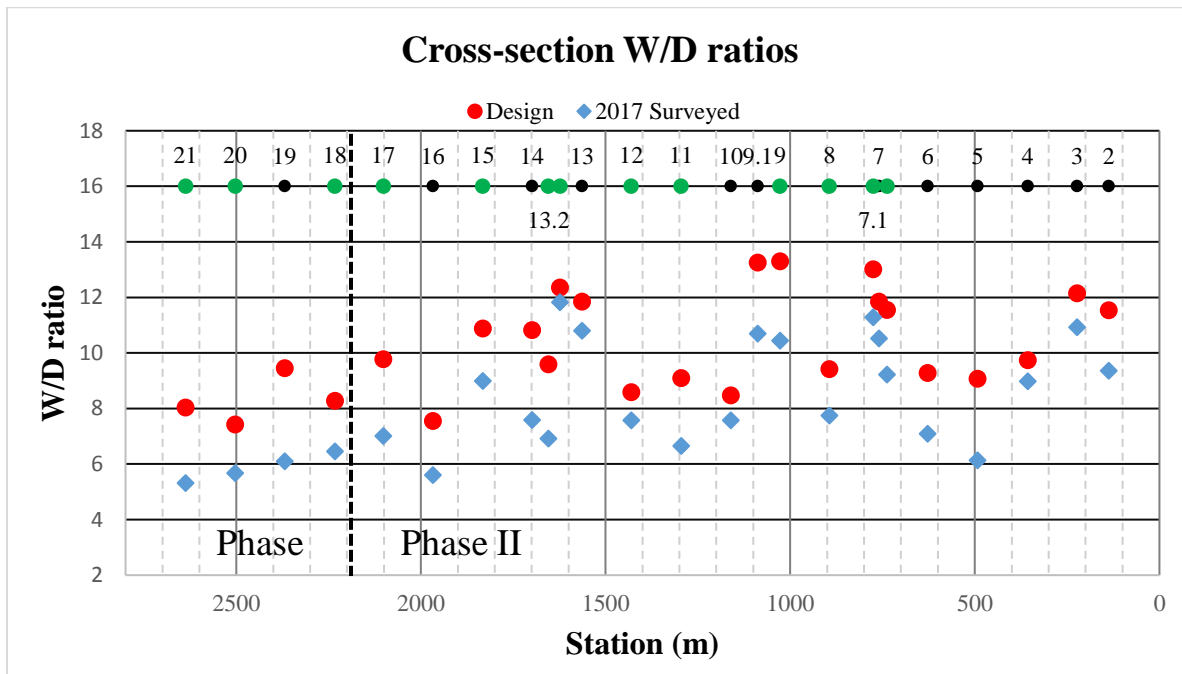
Figure 9. Summary of width/ depth ratios from design and 2017 surveyed cross-sections. Cross-section locations and numbers are shown at the top of plot for reference. Cross-sections located at or near LWM structures are marked in bright green.

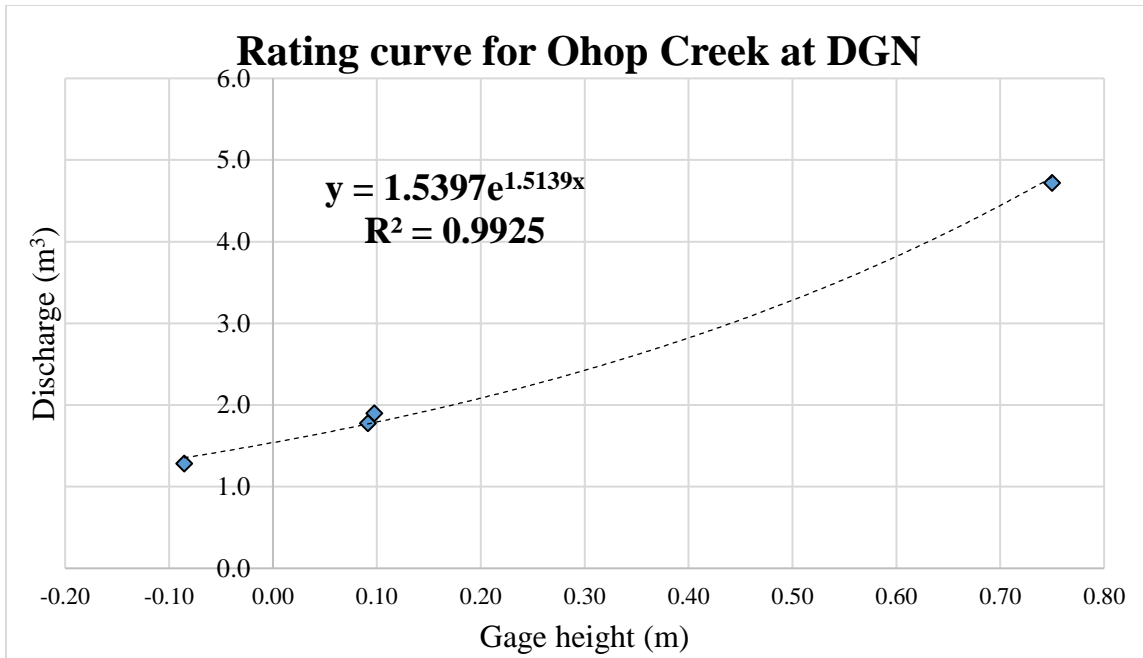
The rating curve constructed from the above discharge measurements (Figure 14) was used to successfully predict within 0.02 m the DGN stage during a site visit on February 10, 2018 by prorating the USGS reported discharge at gage #12088000 by a factor of 6.5%. The discharge that day was 2.4 m<sup>3</sup>/s at the USGS gage and a predicted 2.6 m<sup>3</sup>/s in the Project reach, indicating that the DGN rating curve is useful within the range of measured flows used to construct the curve.

Figure 14. Rating curve from constructed from discharge measurements made during spring of 2017. Negative numbers are measured from the bottom of the DGN gage, which does not extend into the summer low flow

It will be particularly useful to continue to further develop the DGN rating curve for the Project reach. The DGN rating curve is important in that it gives stakeholders and practitioners a means to determine discharge and river stage remotely in the Project reach by relating to discharge measurements reported at USGS gage #12088000. A robust rating curve requires large inputs of data collected at a wide range of stream flows over several years. The DGN rating curve has been calibrated to date using mostly low-flow discharge measurements taken in one month. I recommend future investigators conduct discharge measurements at various flows in the Project reach to make the curve useful at a wider range of discharge-stage values.
