False Bay Creek Water Flow

Biodiversity and Monitoring of Estuarine Ecosystems

Autumn 2021

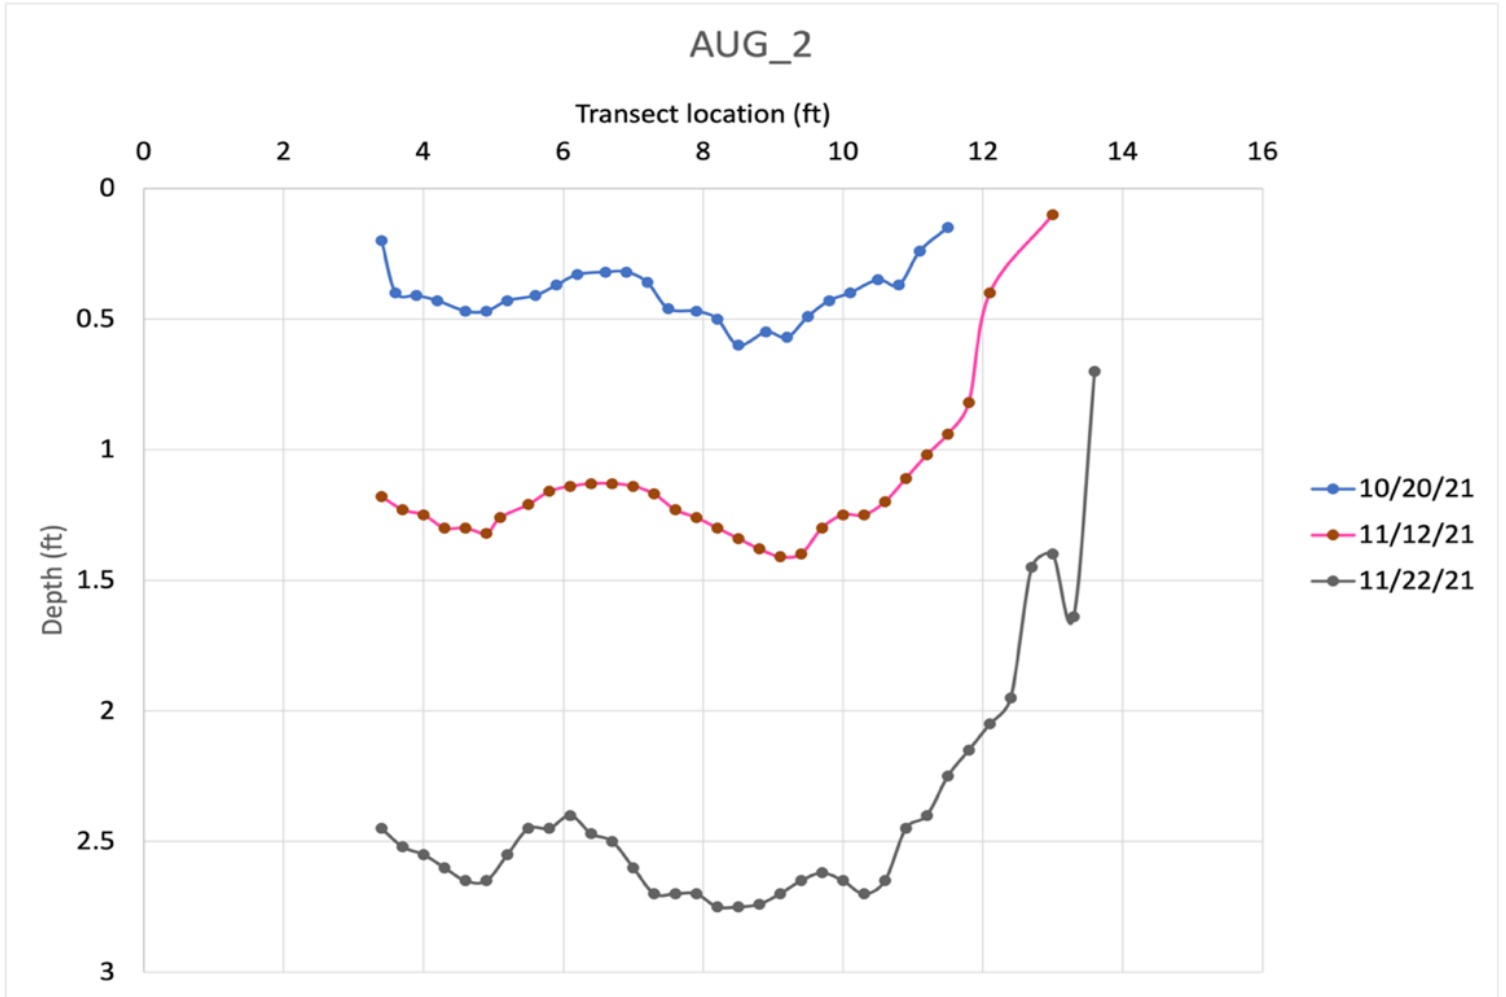
Figure 5. False Bay Creek at AUG2 location. Stream profiles from the start (blue), middle (red) and end (gray) of the study looking downstream as flow data was recorded from left bank to right bank. These three dates also represent low flow and low water height (blue), increased flow and water height (red), and the highest recorded flow and water height (gray).

The bottom contour of the stream bed at the Aug2 testing location changed from the pre-flooding data to the post-flooding data as sediment was flushed downstream (Figure 5). This change can be seen in the depression at about 5 feet and from 8 feet to 10 feet. The post with the SJC height meter is upstream of the transect and there is a more pronounced sediment build up behind this post that can be seen around the 6-foot mark in the transect.
