An Investigation of the Potential for Side Sewer Infiltration to Local Freshwater Systems

Thornton Creek, Seattle WA: A Case Study

A thesis

Masters of Urban Planning

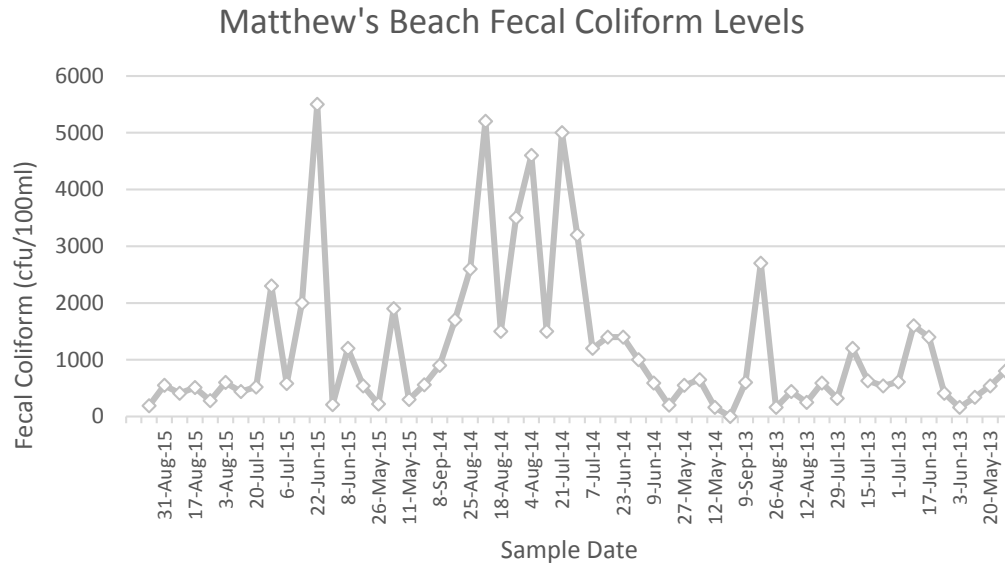
Figure 3: Fecal coliform data collected by King County 2013-2015. Numbers frequently exceeded fecal coliform secondary contact criteria pf >200 cfu/100 ml. Source: King County Water Quality Data

Due to the lack of obvious point sources, Seattle Public Utilities staff hypothesize that one source of the fecal coliform contamination (See Figure 3 for coliform levels) may be due to side sewer failure on private land. Exfiltration from side sewers is point source contamination, but is difficult to identify since breaks and failure is hidden and often unknown. Side sewers are not owned or maintained by the city, rather, ownership and maintenance of these pipes is the responsibility of individual property owners. Side sewer failure can result in a groundwater leak into a side sewer or a sewage leak out of a side sewer, creating a potential public health hazard. In many cases, homeowners are unaware of their responsibility to know the condition of their property's side sewer and maintain/replace their failed side sewers. This lack of accountability, whether intentional

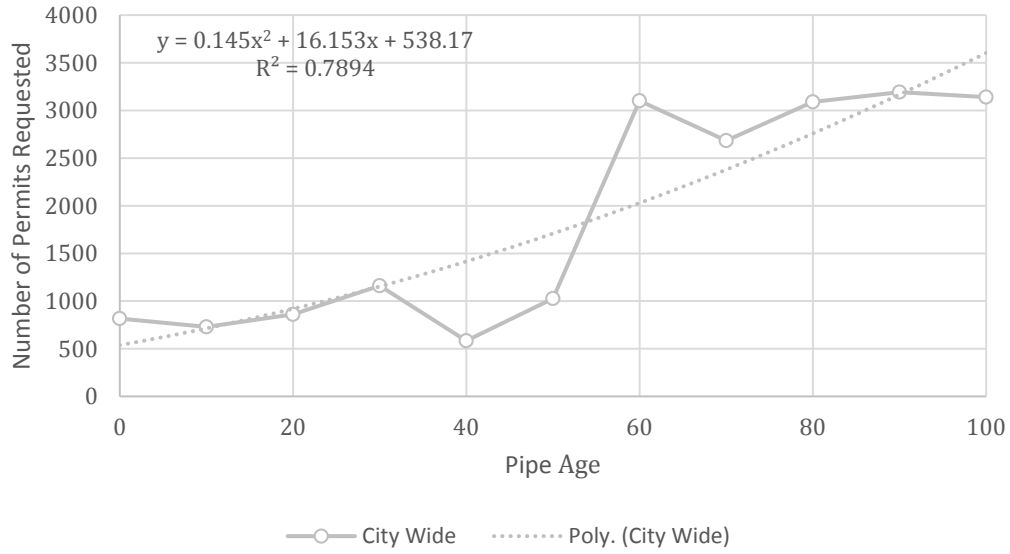
Figure 10: City wide repair and replacement permits by age. Source: Author.

When citywide age and permit request data is plotted against each other, a polynomial regression line with the equation of  $y=0.145x^2+16.153x+538.17$  with an  $R^2$  value of 0.78942 (Figure 10) results.

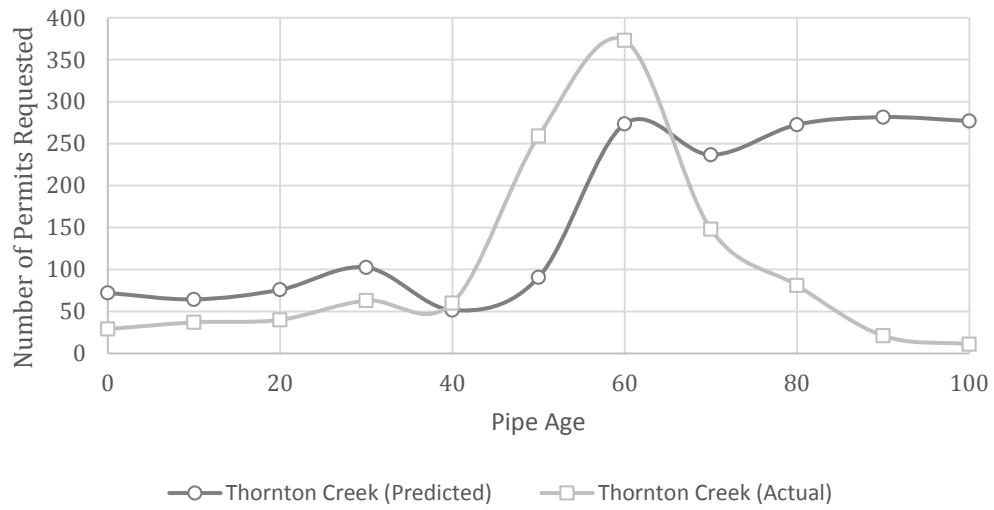
Figure 11: Thornton Creek Basin repair and replacement permits by age. Source: Author.

When values were predicted for Thornton Creek watershed using this same distribution of permits with respect to age, we end up with numbers that look much different from the observed values obtained from the data (Table 2 and Figure 11). The polynomial equation seen in citywide data does not fit the observed data within the watershed. Instead, we see a pattern that more closely resembles a bell-shaped curve with less replacement and repair permits occurring in pipes under the age of 50 years of age and older than 80 years of age and the majority of permits being requested for pipes between 50 – 79 years old.

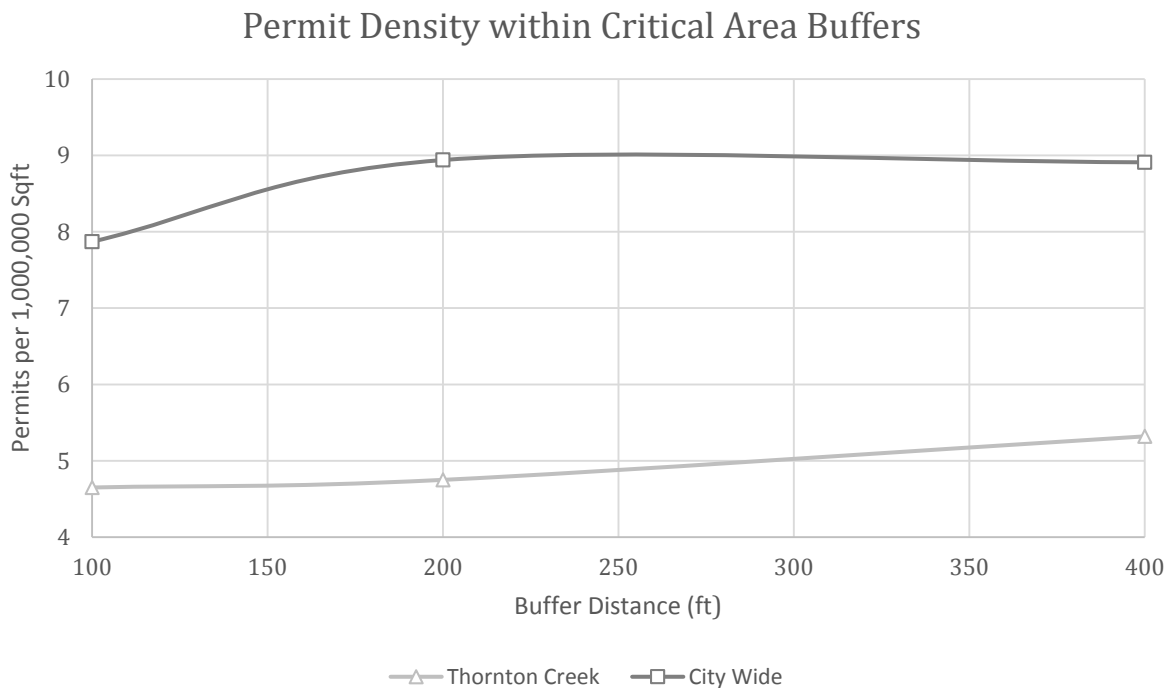
Figure 14: Thornton Creek and City of Seattle repair and replacement numbers within 100, 200, and 400 foot critical area buffers. Source: Author.

The data for permits around critical areas with a steep slope of 40% or greater showed that there were 198, 144, and 265 side sewer permits requested from DPD by private residents from 2005 - 2015 within the 0-100, 100-200, and 200-400 foot buffers within the Thornton Creek watershed, respectively. Citywide there were 4862, 3149, and 4723 side sewer permits requested during the same time periods within buffers applied to all critical areas

Within the 100-foot buffers of the Thornton Creek watershed requested 4.65 permits per 1,000,000 square feet while there were 7.87 per 1,000,000 square feet citywide. In the 200-foot buffers there were 4.75 and 8.94 per million square feet in Thornton and citywide, respectively, and within the 400-foot buffers there were 5.32 and 8.91. These numbers seem substantially closer to the number of permits for all permits requested in both the Thornton Creek watershed as well as citywide. They are also higher across the board implying that permits are requested more often in these critical areas than they are along streams. Additionally, trend lines indicate an  $R^2$  value of 0.7284 (logarithmic) and 0.96 (linear) for citywide and Thornton Creek basin permit requests, respectively (Figure 14). However, with one trend logarithmic and the other linear, it is again difficult to establish a shared trend between the two areas.
