Investigating the Fracture Behavior and Damage Mechanisms of
Discontinuous Fiber Composites Under Significant Out-Of-Plane
Loading

A thesis
submitted in partial fulfillment of the
requirements for the degree of

Master of Science in Aeronautics & Astronautics

University of Washington

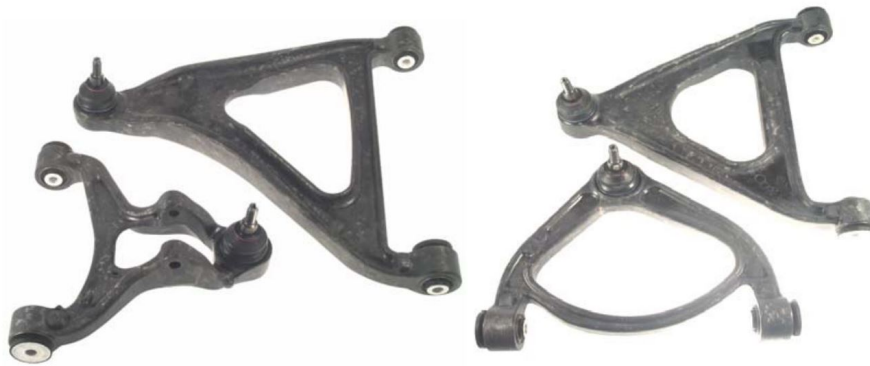
Figure 1.3: Inner monocoque and wishbone suspension arms, [17]

Forged Composite technology was initially introduced on the inner monocoque and the wishbone suspension arms of the Sesto Elemento by Feraboli *et. al*, see Figure 1.3, [17].

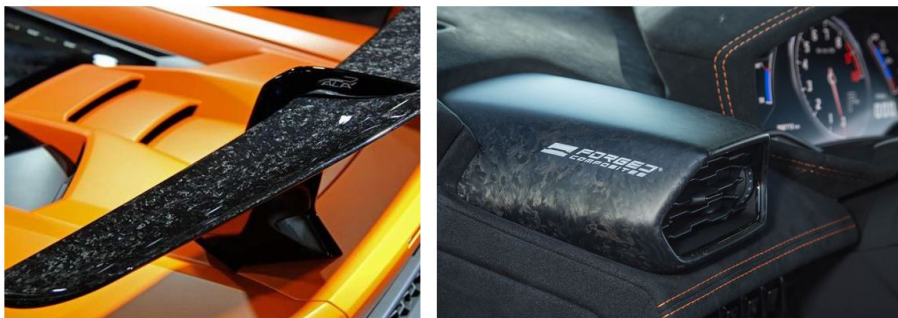
Figure 1.4: Lamborghini forged composite parts, [18,19]

Now, Forged Composites are utilized not only for their structural capabilities, but also for their aesthetic design. The 2015 Huracan sports a Forged Composite engine bay cover and a stylish interior trim package that includes handles, air intakes, central tunnel cladding, and other details of the cockpit, [18, 19].

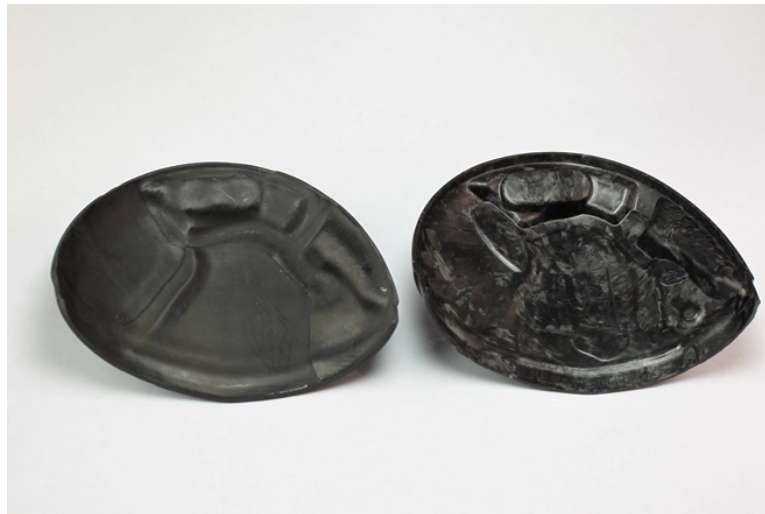
Figure 1.5: Octane driver with the old carbon fiber insides vs Diablo Octane with the Forged Composite technology, [20]

made out of Forged Composites called the Diablo Octane Drivers. DFC is one third the density of titanium, resulting in significant weight savings. Callaway claims that this clubhead has a greater transfer of power at impact and more accurate trajectories compared to traditional all-titanium clubs. This is accomplished by precisely setting the clubhead's center of gravity and moment of inertia through shape and thickness of the crown of the driver. Figure 1.5 shows a comparison between the old design of octane driver that uses a traditional composite fabric, and the new Diablo Octane Driver formed with DFC. With the use of compression molding, designs can be manufactured to a thousandth of an inch. The short fibers make it possible to more accurately fill the acute interior geometry. Notice the precise geometry of the DFC part compared to its predecessor. This club was so successful they released the Callaway RAZR Hawk and RAZR Hawk Tour Drivers, also craftily designed with Forged Composites [20, 21].

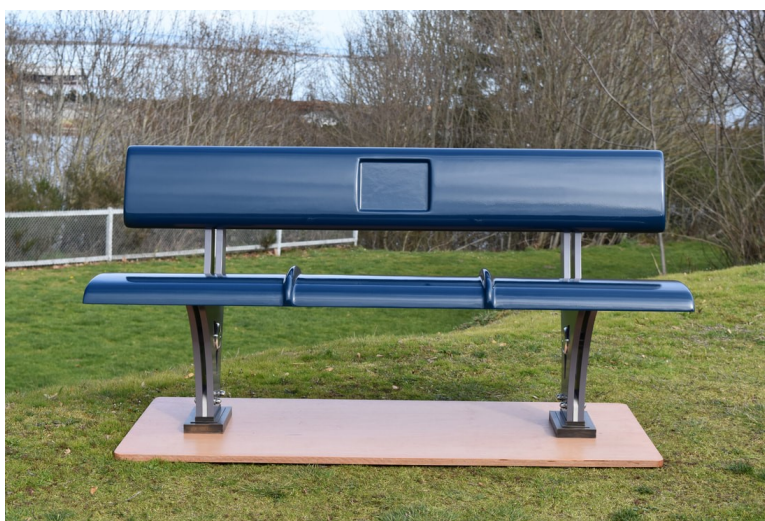
Figure 1.6: CRTC Olympus Bench

CRTC is a not-for-profit corporation in Port Angeles, Washington that focuses on the recycling of uncured carbon fiber composite into new customer products. Scrap material is received from Toray Composite Materials, and a number of other companies, and is repurposed into new customer products. These products include, a fully composite bench, Figure

1.6, that is immune to degradation from the elements like traditional wood benches, light weight pickle ball rackets and net, and even automotive seat backing. They have completed a significant amount of research into the manufacturing of discontinuous fiber composites. It is CRTC's mission to inspire and grow the global composite recycling community through innovation in technology and manufacturing that transforms carbon fiber scrap into products that positively impact people's lives and our environment.

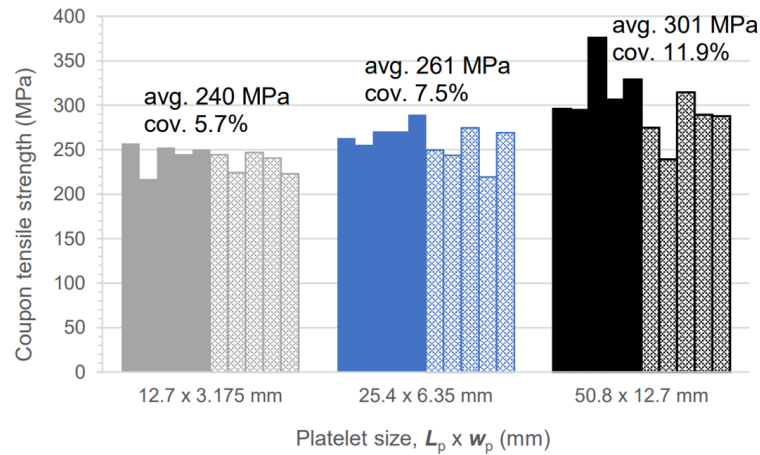
Figure 1.8: Platelet size vs effective tensile strength, [26]

Length-to-width and length-to-thickness of platelets appear to influence the tensile strength and modulus. Longer fibers also generate better tensile material properties [22, 24, 25, 27]. Increased interface connections between platelets better facilitate load transfer. However, Kravchenko *et al.* shows that there is a trade-off between variability and mechanical properties [24]. Increasing the platelet length can increase the variability of the tensile strength whereas, platelets of short length create a more uniform material and result in decreased variability and strength. Figure 1.8 shows the strength of a laminate as a function of platelet size, [26]. It is clear that increasing the size of the platelet results in larger tensile strength.

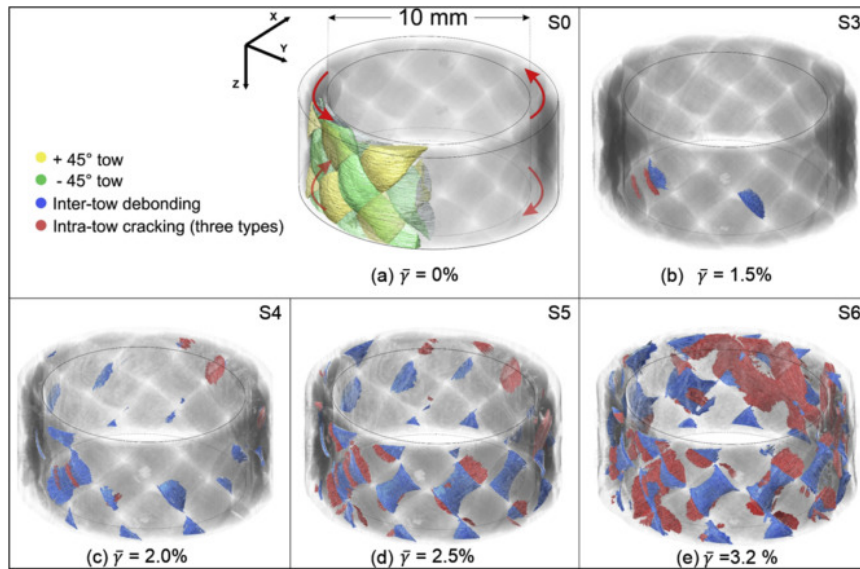
Figure 1.11: Damage initiation and propagation, [30]

Chai *et al.* presents 3D images of damage evolution in woven composite tubes under torsion taken with a CT-scanner [30], which enabled characterization of damage modes and their damage sequences. Figure 1.11 depicts the distinct types of damage and indicates when during loading they occur [30]. Understanding the complex sequence of damage propagation is critical for the safety of design. This cutting edge imagery can provide insight into the magnitude of the non-visible internal damage, and advance the understanding of material failure.

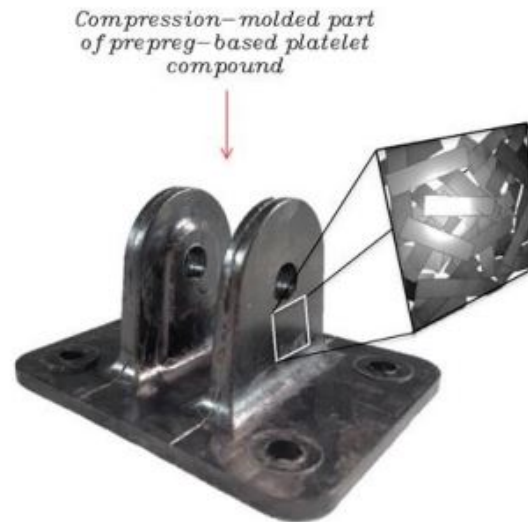
Figure 1.12: Compression molded part, [26]

Kravchenko *et al.* did a study to evaluate the effectiveness of a DFC part experiencing out-of-plane loading on the part seen in Figure 1.12, [26]. The compression molded part was manufactured from chopped prepreg of continuous unidirectional fibers. The platelet size, initial material charge state and manufacturing methodology of pinhole were varied. Two processes for creating the pin holes were applied; molded-in and drilled. The molded-in pin hole parts have a knit line that formed due to the flow dividing around the pin hole and the two flow fronts meeting again on the other side. A CT-scan clearly depicts the knit line in Figure 1.13, [26].

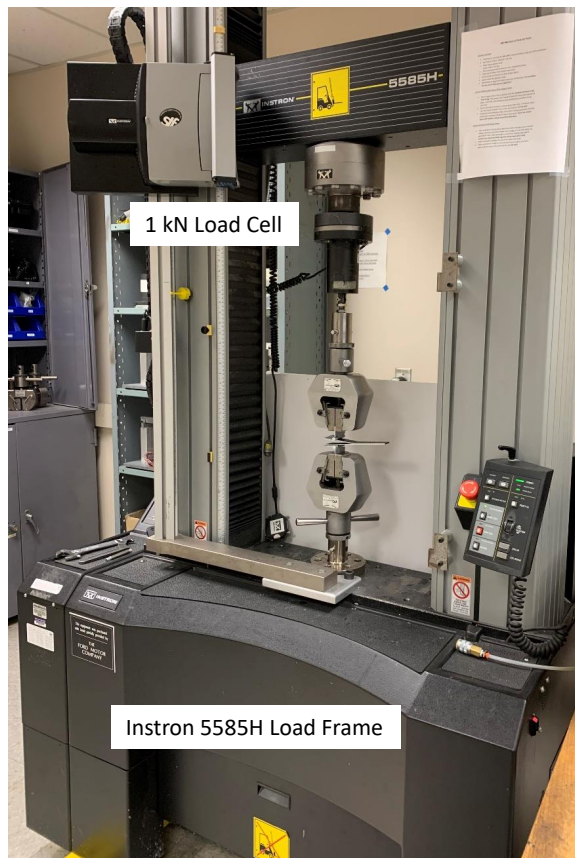
Figure 2.5: Test set up

The Double Cantilever Beam (DCB) tests were completed on an Instron 5585H load frame with a 1-10 kN load cell, as seen in Figure 2.5. The tests were completed under a displacement control of 3-5 mm/min per ASTM standard. The rate was adjusted for each size of coupon to maintain a consistent strain rate. Each test took approximately 10-15 minutes. Load, displacement, and time data was collected throughout the test and are presented in the following sections.

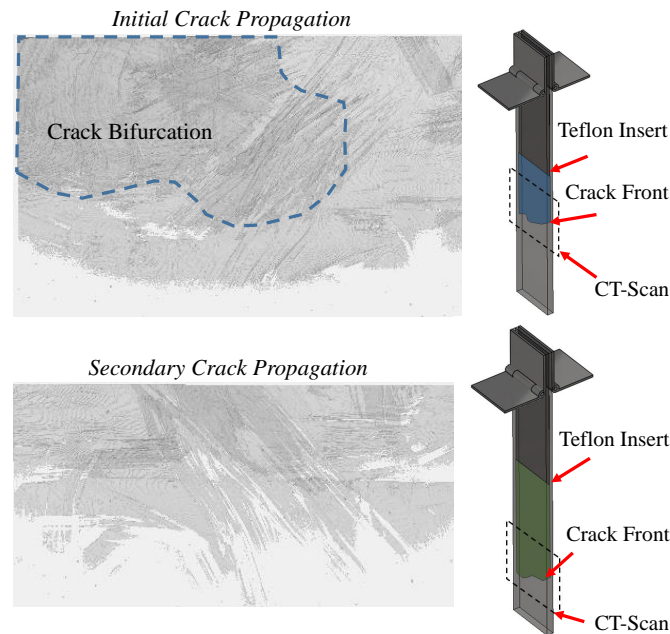
Figure 3.15: Size 3: CT-scans of crack front

For the size 3 coupon, depicted in Figure 3.15, a sizable dark area appears on the scan that is characteristic of a crack bifurcation and long segment of parallel crack growth. This section is outlined for clarity. Note that the crack front in the scan on the bottom is much less full than the scan on the top. In Figure 3.16, the load and displacement plot shows that the crack growth is arrested very rapidly after initiation. It is reasonable that the sparsity of the crack front is representative of this behavior. The complex mesostructure causes different fracture toughness across the width of the specimen as a function of platelet orientation and method of crack propagation. The short drop could represent a small release of energy that only propagated a select portion of the crack front where the least amount of

Notice that all of the crack fronts are non-linear and ragged. Platelet orientation variability, both in plane and out of plane, prevent the crack front from being linear. This provides insight to the limitations of traditional fracture energy calculations that assume a linear crack front and require crack length for prediction of fracture energy.

The results of this process are shown for a size 2 and a size 3 specimen in Figure 3.14 and Figure 3.15 respectively. The specimens were tested to propagate the crack forward a preliminary amount. That initial crack front is visible in the image on the top. After the scan, the specimen was returned the load frame, and the crack was propagated a second time. This second crack front is visible in the image on the bottom. The load and displacement curve that occurs to propagate the crack between the two images are shown in 3.16. During image analysis, a grey scale value is assigned for the density throughout the material. In these images, the threshold value has been set so all that is visible is the very low density air. Locations that are light grey designate a single new surface, like delamination. The regions of increased darkness correlate to locations where there is more than one new surface, like fiber bridging or the presence of two cracks as a result of crack bifurcation.

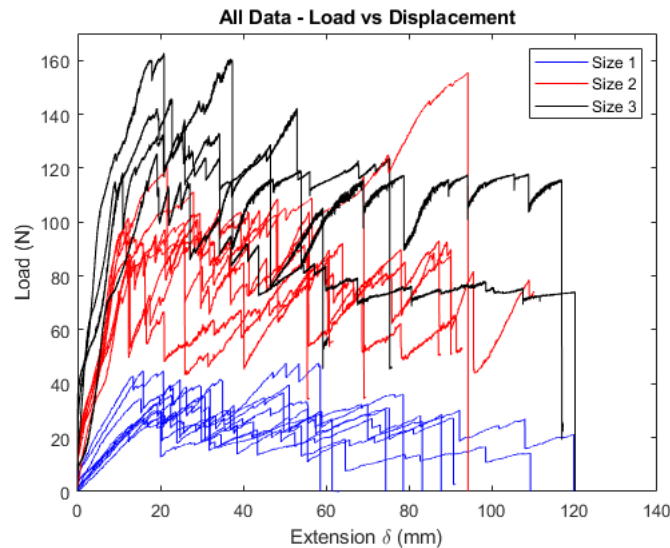
Figure 4.1: Load and displacement data for all DFC coupons

The following graph, Figure 4.1, contains all the data collected from the DCB tests. The size of the coupon increases from the smallest, size 1, to the largest, size 3. It is clear from this data that DFC does not follow traditional post peak behavior. The data exhibits a sawtooth pattern with multiple peaks through the duration of the test. Each drop in the load and displacement graph correlates to unstable crack propagation. After propagation, the crack is arrested by the complex mesostructure of the DFC, increased load is required to propagate the crack further. The peak loads per size have been averaged for each size of coupon, along with the standard deviation. The peak load increases with the size of the coupon, although there is some overlap between the load experienced by the size 2 and size 3 specimens.

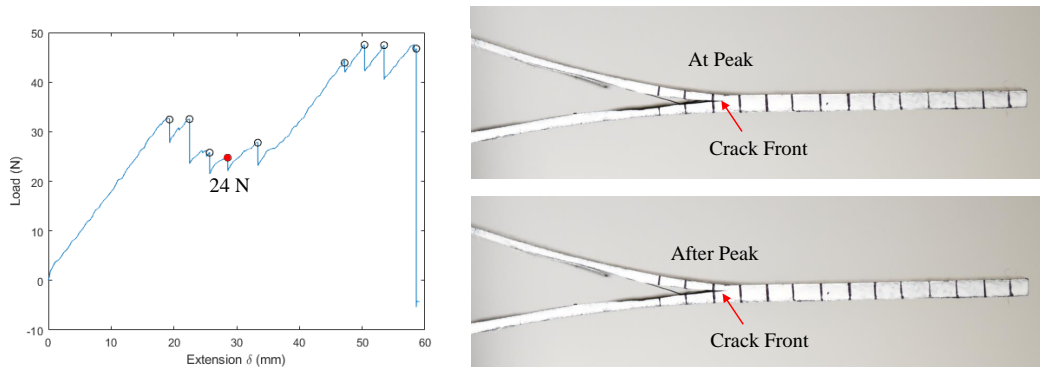
Figure 4.3: Specimen 110: DCB test with single crack front

Specimen 110 exemplifies the crack bifurcation damage mechanism. Figure 4.3 shows the load and displacement curve for the DCB test. There is a distinct sawtooth behavior associated with the peaks throughout the test. The top picture of Figure 4.3 shows the crack before the drop in the load displacement curve located at the red dot. In the bottom, pic-

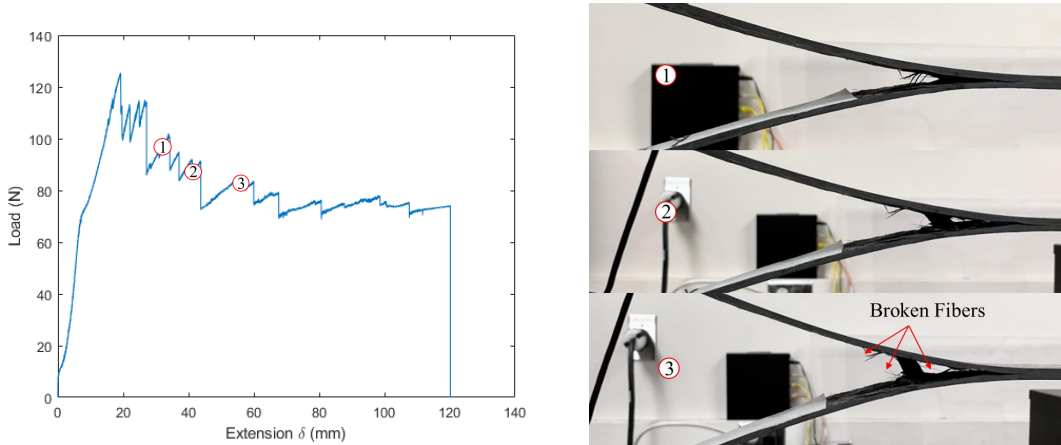
Figure 4.5: Specimen 308: brittle material behavior

Figure 4.5 shows the load and displacement curve for a Size 3, largest sized, specimen. During fracture, this specimen had a large amount of fiber bridging. This is visibly evident in the Figure 4.5 and was audibly evident through a series of 'pings' throughout the test. The individual fibers were pulled in tension and could be heard breaking. Notice the slope of the load and displacement curve. Traditionally, quasi-brittle materials, like composites, have some strain softening before unstable crack propagation. This presents itself as a bending over of the load and displacement curve, similar to yielding, before the drop in load. In this case, the sawtooth peaks do not exhibit strain softening before crack propagation. This is a result of fiber bridging. When a fiber bridges between the two surfaces it loaded in tension. Instead of the matrix material that would traditionally resist the crack opening, the tension in the individual fibers are supporting the load. Because these fibers are brittle and break in tension, there is no strain softening. The load is increased until the fiber has reached its capacity, then it breaks, resulting in stiff peaks in the load and displacement graphs.

A consequence of the complicated mesostructure of DFC is unique load and displacement curves and damage progression for each coupon. In opposition to the brittle peaks of Specimen 308, Specimen 306 has a significant amount of strain softening and exhibits definitively non-brittle behavior. These two coupons are the same size and were cut from the same sheet of DFC. The load and displacement curve of Specimen 306 is shown in Figure 4.6. Before each significant drop, the curve rounds over exhibiting definitively quasi-brittle behavior. This is a function of the micro damage in the fracture process zone ahead of the crack tip. The difference in behavior could be a result of fiber volume fraction. It is possible that there is an uneven distribution of resin through the DFC laminate due to an uneven pressure distribution in the heated platen press.

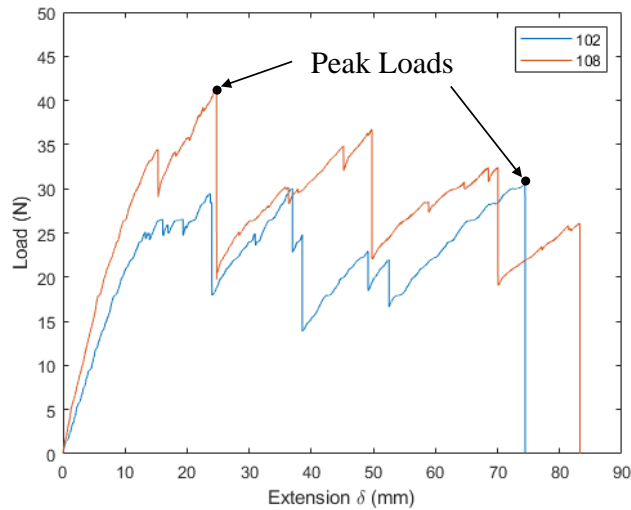
For traditional laminates, the largest stress usually occurs at first peak of the test, and post peak, the crack propagates with relative ease. In DFC, the first peak load is not necessarily the largest. Figure 4.7 shows the load and displacement curves for two size 1, the smallest, specimens. Both specimens are cut from the same sheet of DFC. Specimen 108, experiences

a peak load at the beginning of the test, and peaks progressively decrease in magnitude as the test continues. Conversely, the peak loads of Specimen 102 increase throughout the duration of the test. This shows that the energy required to propagate the test is not entirely a function of crack length, but also depends on the mesostructure of the DFC.

Figure 4.7: Specimens 102 and 108: load and displacement

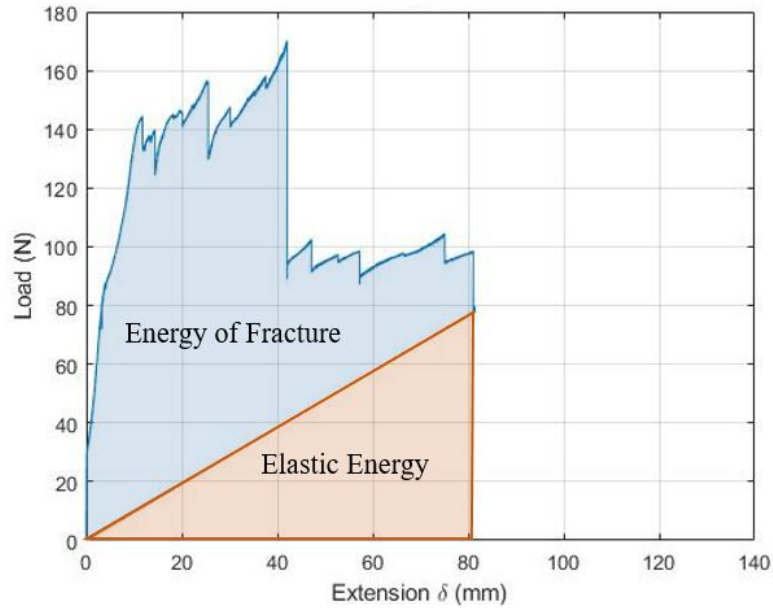
The average fracture energy of each coupon was calculated with a graphical representation method described by Bažant, [49]. The load and extension data was used to find the energy require for fracture. The area under the entire curve is representative of the total work done to open the specimen. Assuming no residual plastic deformation, a line is drawn from the end of the last test point back to zero load and zero displacement. The area under this line correlates to the elastic energy required to open the specimen. Subtracting the elastic energy from the total work results in the energy supplied for fracture, see Figure 4.9 for visual representation. This is then divided by the new surface area to calculate the fracture energy. It is important to note that this is an approximation. The fracture energy is heavily dependent on the length of the crack. The nonlinearity of the crack front and the non-negligible fracture process zone, make the visual inspection of the crack front an estimation, not a precise measurement. The average fracture energy was calculated as:

Figure 4.9: Graphical representation of energy calculation
