**Determining the effects of vegetation on levee structural integrity on the
Green River in King County, Washington**

A thesis

University of Washington
2015

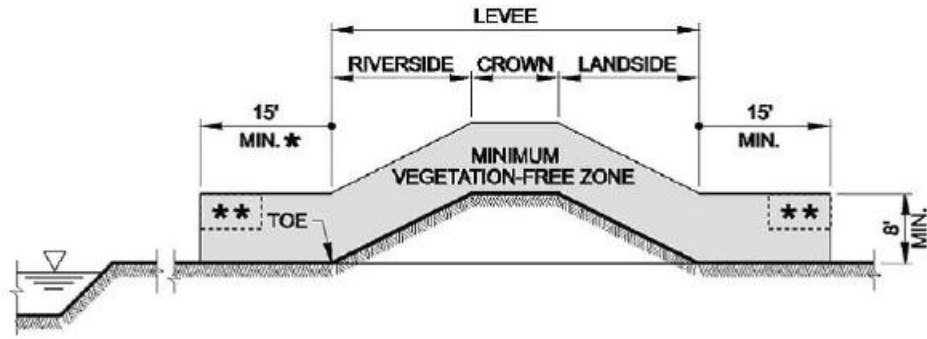
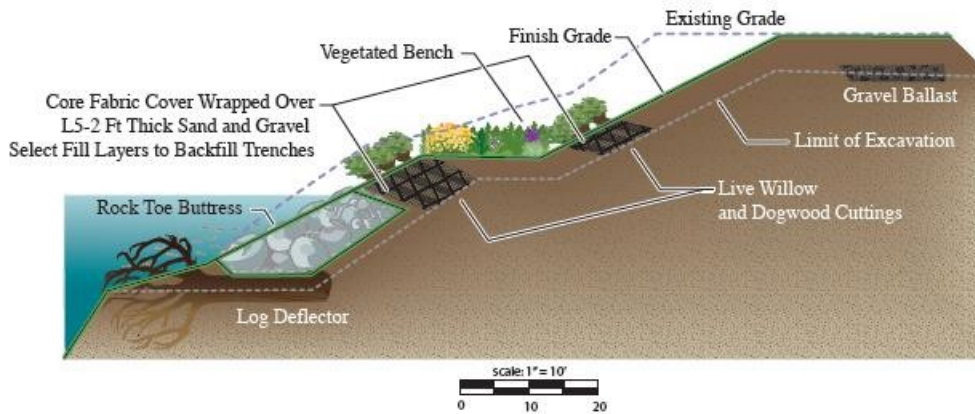
- * 15' OR DISTANCE TO EDGE OF NORMAL WATER SURFACE, IF LESS
- ** IN THIS 4' X 7' TRANSITION ZONE, TEMPORARY OBSTRUCTION BY LIMBS AND CROWN IS ALLOWED DURING DEVELOPMENT OF NEW PLANTINGS, FOR UP TO 10 YEARS
- ▽ NORMAL WATER SURFACE

Figure 1. Schematics of a USACE standard levee cross-section (top, USACE 2014b) and a King County bioengineered levee design (bottom, figure courtesy of King County Water and Land Resources Division).

that provide shade, detritus and prey organisms to aquatic habitats (see Figure 1). Specific limits on water temperature have been adopted in Washington State water quality standards to allow for salmonid survival. A Green River temperature water quality improvement report calls for buffers of native vegetation 32 meters tall (Coffin & Lee, 2011). The vegetation specified in the King County and Washington State bank stability guidelines is native vegetation. Historically, the most common trees in the Green River Valley were red alder (*Alnus rubra*), willow (*Salix spp.*), black cottonwood (*Populus trichocarpa*), bigleaf maple (*Acer macrophyllum*), and vine maple (*Acer circinnatum*) (Collins and Sheikh 2005), of which only the oldest and largest approach 32m.

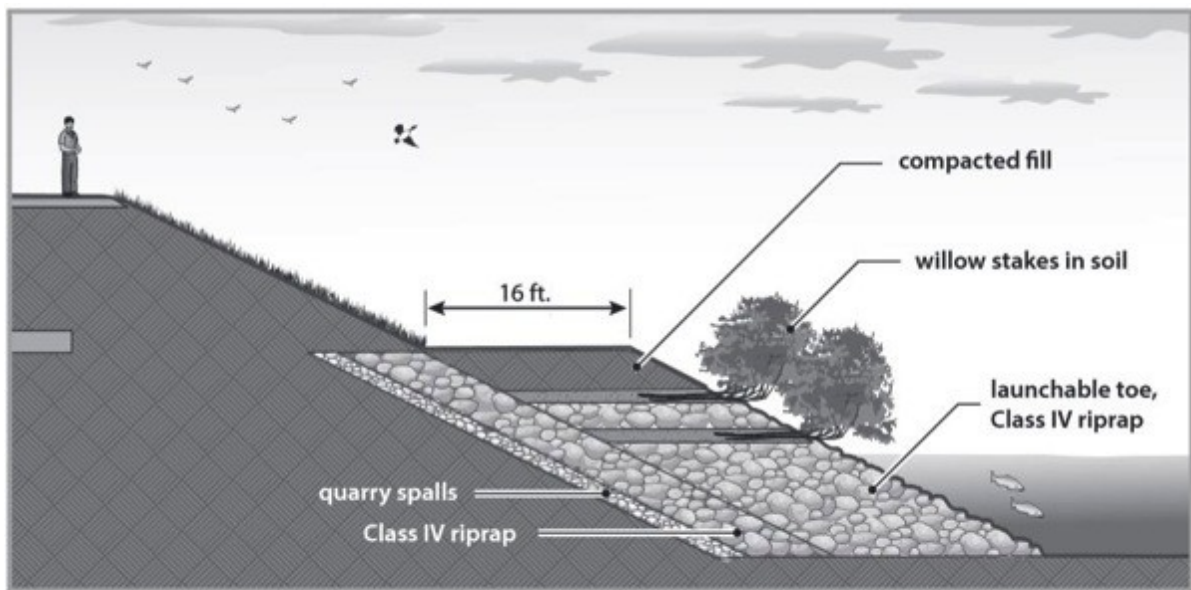
TUKWILA 205 TYPICAL SECTION

Figure 4. Schematic of a bioengineered levee repair with a launchable toe design in King County (image courtesy of King County).

Positioning System (GPS) unit was used to map points at the upstream and downstream end of each bioengineered levee repair project in the study area in January and February, 2013. A King County Senior Engineer, Andy Levesque, who had designed and worked on many of the projects helped identify project locations. Data were downloaded onto a desktop computer and used to create a data layer within the King County Geographic Information Systems (GIS) with ArcMap 10.1. Fifty-four bioengineered repairs on the Green River were visited and geo-referenced. Eleven of the 54 sites were projects designed and constructed by the USACE with different standards than those used by King County. Figure 4 depicts a typical cross section of a USACE-designed and constructed levee repair in King County. Some differences between these repairs and bioengineered repairs completed by King County were that the USACE repairs typically have wood that was not anchored directly into the levee structure, and that large volumes of rock were used to create “launchable toes” that are intended to slide into the river and thus prolong the life of the levee as channel incision progresses.

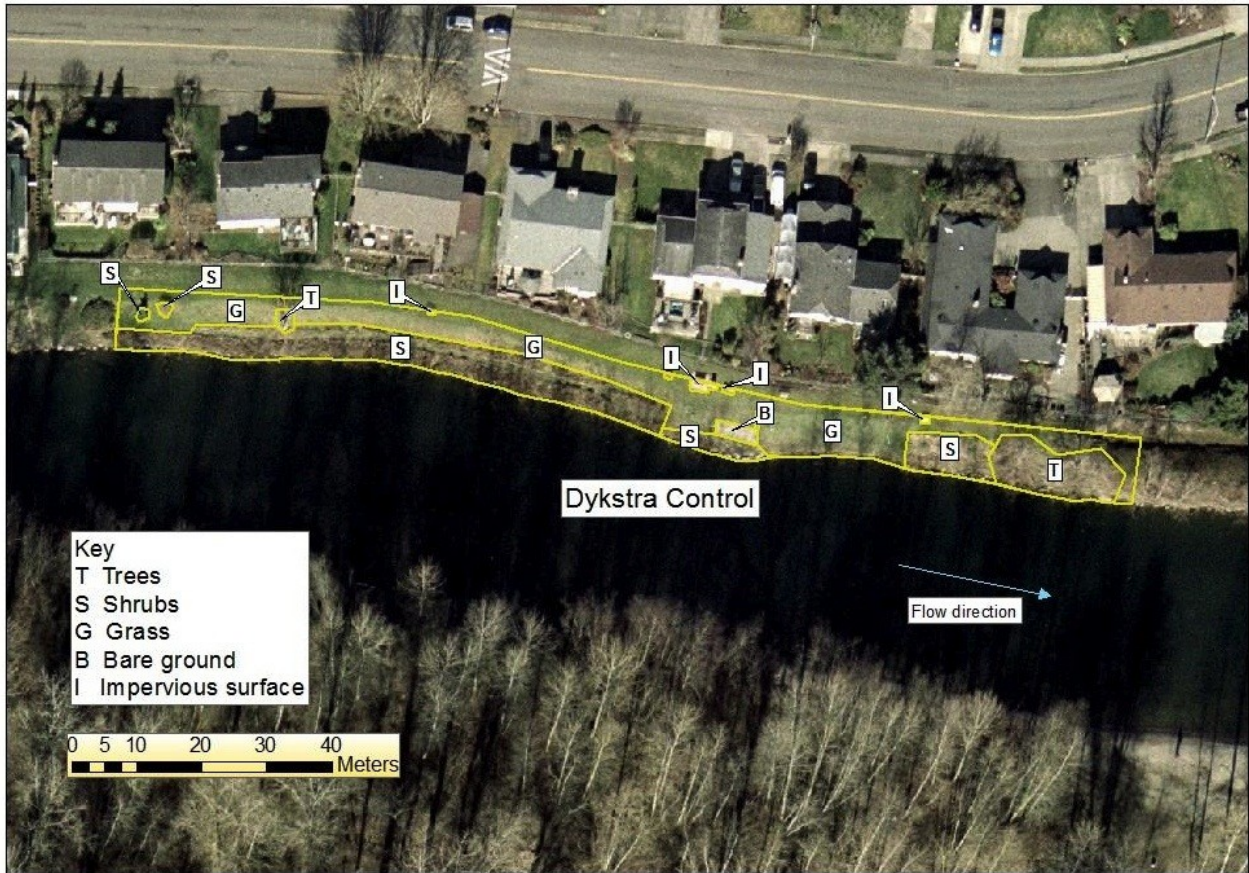
Figure 5. Example of vegetation classification polygons.

Green River and imported into the map layer. Then a polygon was created at each location using the edge of water as the riverside boundary and the length of the repair as the upper and lower boundaries. The fourth boundary of the polygon was placed on the middle of the crest of the levee determined through aerial photograph interpretation (Figure 5).

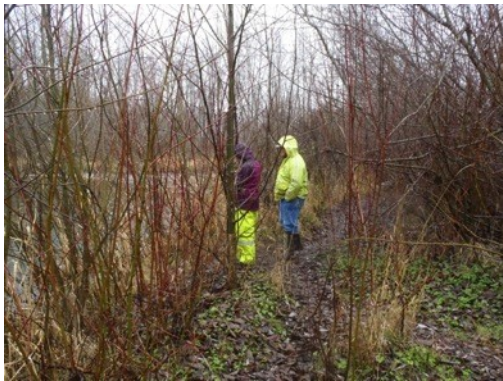
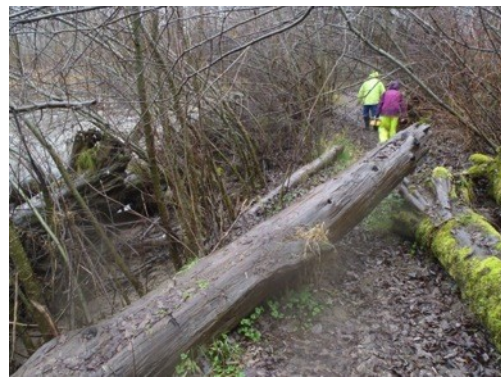
Figure 6. 2004 Fenster levee repair - photos taken January 7, 2013.

During the field mapping, it was obvious that a number of additional variables were at play on these levees, which made it challenging to group sites into discrete treatments. Although all of the repairs at the bioengineered sites had been completed using native vegetation, maintenance of these repairs varied significantly over the years. This resulted in many different vegetation regimes at the repair sites, from total native plant vegetation cover (Figure 6) to complete removal of the native vegetation and replacement with turf grass (Figure 7).

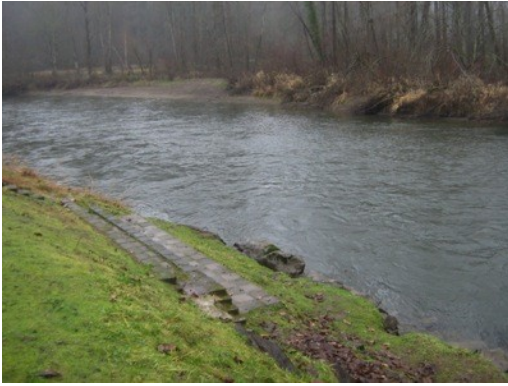
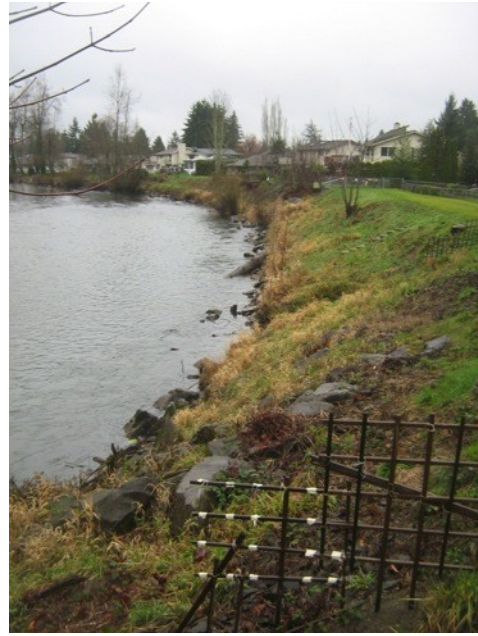
Figure 7. 1995 Dystra levee repair - photos taken January 7, 2013.

Although bioengineering projects on the Green River are abundant, with 54 total projects to date, site visits revealed that sites have been maintained very differently over the years. This adds to the complexity of trying to design a study comparing bioengineered sites with non-bioengineered sites because it's possible that, even though a site would have been bioengineered with native woody vegetation, it may in fact look more like a traditional repair site with sod-producing grasses, as was the case at the 1995 Dykstra levee repair site (Figure 7).

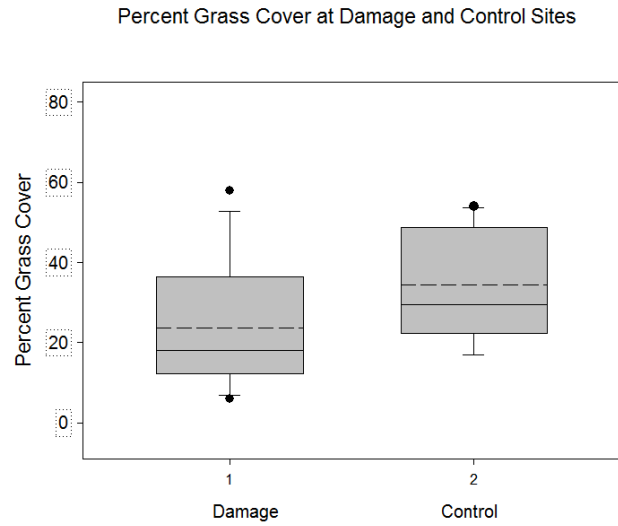
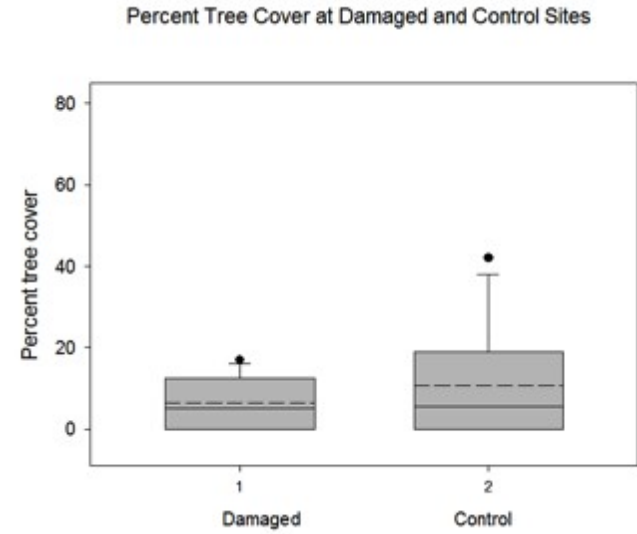
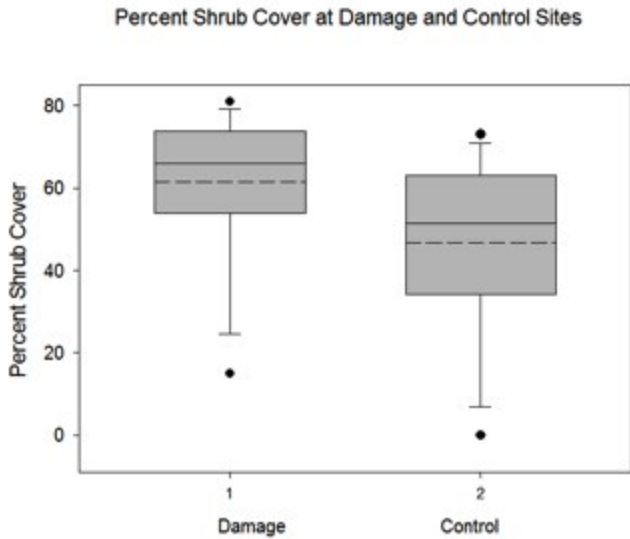
Figure 8. Box plots showing distribution of vegetation cover at sites prior to the November 2006 flood event. Solid line is median, dashed is average, box is 75th and 25th percentile, whiskers are 90th and 10th percentile. Dots are outliers.

class was determined for each case (damaged) and control (undamaged). A King County data layer, not available at the time of control selection, revealed that six of the controls are sites that had been previously damaged but were repaired using bioengineered methods. Tables 2 and 3 show percent covers for each case and control. Figure 8 shows the distribution and range of percent covers between cases and controls as box plots.

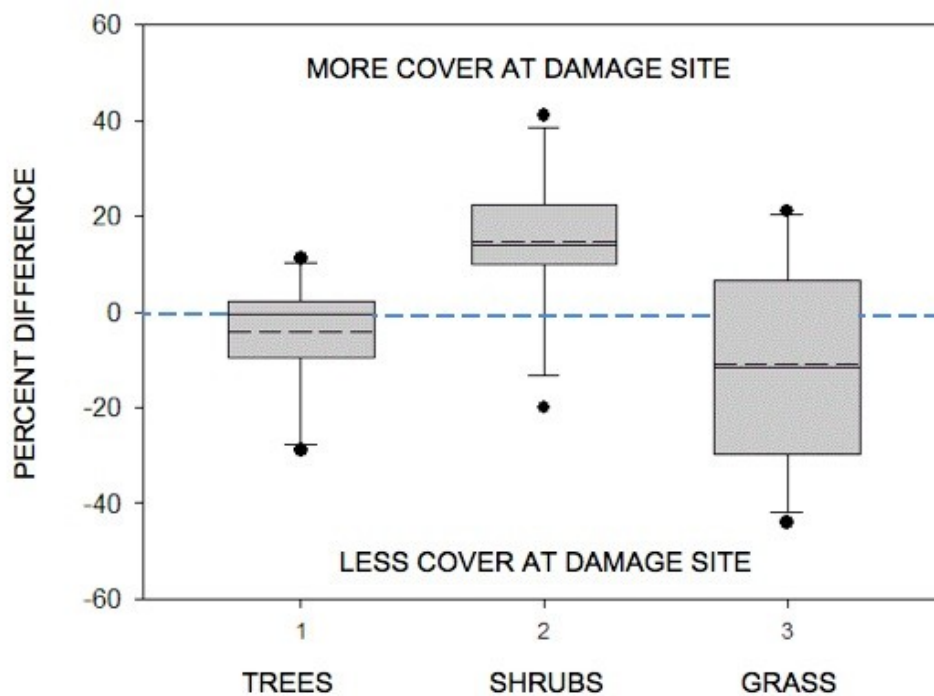
PAIRED DIFFERENCES BETWEEN CASES AND CONTROLS % VEGETATION

Figure 9. Box plots of paired differences in vegetation cover between damaged and undamaged sites. Solid line is median, dashed line in box is average, box is 7th and 25th percentile, whiskers are 90th and 10th percentile. Dots are outliers. Dashed blue line is zero percent difference.

In this case-control study, the important variable is not the total cover but rather the difference in cover at each paired site. Figure 9 shows the range of paired differences for each category of vegetation. Negative values mean that the case (damaged) site had less cover than its paired control; positive values mean that the case site had more cover than its paired control. The box plots show that overall, the control sites had more tree cover and less shrub cover than their paired case (damaged) site. To test whether the paired differences were statistically significant a paired t-test was performed for each (Table 4).
