RIVER ICE MEASUREMENTS FOR TRANSPORTATION SAFETY IN RURAL COMMUNITIES

FINAL PROJECT REPORT

Svetlana Stuefer
Elizabeth Richards
University of Alaska Fairbanks

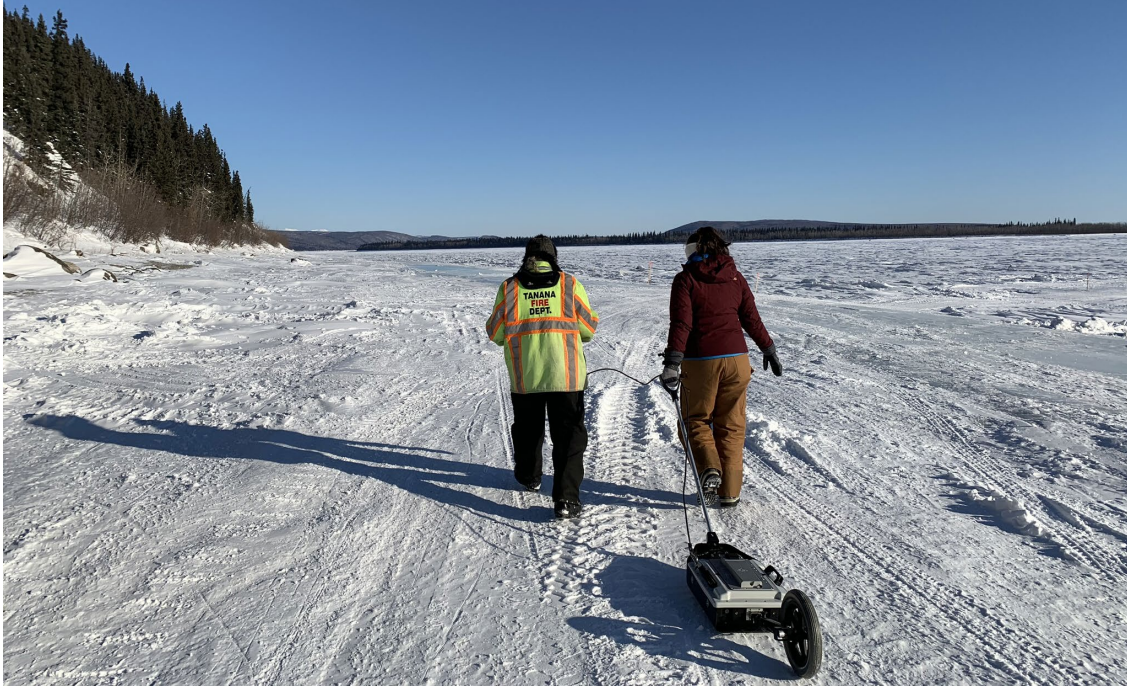
Figure 3.1 GPR measurements by Elizabeth Richards and Stan Zuray, Yukon River, February 27, 2020

The river ice data from this study included manual and GPR measurements of ice thickness where the ice road crossed the main channel of the Yukon River. In 2019–2020, the Tanana community constructed two river crossings: a trench road and a packed road (see Section 4.3 for trench road and packed road descriptions). We used a MALÅ Ground Explorer GPR instrument with 450 MHz and 750 MHz central frequency antennae. Distance was measured by both GPS acquisition and an all-terrain wheel attached to the instrument (figure 3.1).

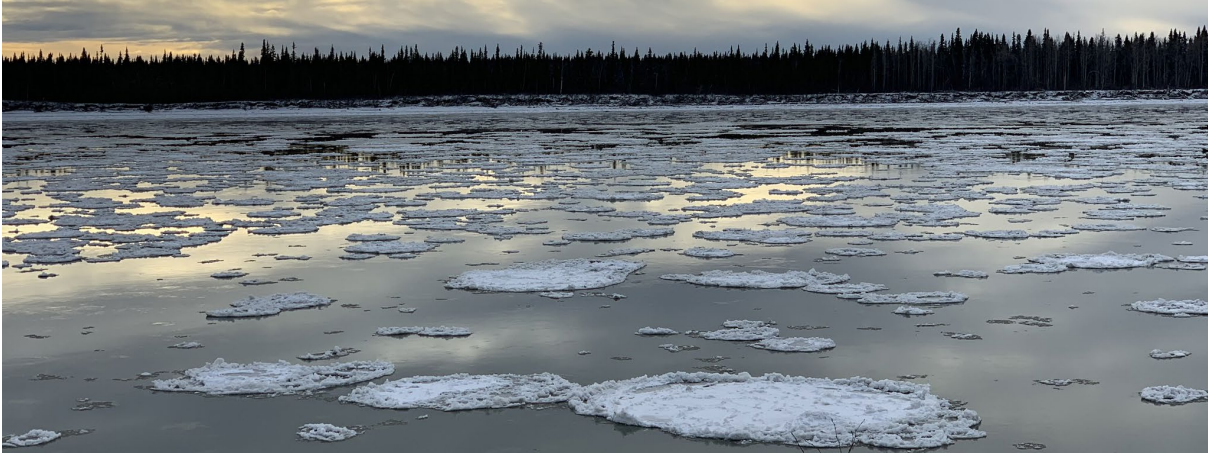
Figure 4.3 Frazil ice pans observed on the Yukon River near Tanana on October 24, 2019

The Yukon River freeze-up process starts in October. Figure 4.2 shows that October daily air temperatures were within the normal temperature range during the first few weeks of the month, with an unusual warm snap later in the month. By the end of October, border ice had formed, and frazil ice pans were observed drifting downstream with the flow (figure 4.3).

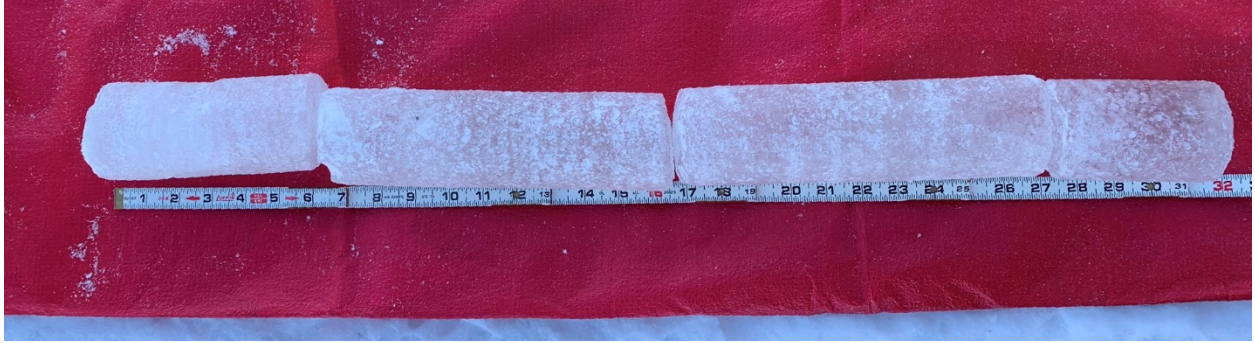
Figure 4.8 Photograph of a 0.80-m-long ice core collected from the trench road.

Ice coring on the trench road and packed road revealed primarily columnar ice, with some sections of higher gas bubble content, occasional sediment inclusion, and a layer of snow ice. A layer of hard-packed snow was present at the top of cores collected from the packed road (figure 4.8). The effort to identify snow and columnar ice layers with GPR is ongoing.
