Drilled Shaft Socket Connections for Precast Columns in Seismic Regions

A thesis

Master of Science in Civil Engineering

University of Washington

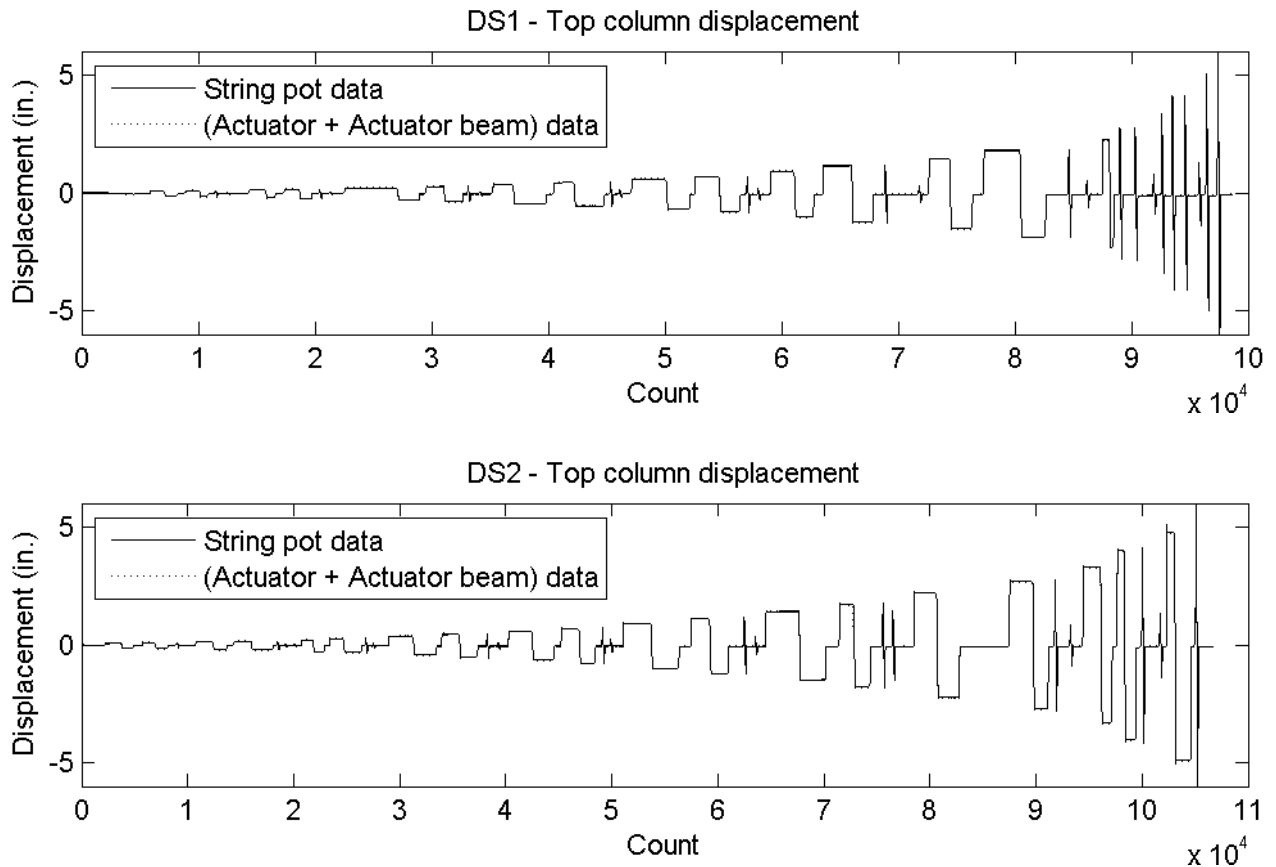
Figure 3-3. Top column displacement comparison for (a) DS1 and (b) DS2

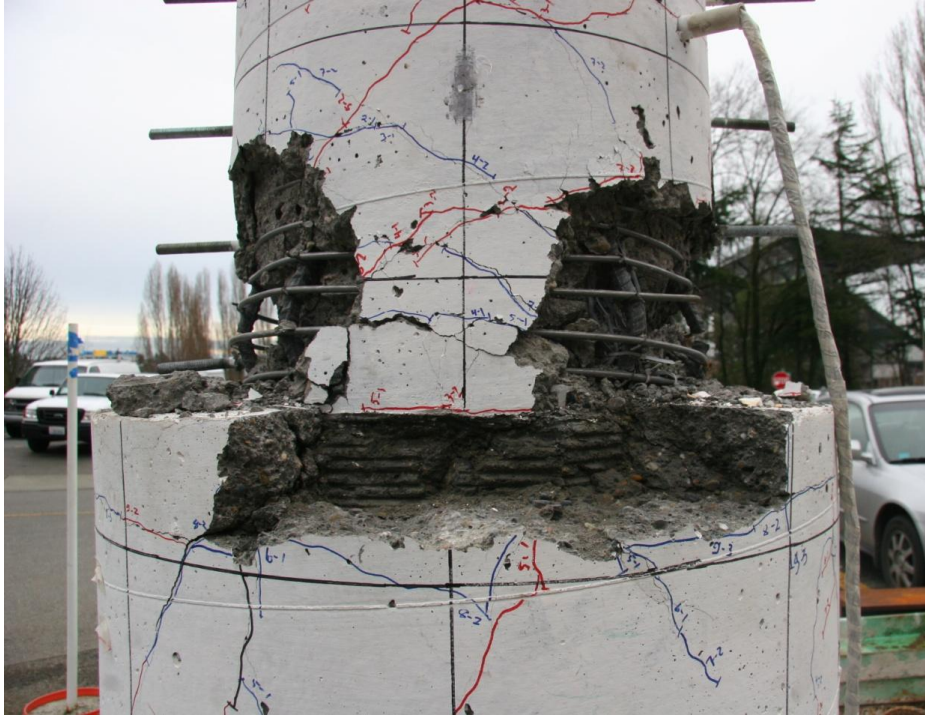
Figure 4-2. Specimen DS-1 after testing

After the longitudinal column reinforcement yielded, the behaviors of specimens DS-1 and DS-2 differed significantly. In DS-1, the damage was concentrated in the column, and the specimen eventually failed by fracture of the longitudinal steel in the plastic hinge region of the column, in what might be thought of as a typical column failure. The longitudinal bars buckled, causing a kink in the spiral steel, which initiated its fracture. After the spiral fractured, the longitudinal bars straightened and re-buckled with each load cycle and eventually fractured due to the low-cycle fatigue caused by the alternate bending and straightening. The longitudinal steel in the shaft never yielded, and the transverse steel in the shaft yielded but never fractured. This behavior, characterized by concentration of damage in the column, was similar to that of specimens SF-1 and SF-2.

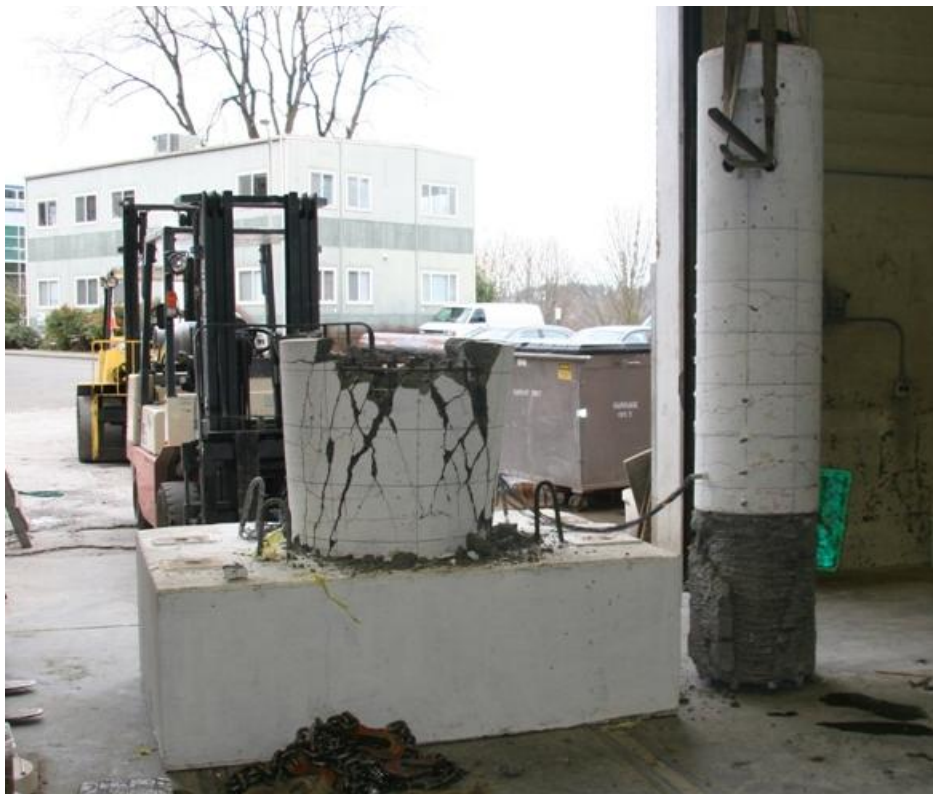
Figure 4-3. Specimen DS-2 after testing

In Specimen DS-2, the amount of spiral steel in the shaft was only half that in Specimen DS-1. It is therefore not surprising that, in it, the transverse reinforcement in the shaft yielded earlier than in DS-2, and subsequently fractured. The behavior of the specimen was characterized by very large cracks opening in the shaft, which suffered extensive shear deformations as a result. Failure was initiated by fracture of the spiral steel in the shaft, starting at the top and progressing downwards. The damage to the shaft caused the load to drop even though the drift was increasing. The longitudinal bars in the column did not buckle, and by observation, it was known that the spirals in the column never fractured.

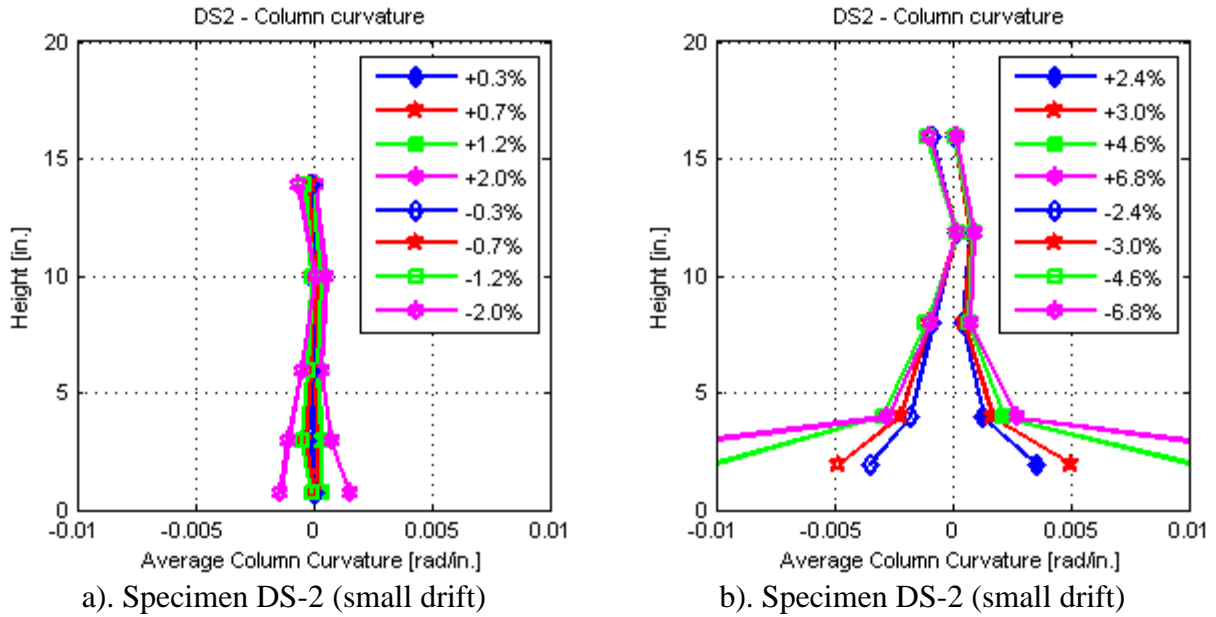
In DS-2 specimen, the method using three “Optotrak” markers to measure rotation was performed in the column to compare with the result of using curvature rods. The column average curvature versus height for selected drift ratios were provided in Figure 5-6. The result of column curvature distribution were quite similar by using “Optotrak” markers and curvature rods. The different curvatures at the bottom segment were unknown but this values were unreliable as explained above. In the next section, the comparison of rotation of column show that using “Optotrak” also had the similar result with using inclinometer. Therefore, the motion capture system is recommended to use because of its multipurpose.

Figure 5-6. Average Column Curvature (measured by Optotrak) – Specimen DS-2

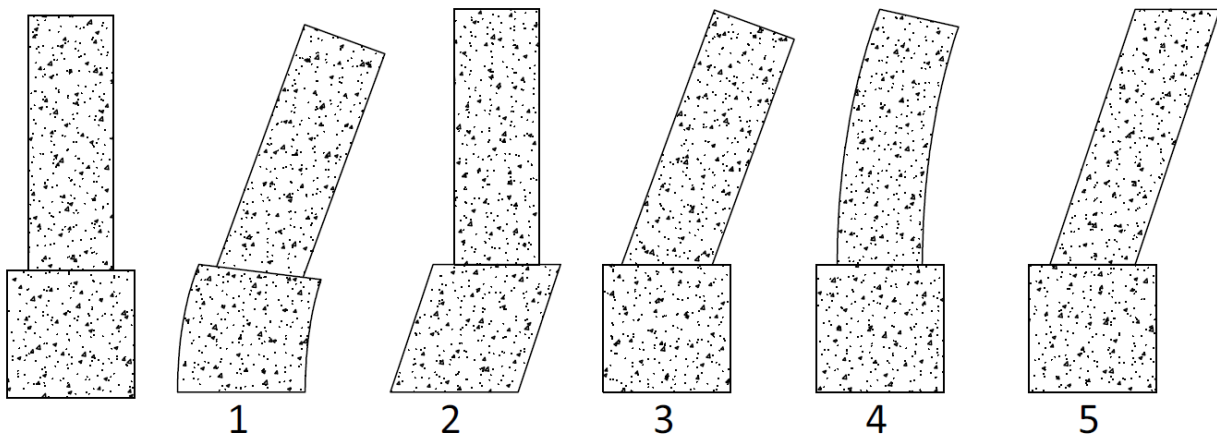
In the test specimens, the horizontal displacement at the top of the column depended on the deformations of the individual elements. To simplify discussion, those deformations are broken down into the following components, which are illustrated in Figure 5-8:

Figure 5-8. Displacement types

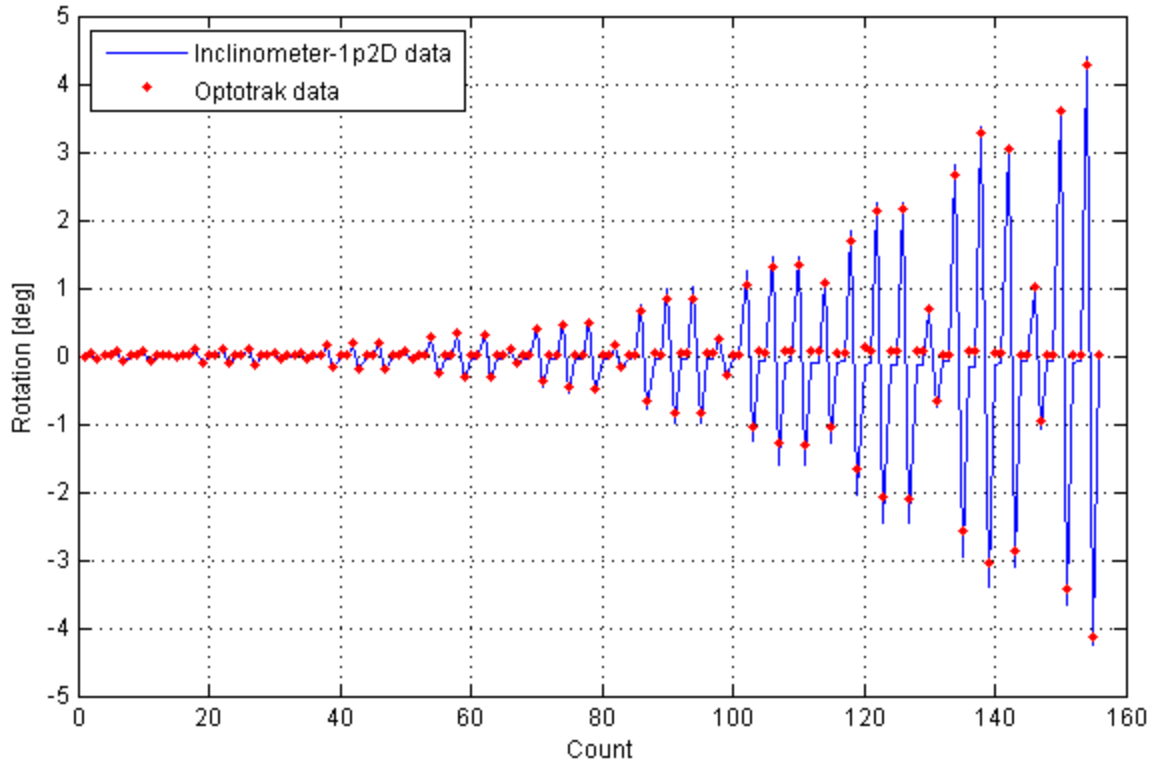
The method of measuring rotation of specimens using groups of three Optotrak marker was compared with the results of inclinometers to show the accuracy of this method. The comparison is shown in Figure 5-9 and Figure 5-10 with the results were measured in specimen DS-2. The comparison show that the result of method using Optotrak were similar to inclinometers' result.

Figure 5-9. Rotation Comparison at 10" above the interface position (Specimen DS-2)

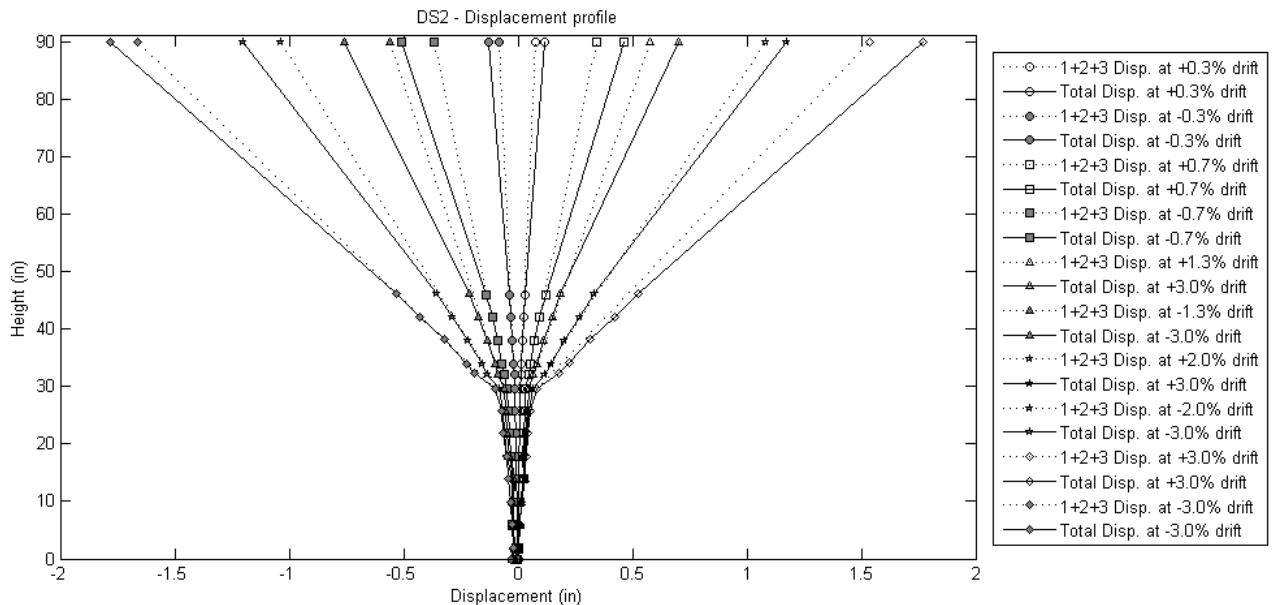
Figure 5-12. Specimen DS-2 - Displacement profile

column base rotation, which was 0.012 rad (1.2% drift) in DS-1 and 0.007 rad (0.7% drift) in DS-2. However in DS-2 specimen, the percentage of column base rotation contributed to total deformation was higher than in DS-1 specimen.

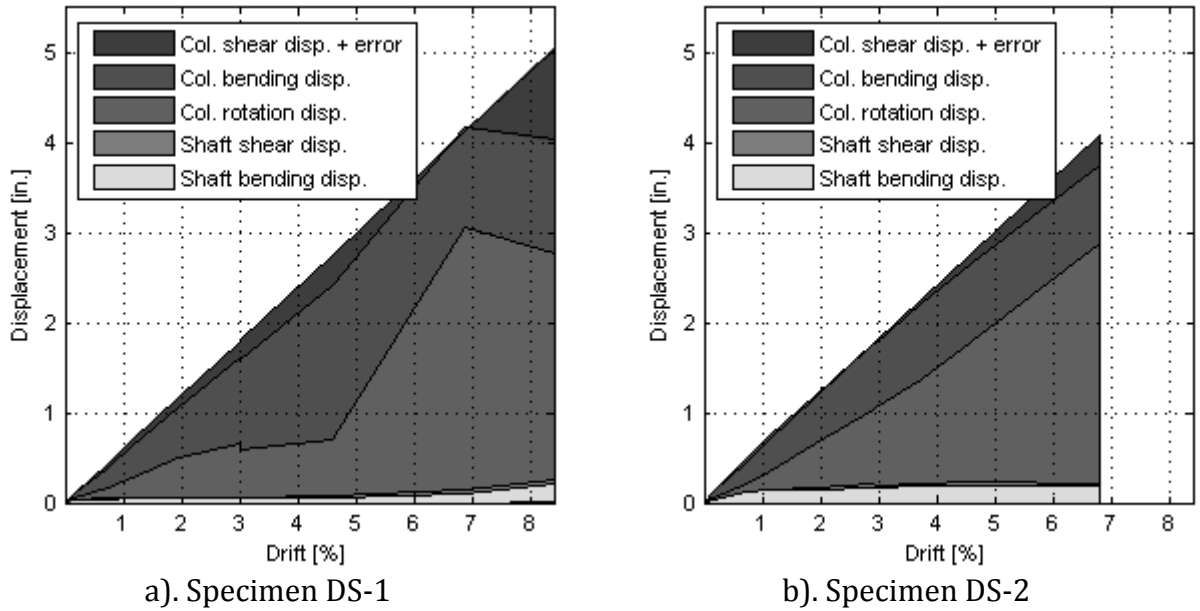
The contribution of displacement types were shown in Figure 5-13 and Figure 5-14. In specimen DS-2, after set 8-cycle 1 (near 7% drift), big vertical cracks appeared in the shaft. Thus, the data of “Optotrak” marker attached in the shaft were not reliable for calculating the curvature of the shaft. Therefore, the displacement of the shaft bending, column shear and error were not reliable after 7% drift.

Figure 5-13. Displacement-Drift response (specimens DS-1 and DS-2)

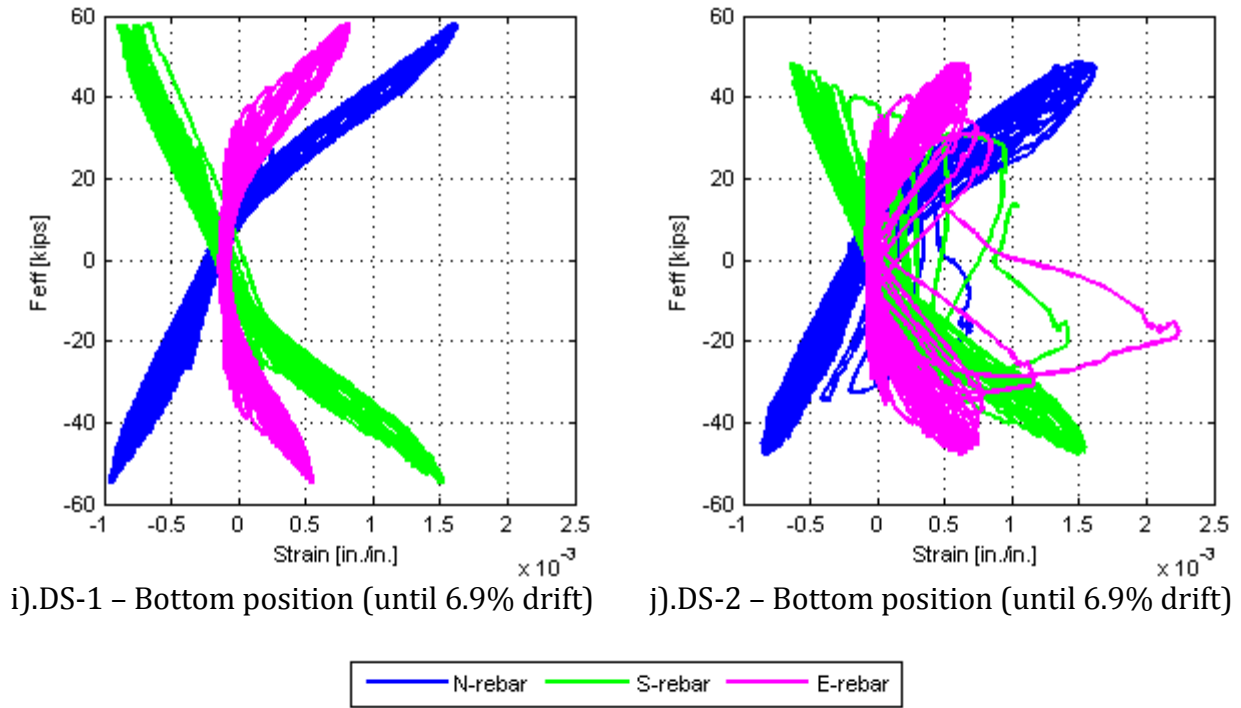
At 28 in. below the interface position, the relationships were plotted up to 6.9% drift. As shown in the figures, the friction was still good and the reinforcing bars were still in the elastic range in DS-1. In DS-2, before 4.6% drift, the behavior was similar to in DS-1 specimen. The friction was good and reinforcing bars worked in elastic. However, after 4.6% drift, the friction was lost and spirals were broken, and the strains in rebar decreased dramatically.

Figure 5-23. Strain-Effective force relationship of the shaft reinforcing bars

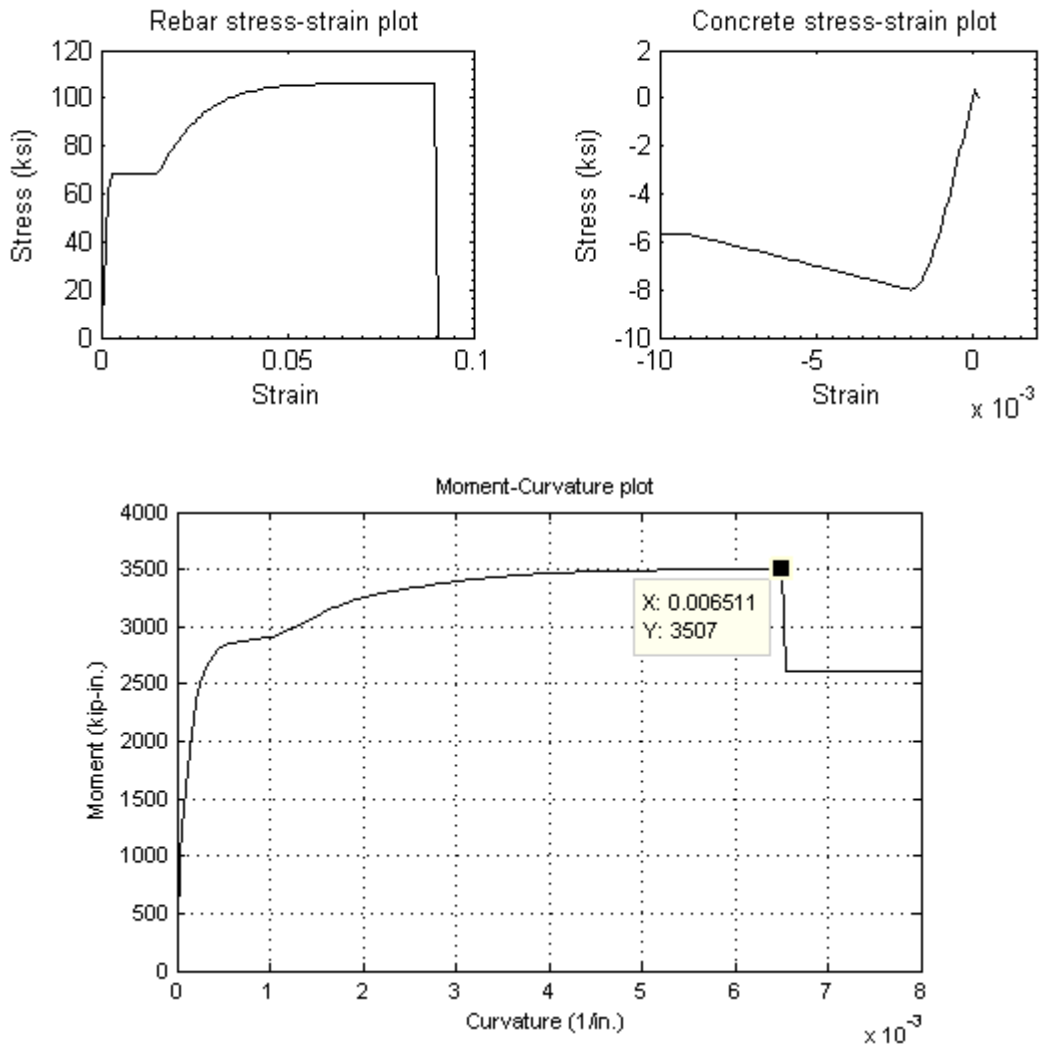
Figure 6-4. Moment-curvature analysis (based on expected material properties)

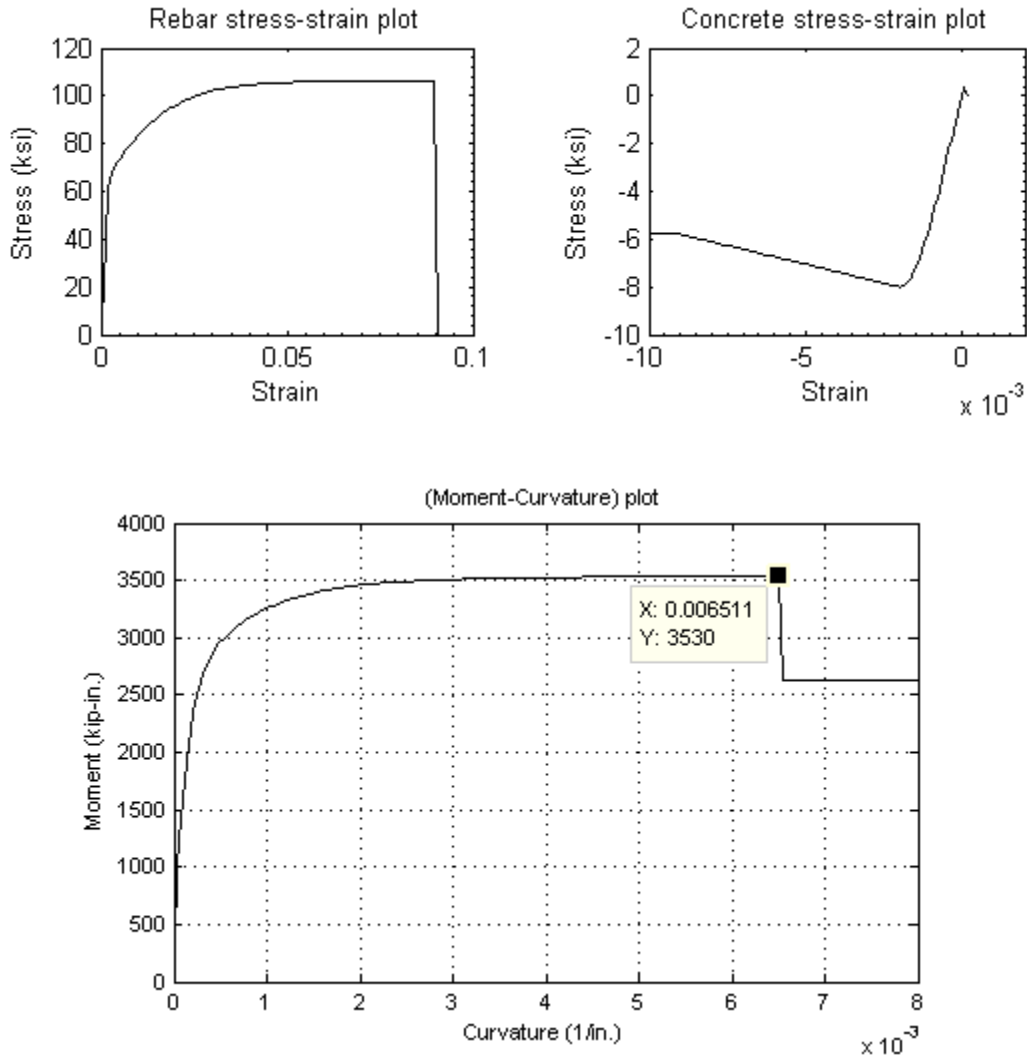
Figure 6-5. Moment-curvature analysis (based on measured material properties)

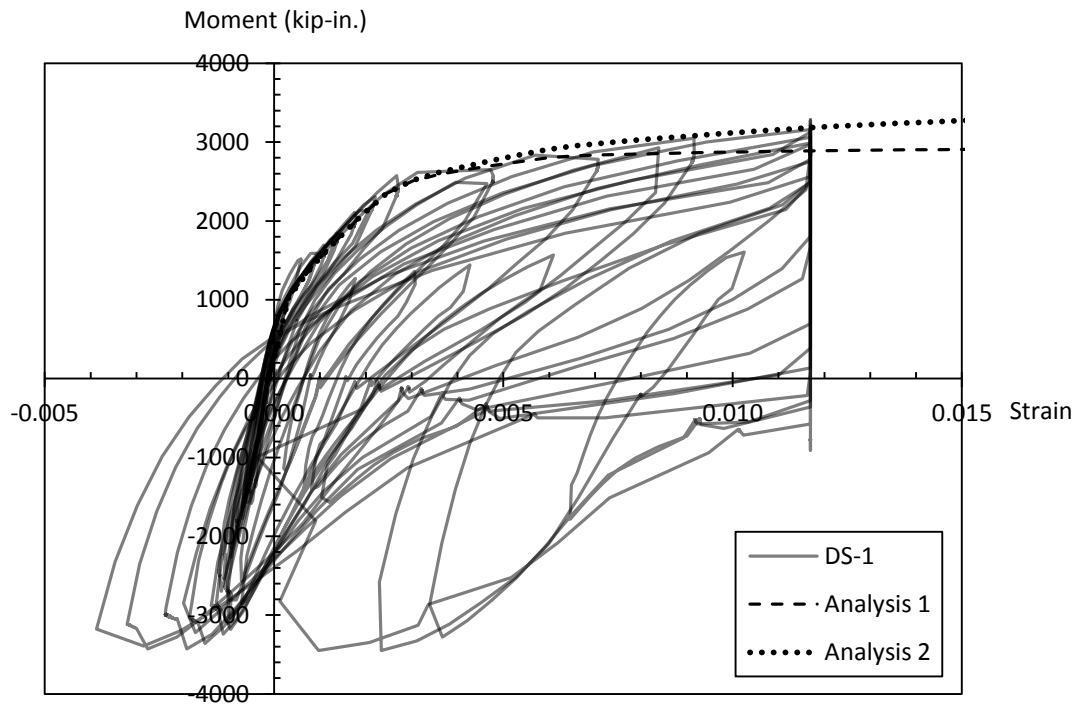
Table 6-1 compares the measured and predicted peak moments. For a more detailed comparison, Figure 6-6 and Figure 6-7 show a plot of moment vs. strain in the extreme tensile reinforcement, and gives the measured values for specimens DS-1 and DS-2 and the values predicted by the moment-curvature analyses. The curves were plotted up to the peak strain measured in the tests, of about 0.011 (At larger strains, the gages continue to read but the data acquisition system saturates, and simply displays the saturation strain). All curves include two regions: an elastic region and a curved post-yield region.

Figure 6-6. Moment-extreme reinforcement tensile strain relationship for column (in DS-1)

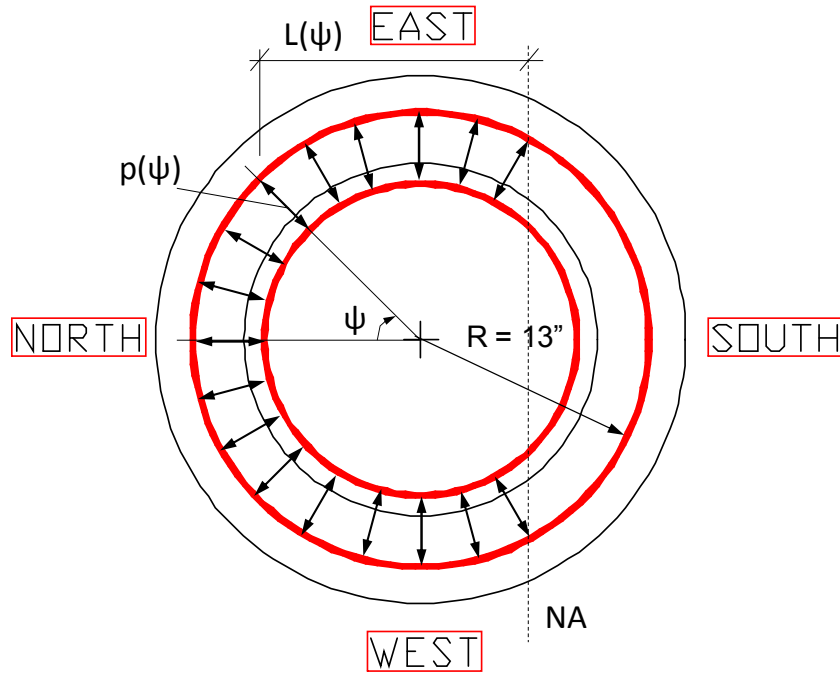
and the struts C_1 directions are radial as shown in Figure 6-11. The horizontal component of the strut force C_1 is $T_1/\tan\theta$, and this is therefore the radial force per unit length applied to the shaft spiral. The distribution of tension T_1 in the shaft longitudinal bars is calculated by using moment-curvature analysis proposed above.

Figure 6-11. Tension transfer from column to shaft longitudinal reinforcement

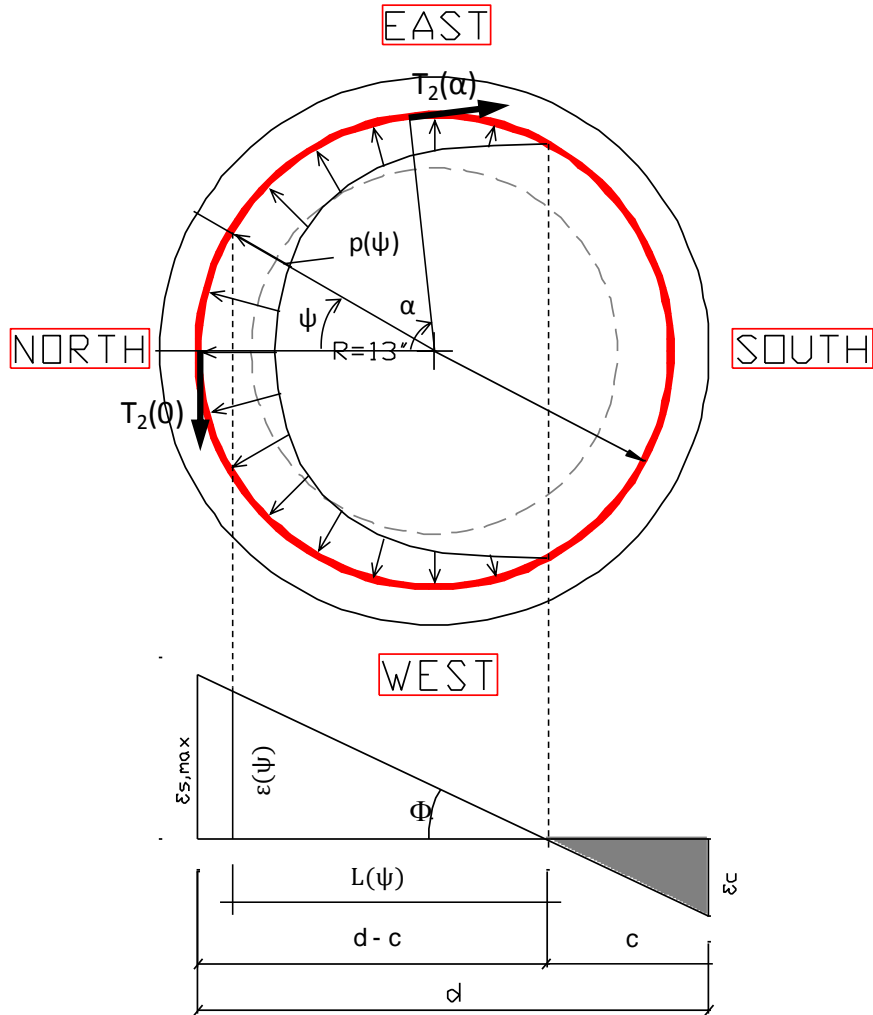
Figure 6-12. Distributed load applied to shaft spirals

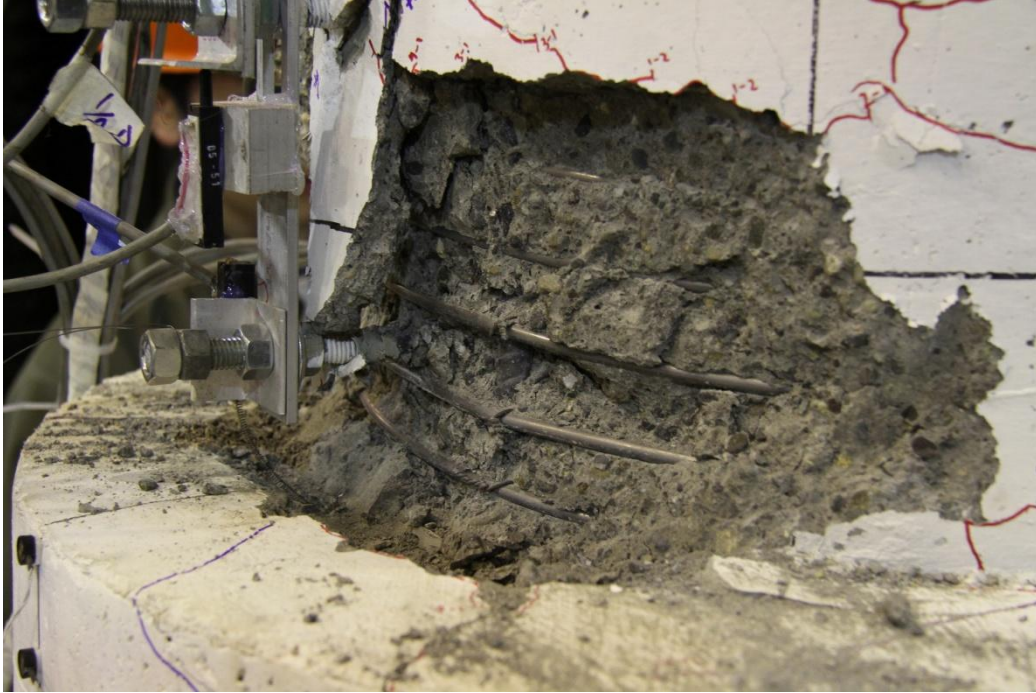
Figure C-0-4. DS-1 – First noticeable bar buckling in the column in Cycle 9-3 (6.90/-6.81 percent drift)

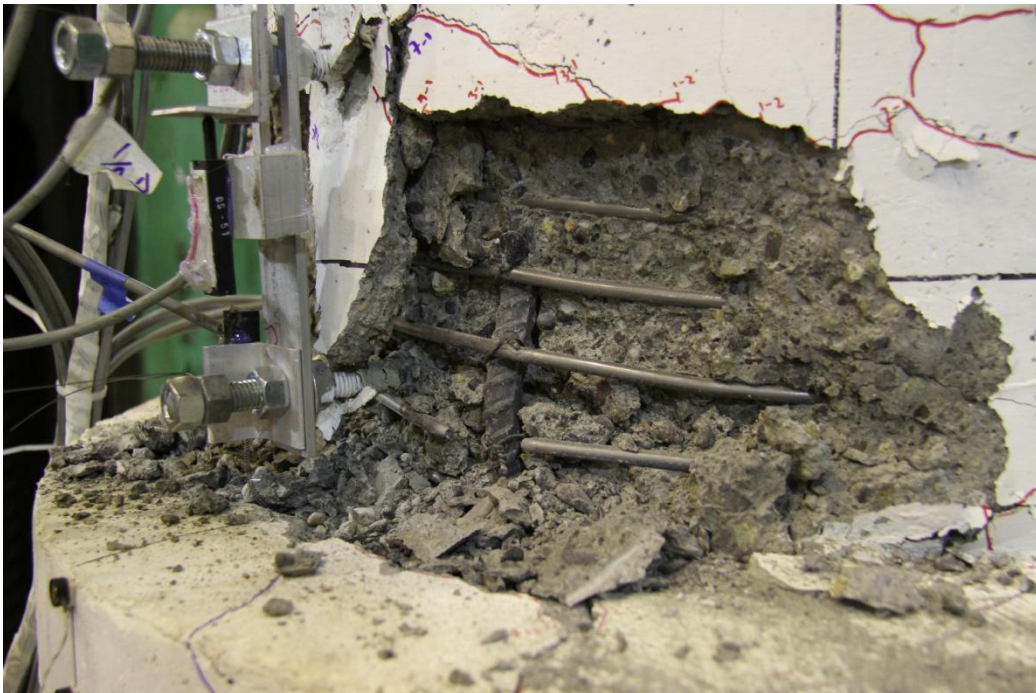
Figure C-0-5. DS-1 – First column spiral fractured in Cycle 10-1 (8.43/-8.27 percent drift)

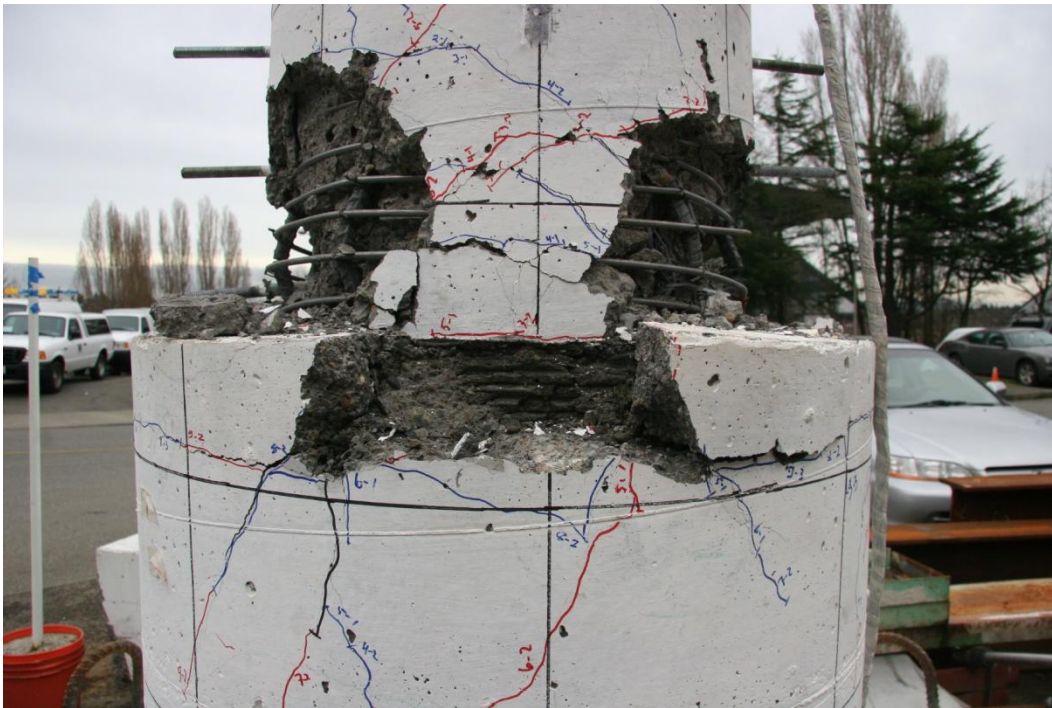
Figure C-0-6. DS-1 – Column damage after cyclic testing

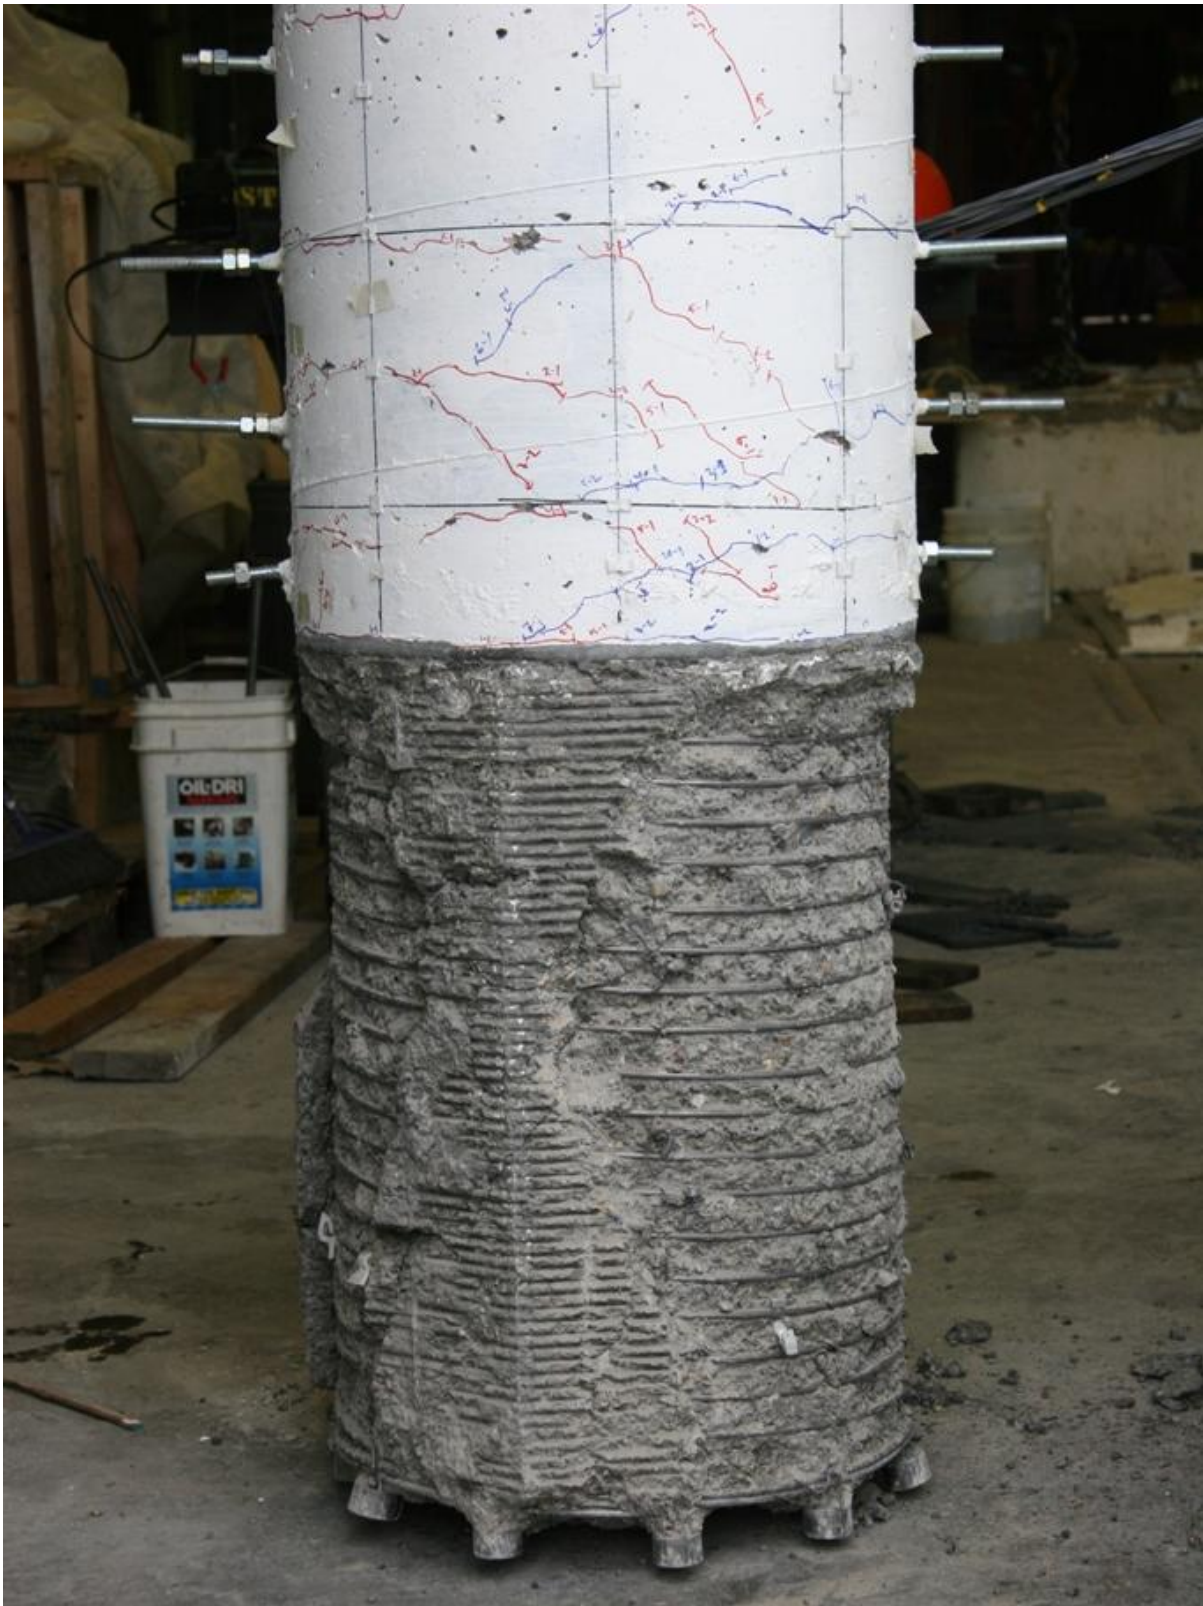
Figure C-0-13. DS-2 – Column damage after cyclic testing
