Seismic Retrofit of Bridges Supported on Hollow Core Prestressed Concrete Pile-
Columns

A thesis

Master of Science in Civil Engineering

University of Washington

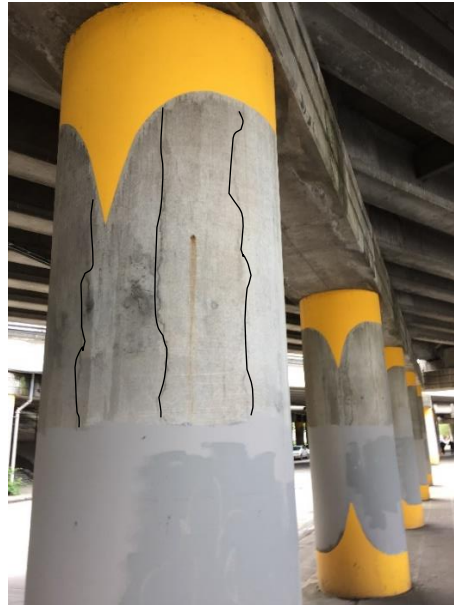
Figure 1-2. Longitudinal cracks on columns of Ravenna Bridge

the first piles were driven (See Figure 1-2). These cracks also aligned well with the three-strand tendons of the column, which were detected using a reinforcement locator, but the precise cause of the cracks is unknown.

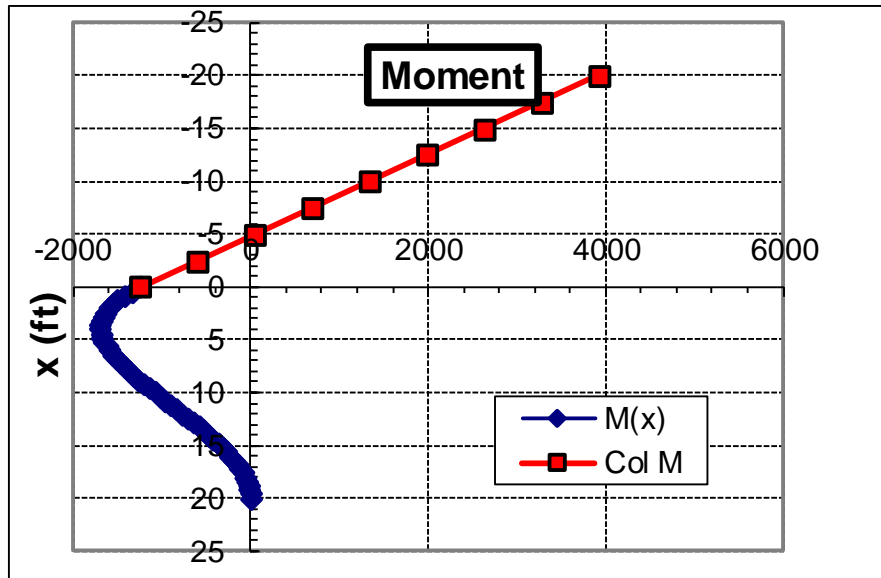
Figure 1-5. Moment demand for as-built conditions

Two locations in the pile-column are particularly susceptible to large moments and were deemed critical by the research team. These are at the cap-beam-column connection and below-grade (See Figure 1-5, grade line is at the x-axis, positive downwards into soil). For elastic response, the above-grade column moments are shown by the red line in Figure 1-5, while the below-grade pile moments are shown in blue and are based on a beam-on-elastic-foundation formulation (Hetényi, 1946). The peak column moment occurs at the cap beam connection and is higher than the peak pile moment, which occurs one to two column diameters below-grade, depending on the soil conditions. The presence of the solid concrete plug at the cap beam connection prevents the inward implosion of the hollow section there under large moments but depending on the length of the plug and the moment gradient along the length of the column, there exists the risk of a hollow section flexural failure just beyond the end of the plug at the sudden change in the column's flexural capacity. The below-grade moment also poses problems as moments high enough to cause potentially non-ductile failure there could be reached after the cap beam connection has yielded. Tests conducted on the as-built specimen and subsequent analysis showed that the more critical component is the cap beam connection. In addition, this location is more practical and convenient for retrofit, and efforts were focused on improving the ductility there by commercially available means.

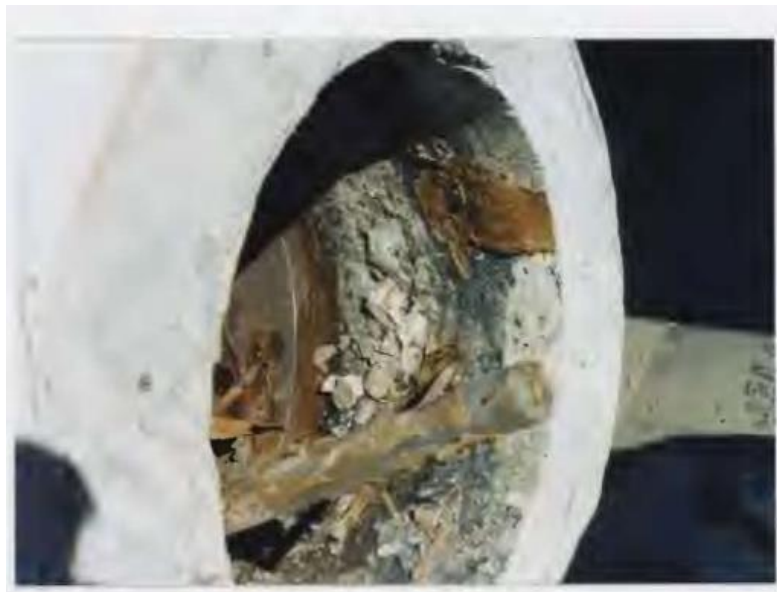
Figure 2-1. Internal spalling at core face of hollow specimen (Fig. 6.1.2., Budek, Benzoni and Priestley, 1997)

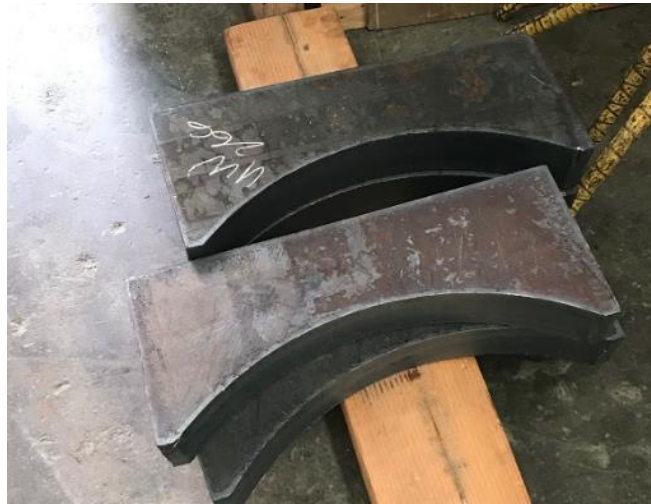
Figure 3-6. Load and support cradles

The two tests to be described in this chapter were chosen by the research team to further understand the behavior, and establish a basis for strength, of the hollow piles in pure bending, as well as combined bending and shear. In order to achieve the desired failure modes while minimizing construction time and resources required, the pile-columns were tested as beams (see Figure 3-4 and Figure 3-5). The support and load cradles were custom made, 4-inch thick steel cradles (see Figure 3-6).

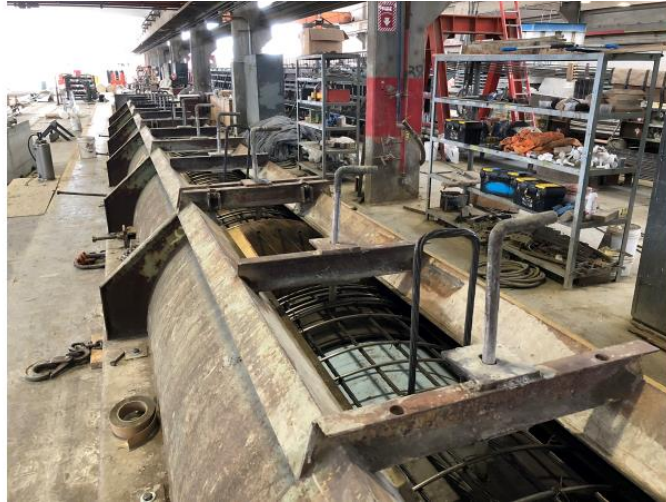
Figure 3-10. Pile-column formwork ready to be line-cast at Concrete Technology Corporation

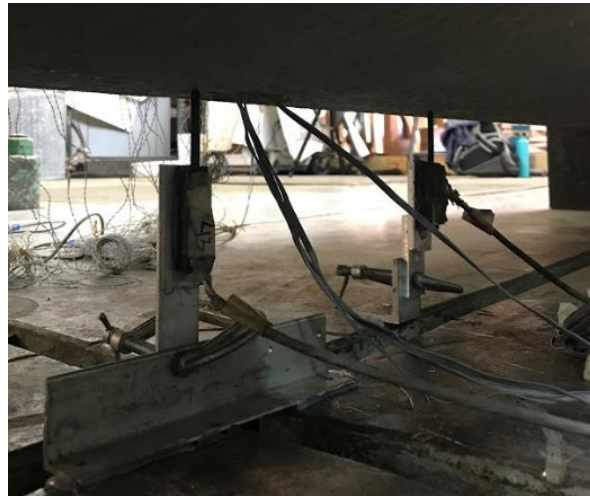
Figure 3-26. Bottom Duncan potentiometers

(Figure 3-27). The displacements measured using the Duncan potentiometers allow for the development of a displacement profile of the specimens under the different loading conditions and determine the rotations along the specimen. The same Duncan potentiometer arrangement was used on both test specimens.

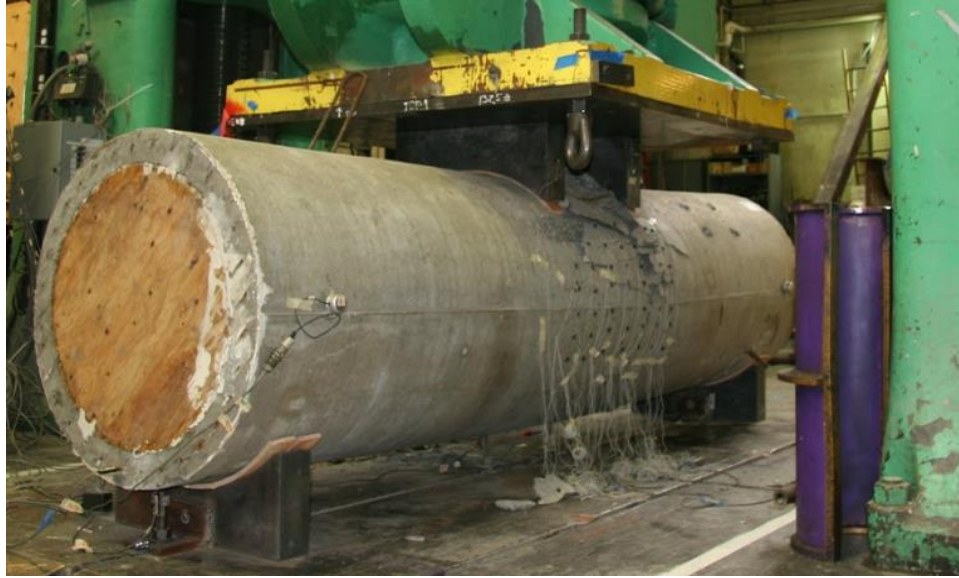
Figure 4-3. Specimen position at failure

Similar behavior was observed on the third cycle, when the specimen was loaded to the same moment demand of the previous cycle (the intention being to give another chance to accurately predict the decompression load, and thus, how much prestressing remained). On the final cycle, a moment demand of 12,761 in-kips was achieved at ultimate failure. During the test there was no visible evidence of premature internal spalling (the primary concern at the start of the research project); however, the internal diaphragms prevented placement of any cameras or sensors inside the specimen to confirm these observations. Ultimate failure occurred due to concrete crushing on the outer face of the wall and subsequent buckling of strands (see Figure 4-2); the specimen position at failure is shown in Figure 4-3.

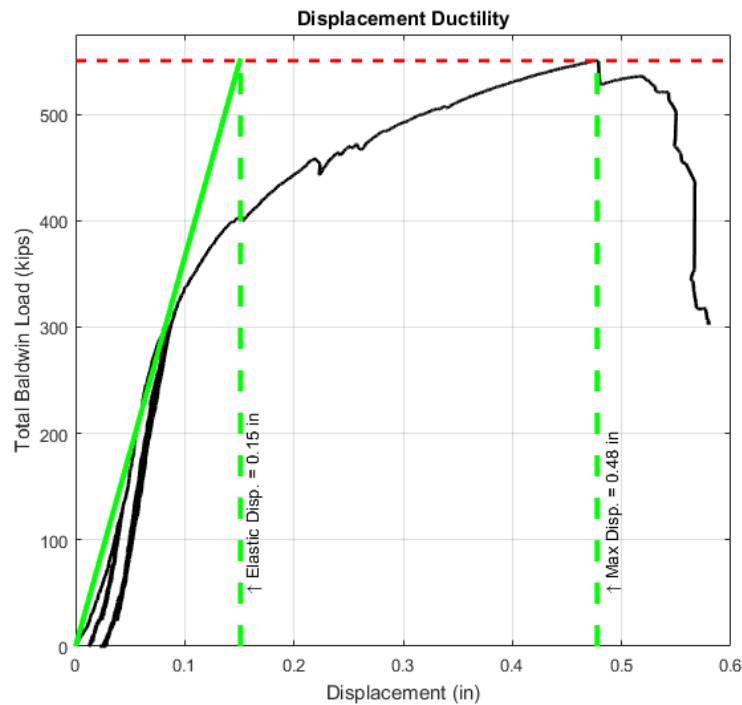
Figure 4-5. Displacement ductility in pure bending

The linear elastic (uncracked) stiffness line was drawn tangent to the measured data, which resulted in an elastic displacement of 0.15 in. The load at peak displacement was 0.48 in, leading to an elastic ductility ratio of 3.2. The slope of this elastic stiffness is lower than the theoretical value (see Appendix C). If the latter were to be used, the elastic ductility ratio would be higher.

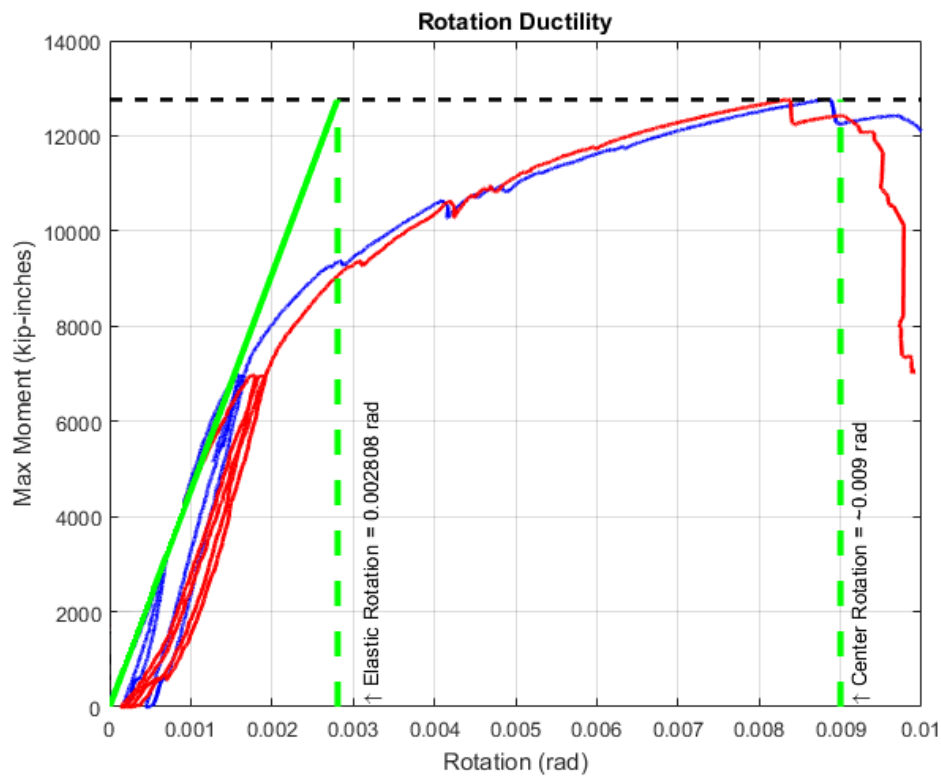
Figure 4-8. Center moment-rotation curves with associated ductility measurements

In Figure 4-8 the moment-rotation curves from the center potentiometers are isolated to calculate the associated rotation ductility factor. Again, a linear elastic stiffness tangent to the measured data is projected to the maximum moment achieved. The corresponding “elastic rotation” is 0.0028 radians, while the total achieved rotation was ~0.009 radians, giving an elastic ductility ratio of 3.20 (same as the displacement ductility). The drop in strength after the peak moment was rapid (see Figure 4-7), suggesting that failure was initiated by external spalling, followed almost immediately by internal spalling.

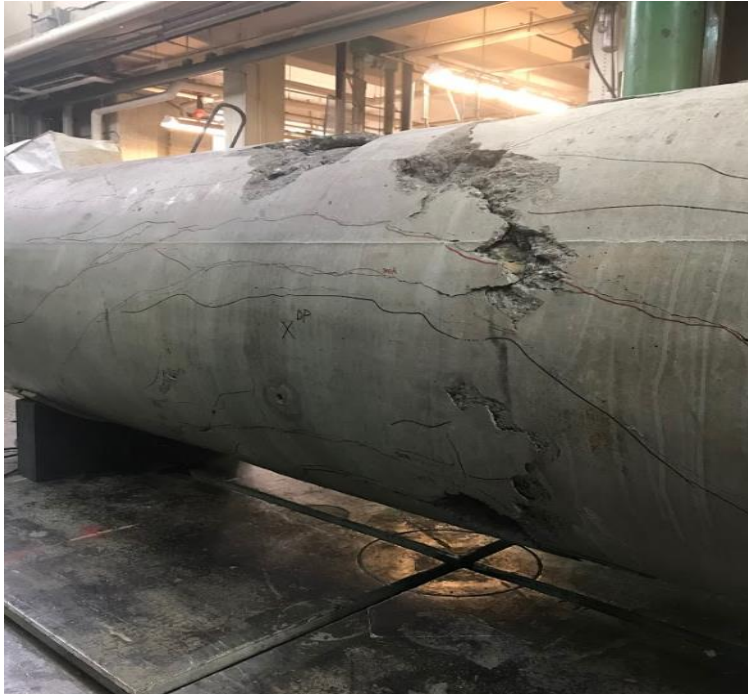
Figure 5-1. Specimen position after failure, note the angle of the cracks

In this section, the observed behavior is discussed. The test protocol described in Table 3-2 was implemented, starting with a cycle to check instruments and check the settlement of the Cotton Duck Padding (CDP). A shear demand of 100 kips was achieved on the first cycle, corresponding to a mid-span deflection of approximately 0.05-inches, and it caused the specimen to crack. This load was smaller than the predicted cracking load. This was attributed to the additional stresses due to bending and prestressing that were not originally accounted for in the cracking load prediction. On the next cycle, a shear demand of approximately 165 kips was achieved, followed by a cycle to failure that achieved a total load of 478 kips (or a shear demand of 239 kips). Figure 5-1 shows the specimen after failure. During the test, progressive cracking occurred in both of the hollow regions. The cracks grew at an incline flatter than 45° (see Figure 5-1). This is consistent with the existence of longitudinal compression from the prestressing.

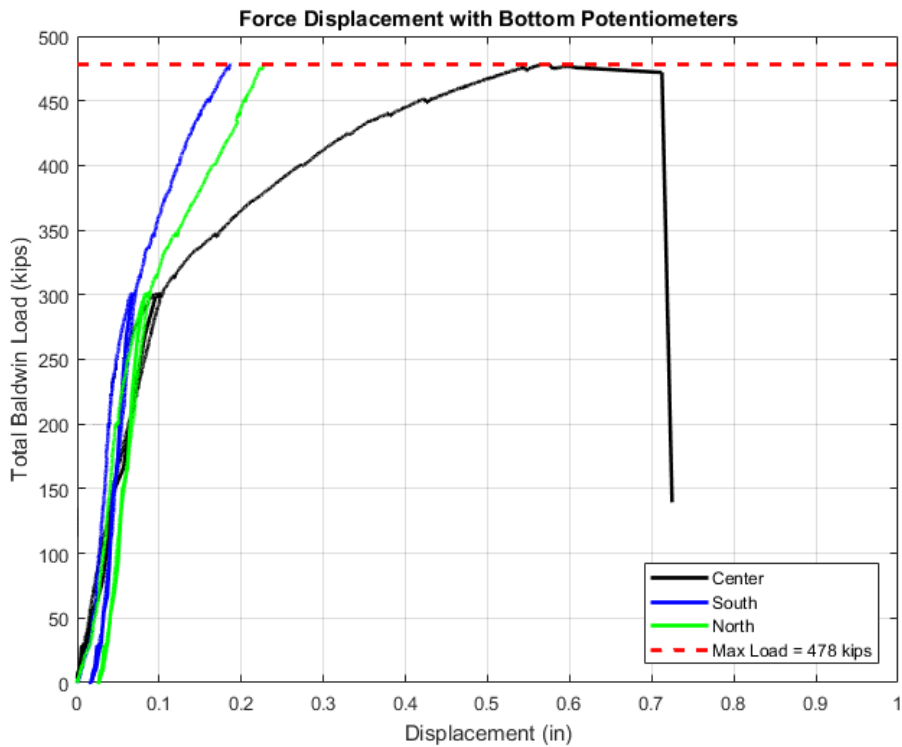
Figure 5-2. Force-displacement curve for all bottom potentiometers

The maximum achieved force was 478 kips, corresponding to 239 kips of shear demand. Figure 5-2 shows the force-displacement curve, as measured by the potentiometers along the bottom of the specimen.

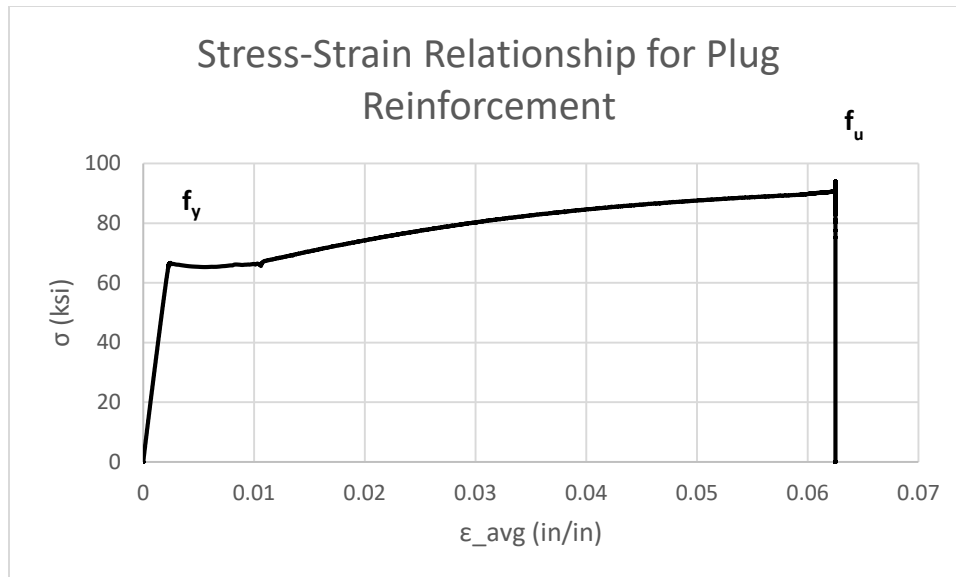
Figure 6-8. Stress-strain relationship for plug reinforcement

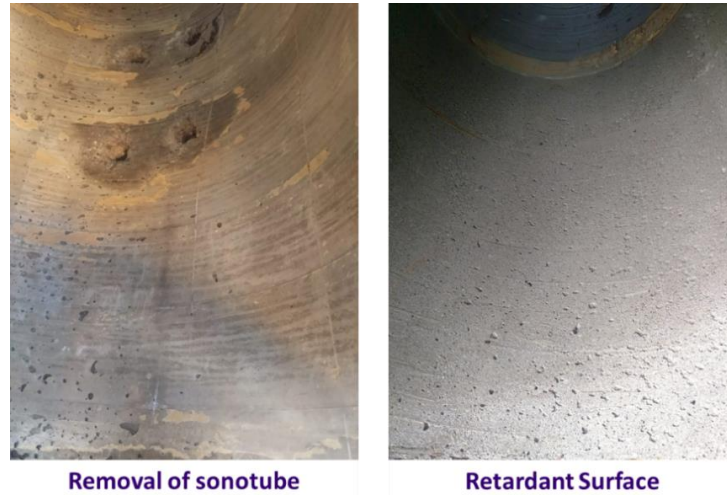
Figure 6-9. Comparison of surface roughness after removal of sonotube, with and without retardant

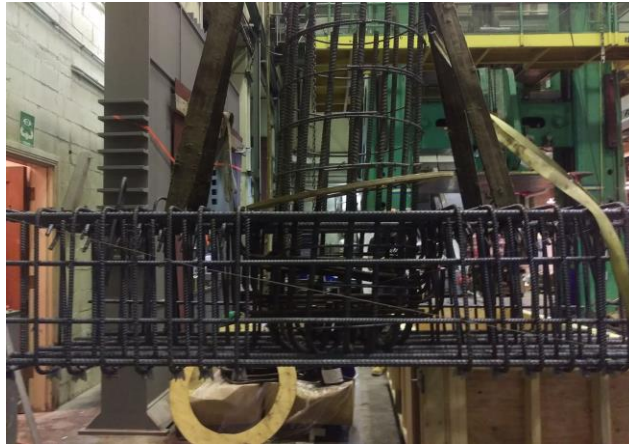
Figure 6-11. Reinforcement cage for cap beam being lifted into formwork for casting

The cap beam reinforcement cage, including the plug reinforcement, was fabricated outside of the formwork and then positioned into the beam form (see Figure 6-11).

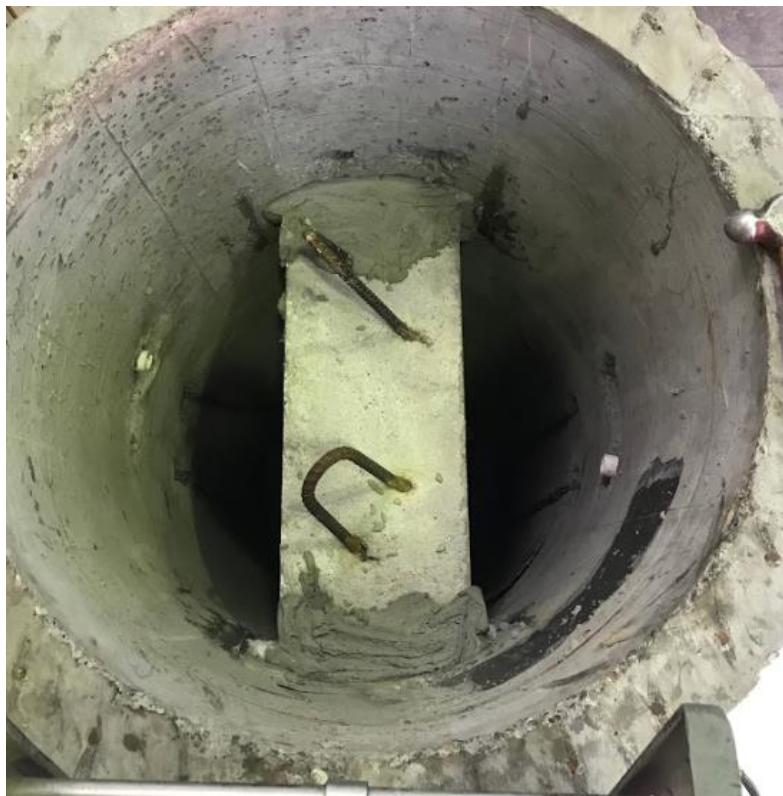
Figure 6-19. Concrete diaphragm to prevent punching shear (temporary wood formwork)

The actuator was connected to the specimen using four 1-inch diameter high-strength steel threaded rods and two steel plates (1 inch thick) with timber and steel shims and thin rubber pads to protect the concrete wall (see Figure 8-4). The timber shims were machined to conform to the outside circumference of the column. On the interior of the specimen, a precast concrete diaphragm was grouted in place between the rods to eliminate the possibility of punching shear through the thin pile-column walls by the applied lateral load (see Figure 6-19).

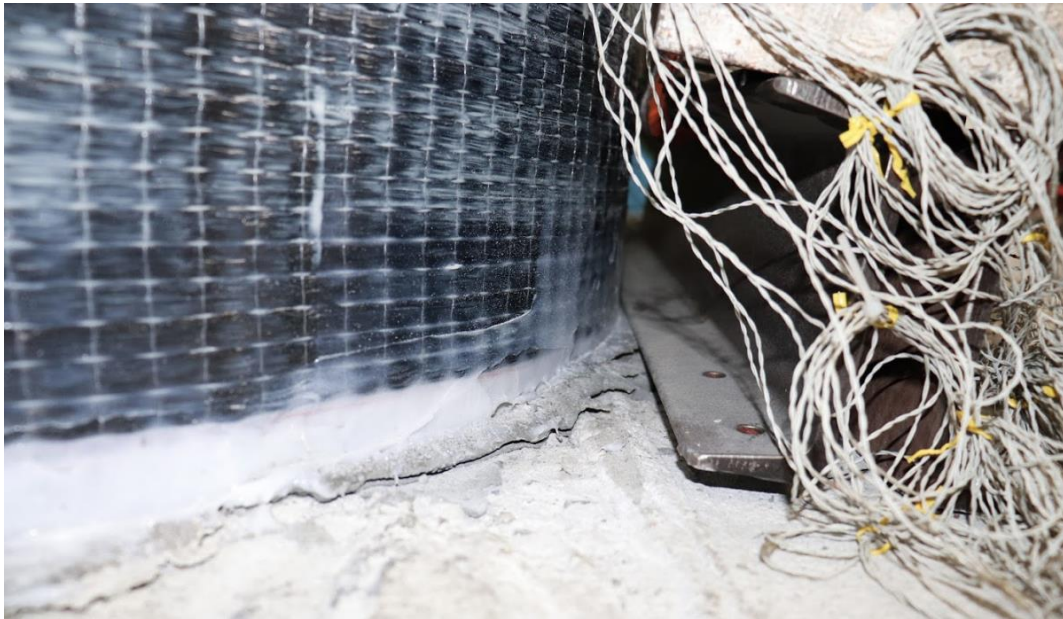
Figure 7-4. Uplift on Cycle 3 of Series 3 (+0.78%, -1.20% drift)

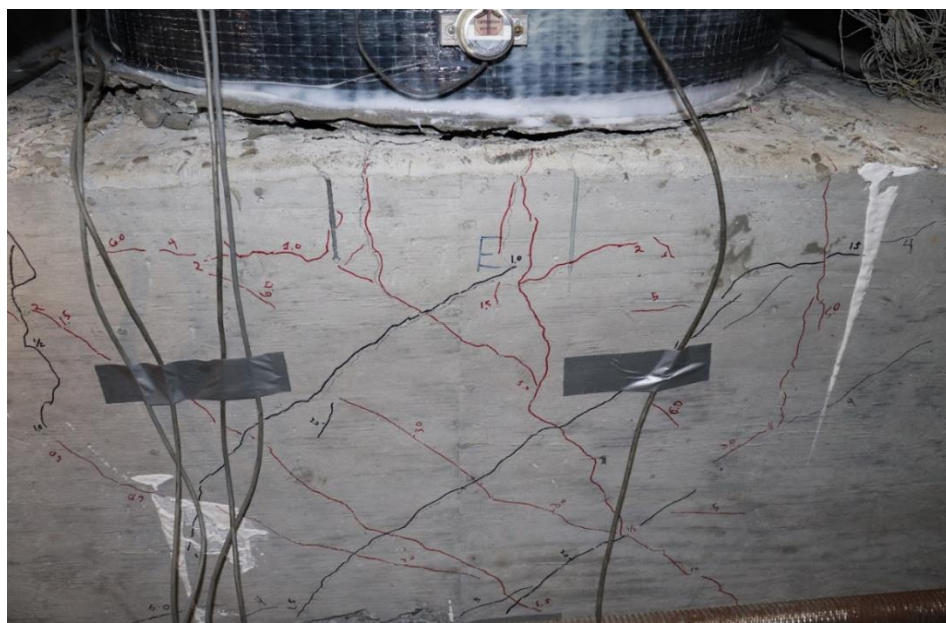
Figure 7-5. Progressive joint shear cracking on base beam on Series 8 (+4.70%, -5.49% drift)

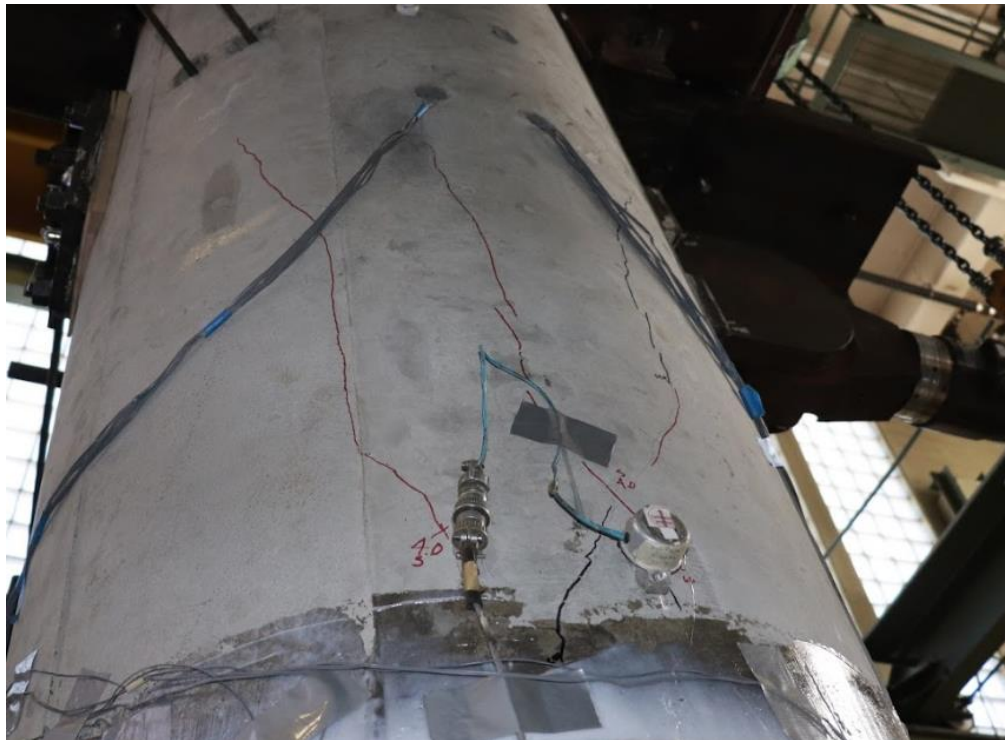
Figure 7-8. Progressive cracking above fiber on Series 8 (+4.71%, -5.49%)

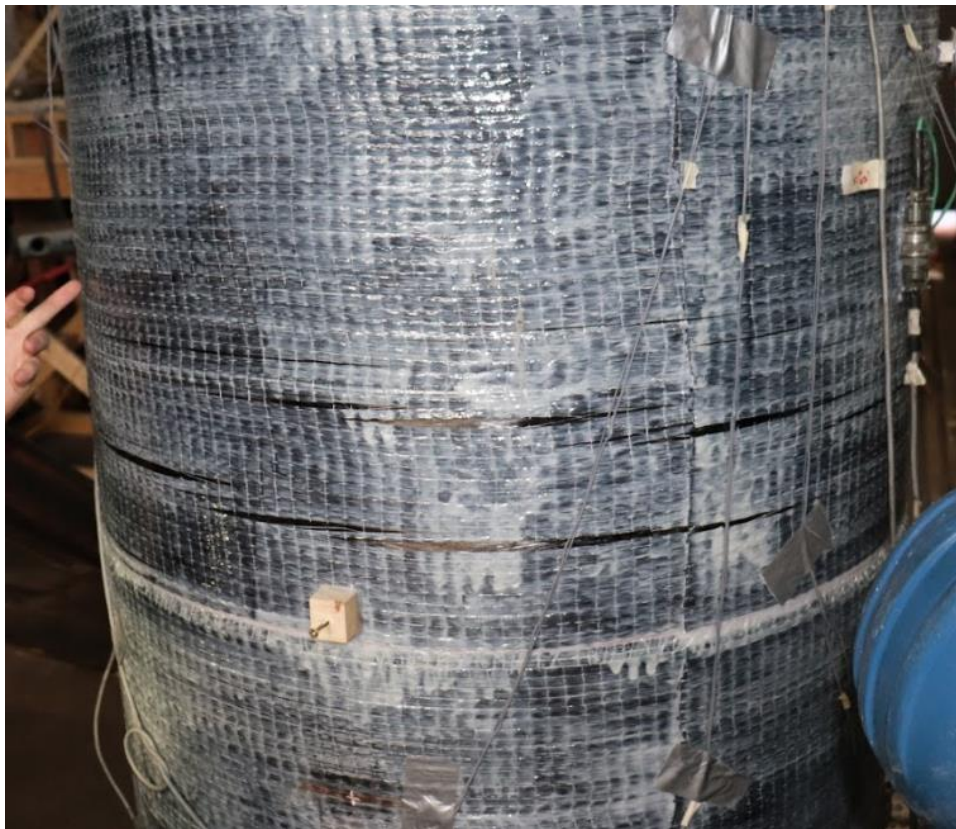
Figure 7-13. Fiber splitting on south face during Series 10

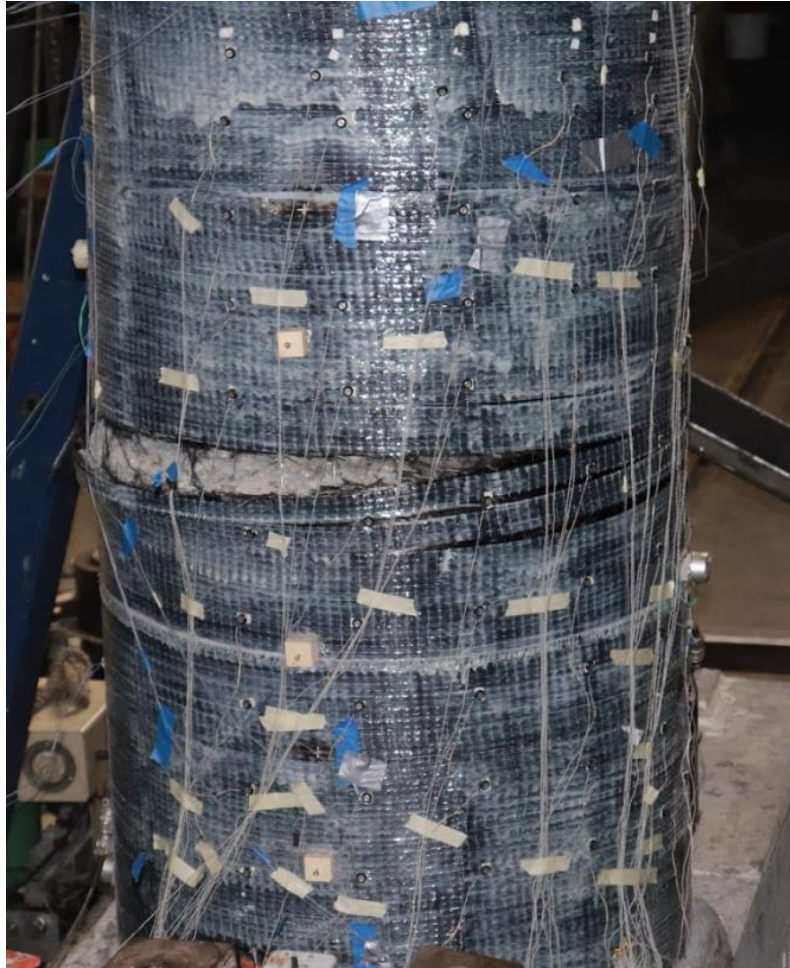
Figure 7-14. Fiber rupture on north face during Series 11

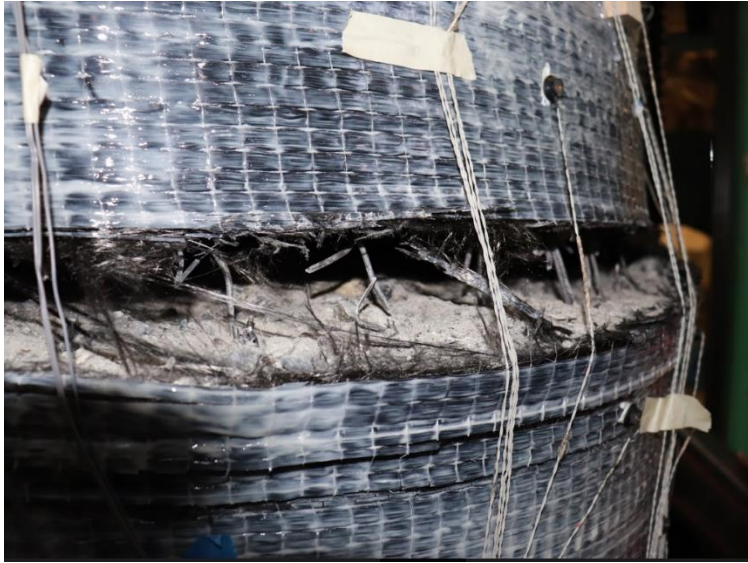
Figure 7-15. Widened fiber split on north face during Series 11

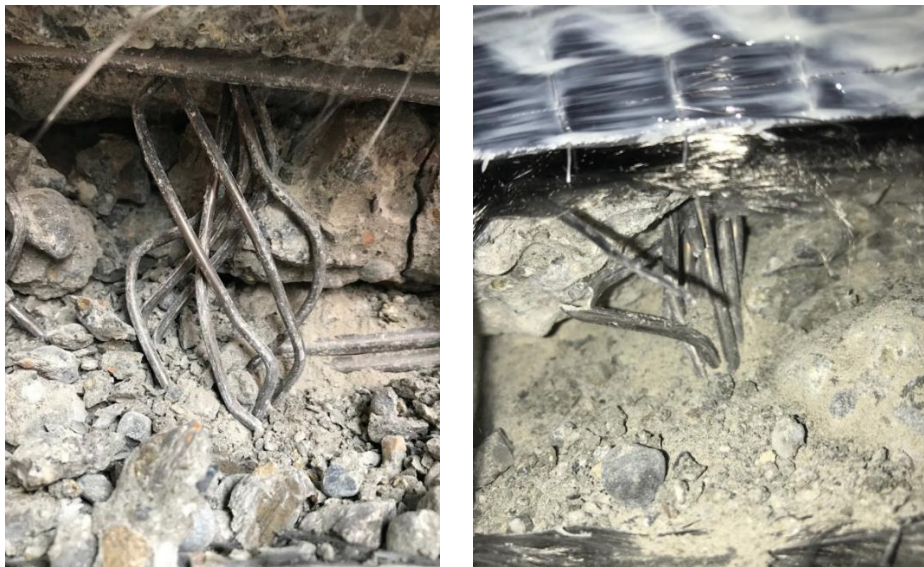
Figure 7-16. Buckled strand (left) and fractured strand (right)

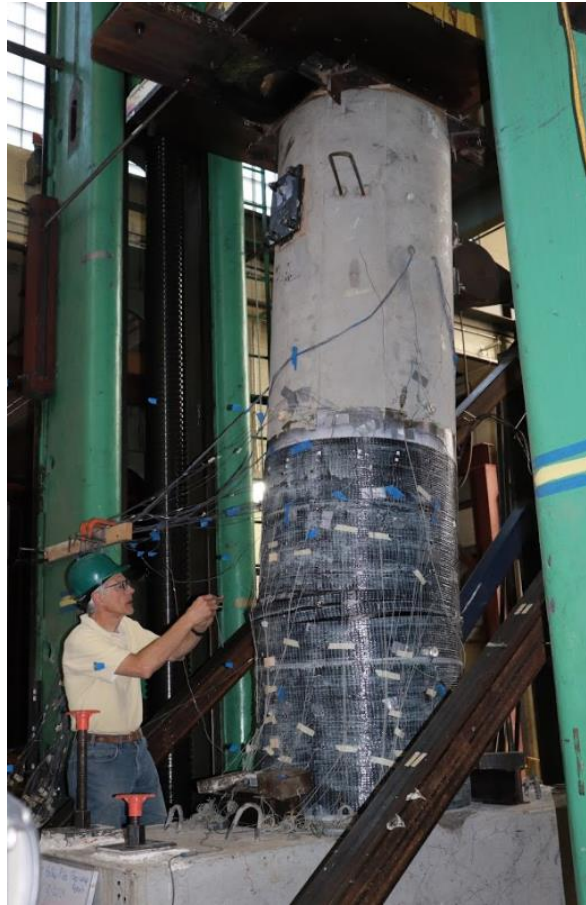
Figure 7-17. Specimen position at +8.09% drift

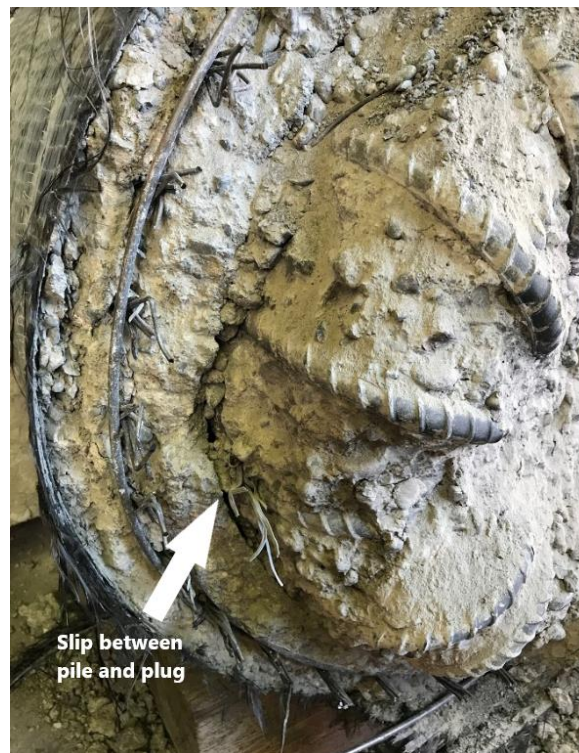
Figure 7-18. Looking down at plug reinforcement after top segment of specimen (portion above the plug in test orientation) had been removed

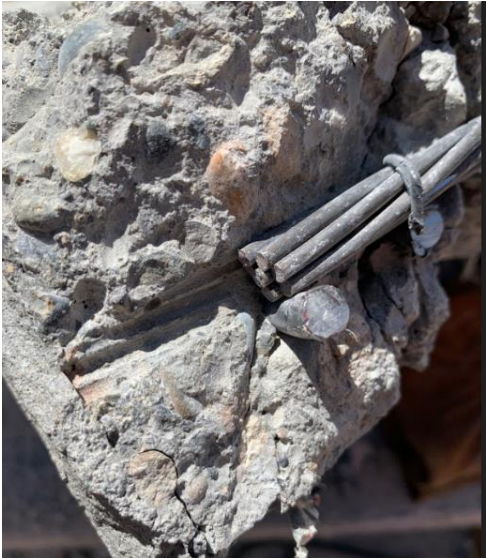
Figure 7-21. Strand slip at the base of the pile-column wall

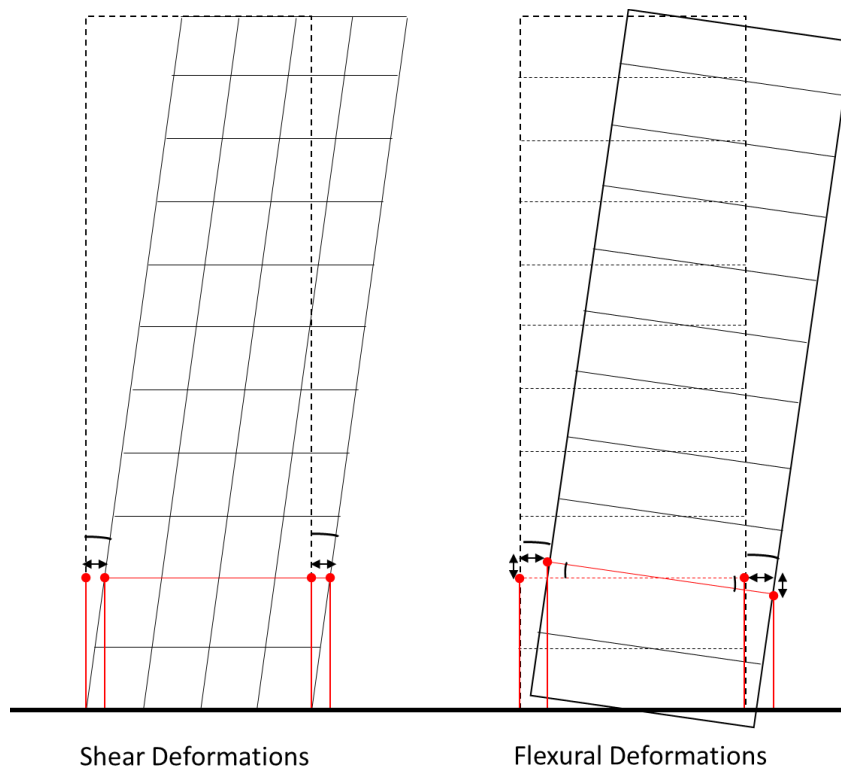
Figure 7-30. Shear vs. flexural deformations due to pile-column displacement

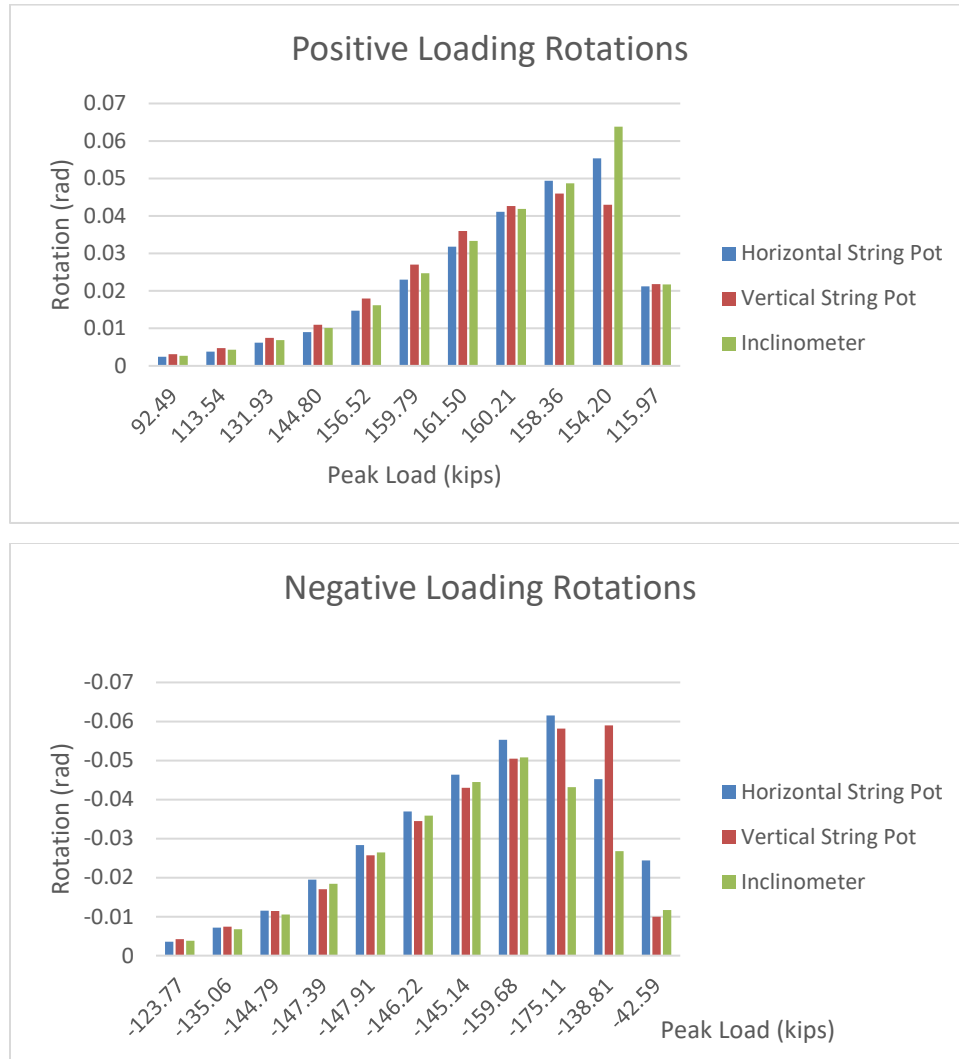
Figure 7-31. Rotations due to vertical and horizontal displacement of pile-column

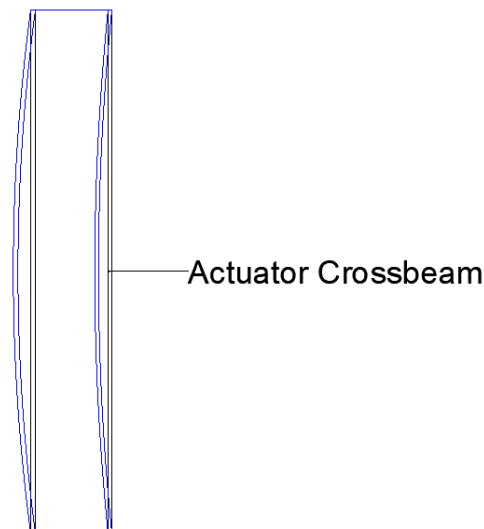
Figure 8-2. Flexing of actuator crossbeam

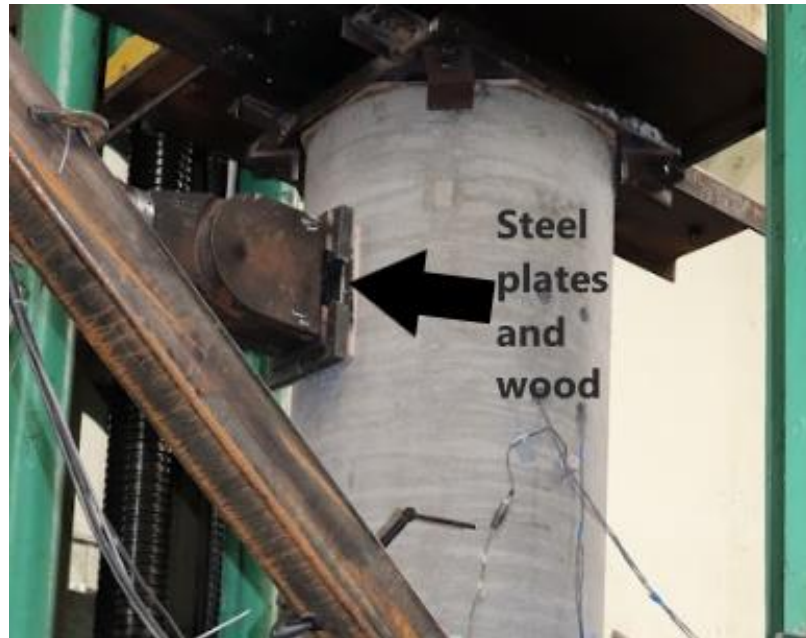
Figure 8-4. Packing underneath actuator connected to specimen

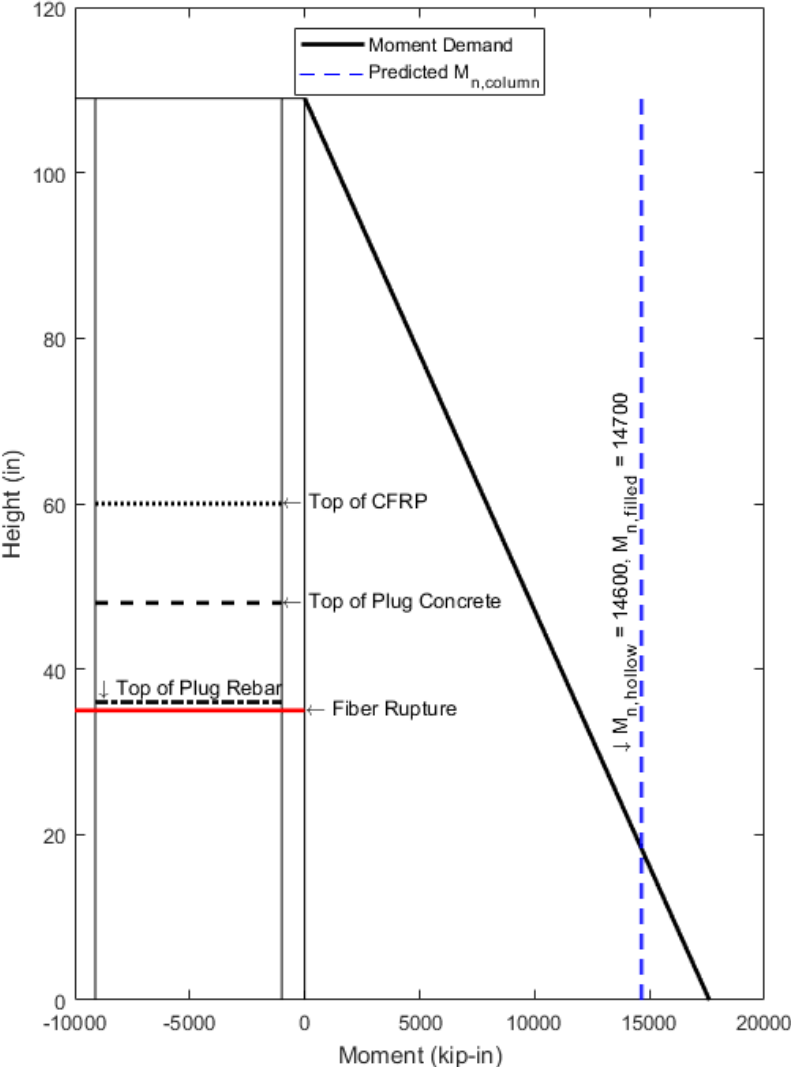
Figure 8-8. Conditions at maximum moment

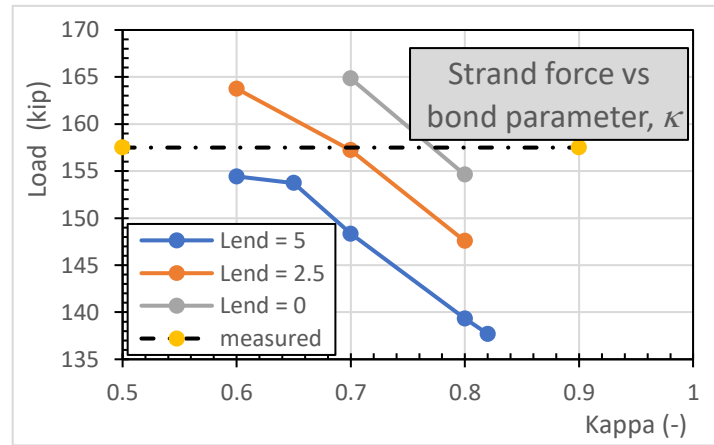
Figure 8-15. Test pile-column ($z = 35$ inches). Effect of L_{end} and κ on predicted failure load.

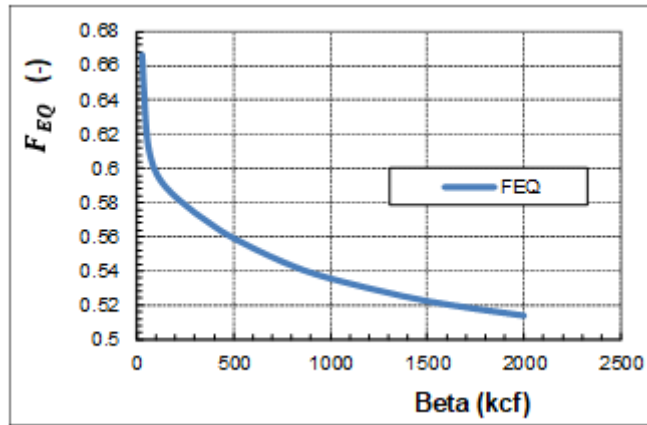
Figure 9-8. Earthquake Scale Factor for plug yielding vs soil stiffness.

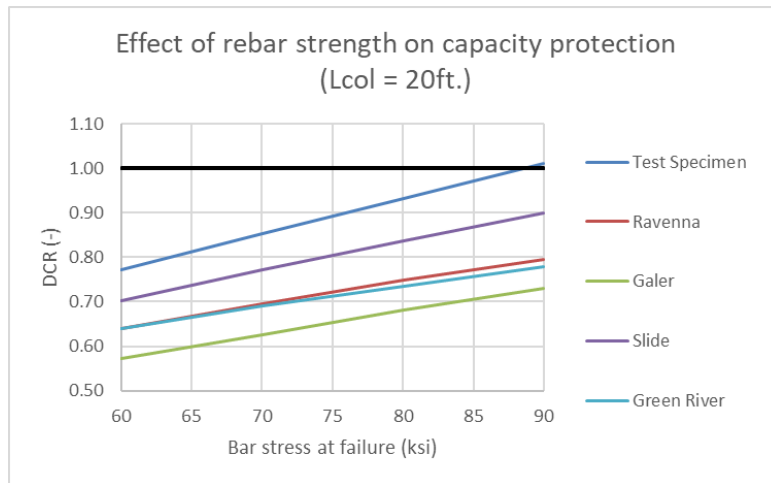
Figure 9-15. Effect of bar stress at failure on DCR at end of plug ($L_{col} = 20$ ft.)

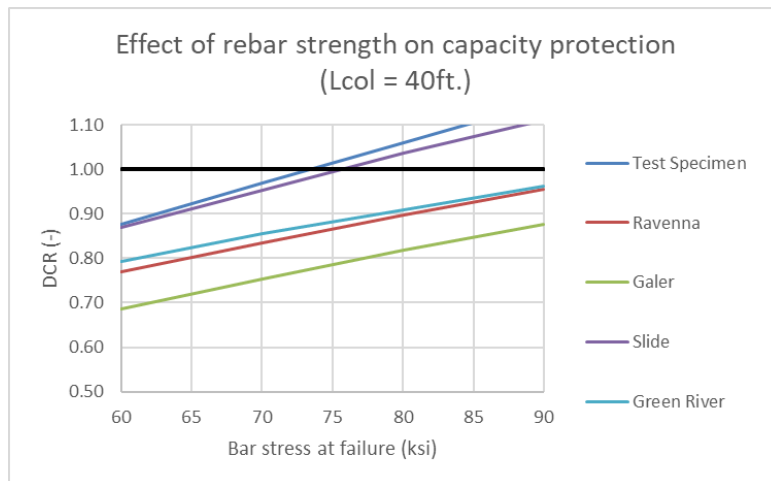
Figure 9-16. Effect of bar stress at failure on DCR at end of plug ($L_{col} = 40$ ft.)
